**ALBERTA TRANSPORTATION
GEOHAZARD ASSESSMENT PROGRAM
PEACE REGION (GRANDE PRAIRIE DISTRICT- NORTH)
2021 INSPECTION**

Site Number	Location	Name	Hwy	km
PH067	West of Fairview	East Hill Ditch Erosion Section	682:02	13.8-14.1
Legal Description		UTM Co-ordinates (NAD 83)		
Centre 36-81-5-W6		11 N 6214450	E 398000

**PH067-1: HWY 682:02 - HINES CREEK
 2021 INSPECTION PLAN**

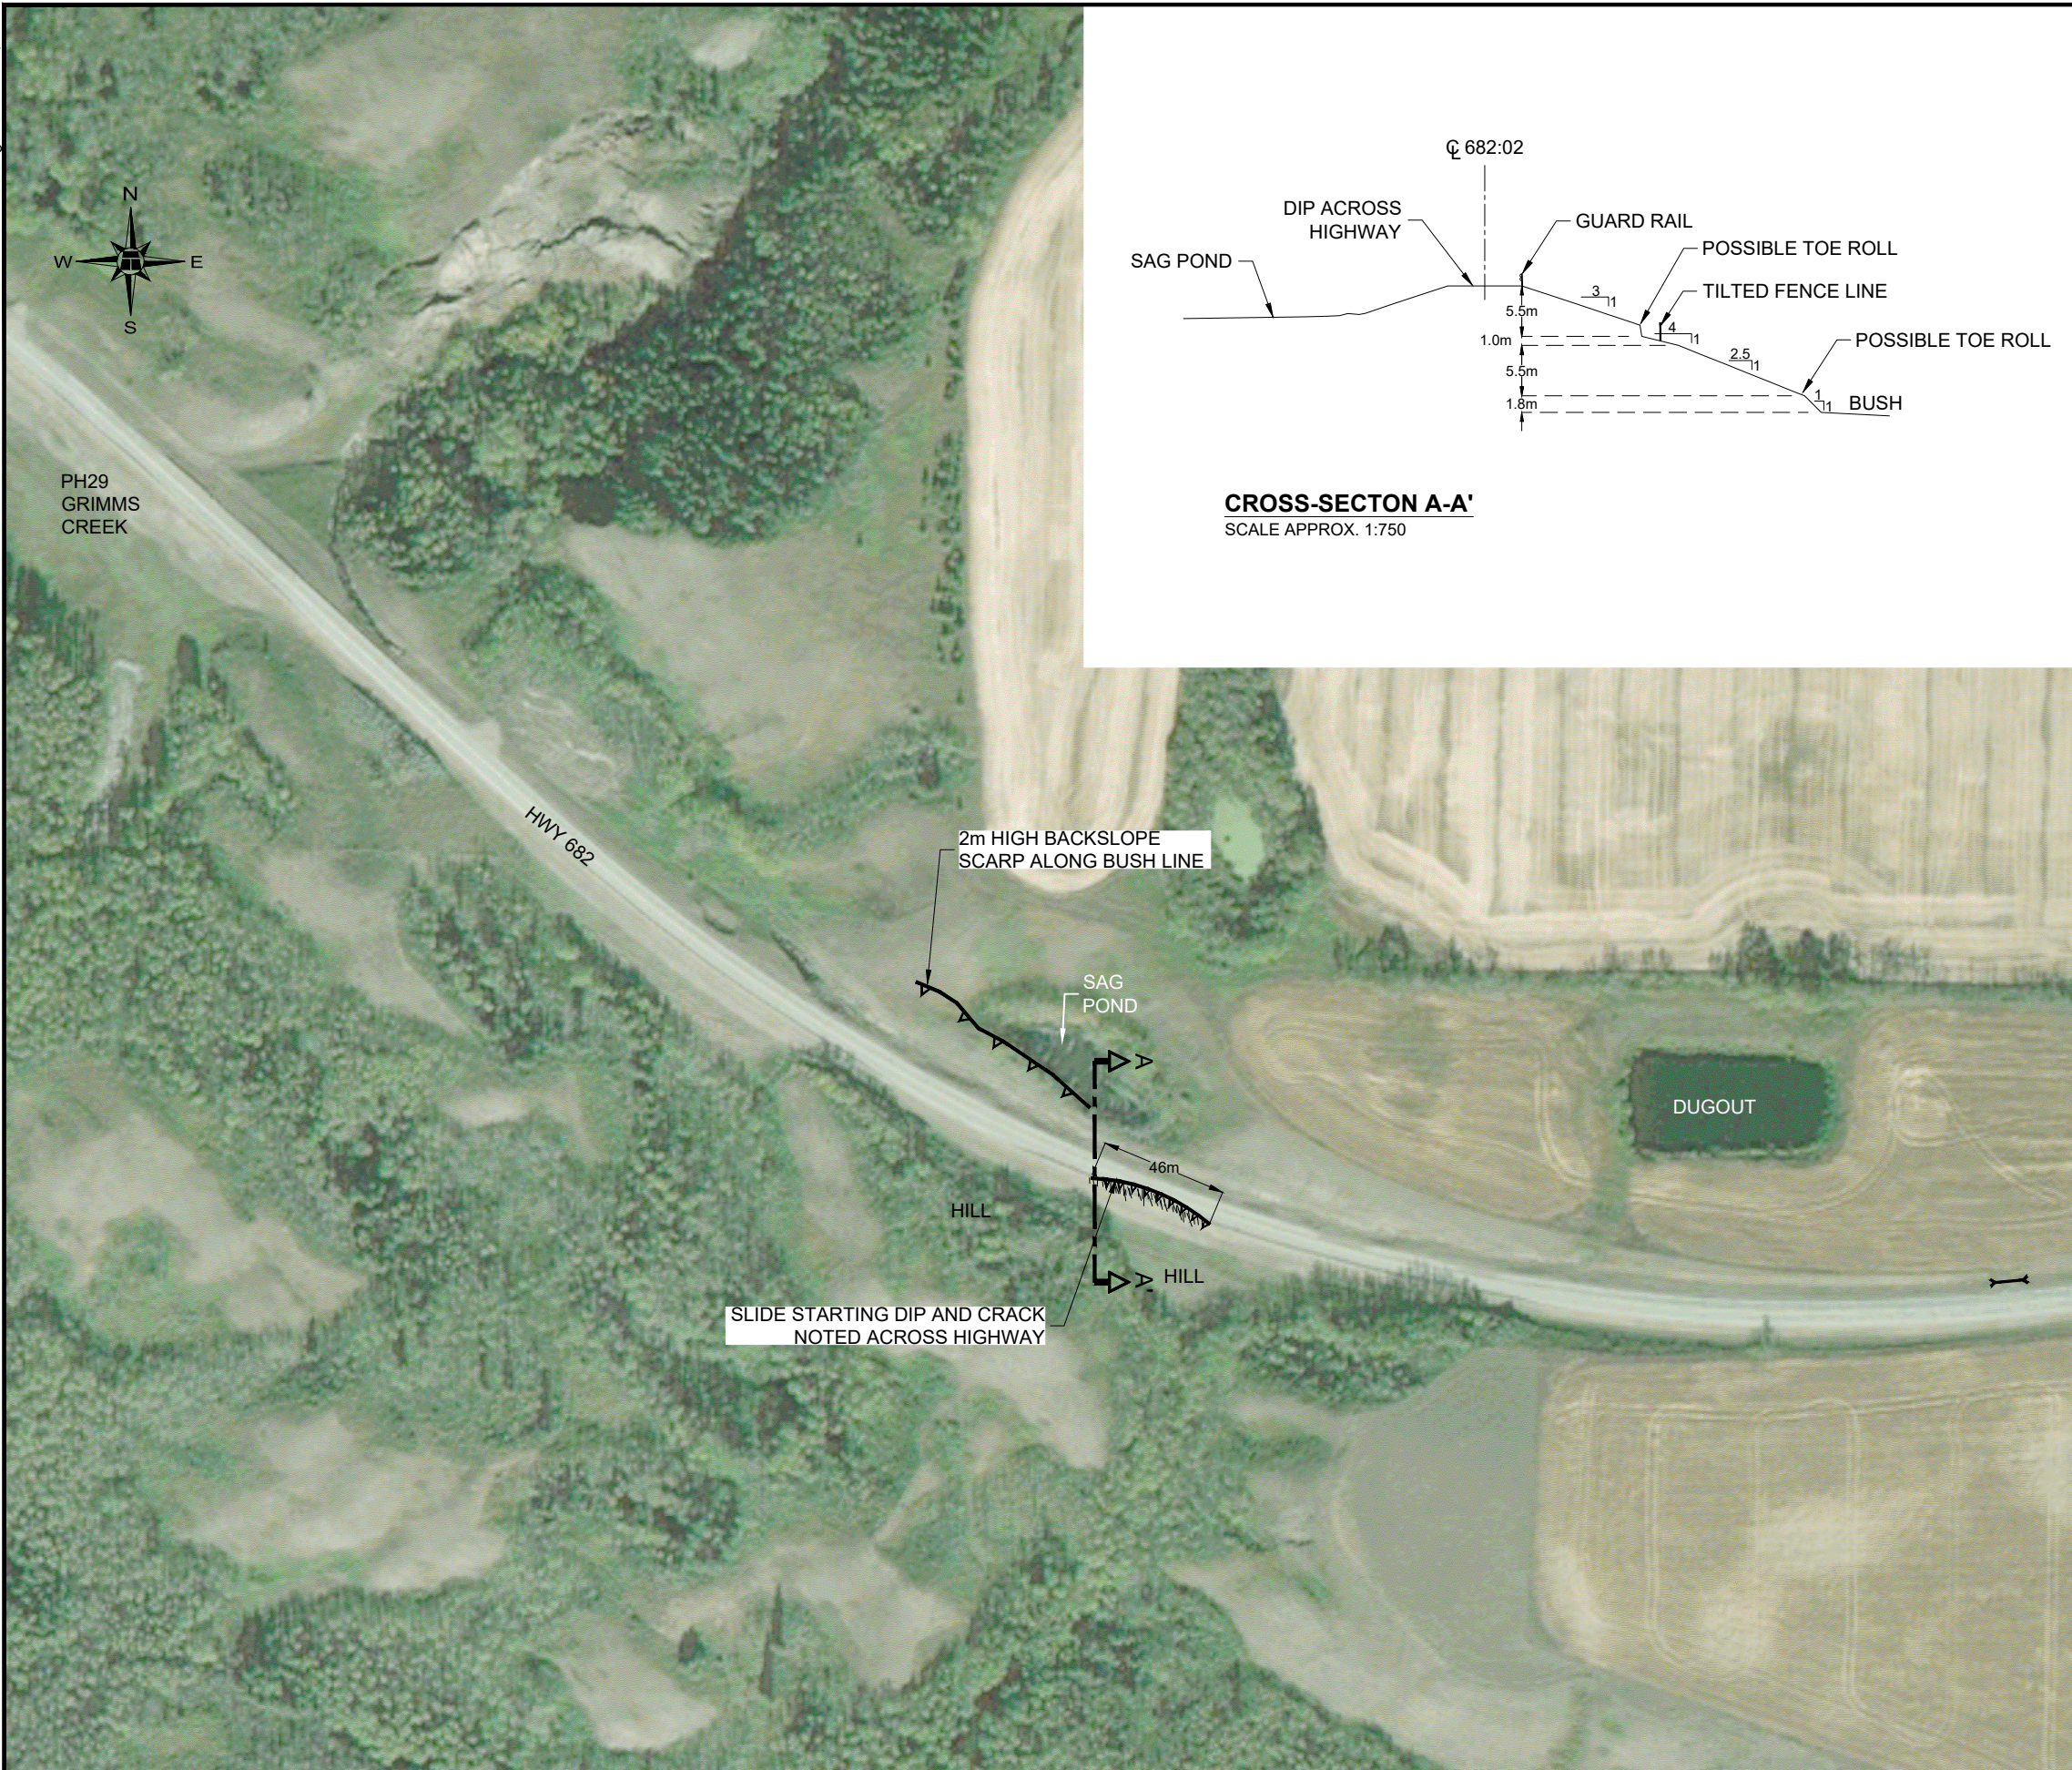
H:\32000\32123 AT GRMP Grande Prairie District North 2021-2025\CAD\BDM\32123 PH067-1-1.dwg - 1 - Oct. 07, 2021

- NOTES :**
1. FEATURE LOCATIONS ARE APPROXIMATE
 2. PREVIOUS OBSERVATIONS SHOWN IN BLACK
 3. **JULY 13, 2021 FEATURES SHOWN IN RED**
 4. ADVANCED ABRASION & SPALLING OF ACB MAT BLOCKS AND MANY BROKEN BLOCKS ALONG CENTER BASE OF CHANNEL; SOME MATS WORSE THAN OTHERS.
 5. HIGHWAY SAND / SALT STAINING ALONG BASE & HIGHWAY SIDE OF ACB MATS IN CHANNEL.
