**ALBERTA TRANSPORTATION
GEOHAZARD ASSESSMENT PROGRAM
PEACE REGION (GRANDE PRAIRIE DISTRICT- NORTH)
2022 INSPECTION**

Site Number	Location	Name	Hwy	km
PH067	West of Fairview	East Hill Ditch Erosion Section	682:02	13.8-14.1
Legal Description		UTM Co-ordinates (NAD 83)		
Centre 36-81-5-W6		11 N 6214450	E 398000

PH067-1: HWY 682:02 - HINES CREEK
2022 INSPECTION PLAN

PEACE REGION (GRANDE PRAIRIE DISTRICT - NORTH)
PH067-1: HWY 682:02 km 11.6 TO 14.1
DITCH EROSION REPAIRS
SITE 3
DWG No. 32123-PH067-1-2

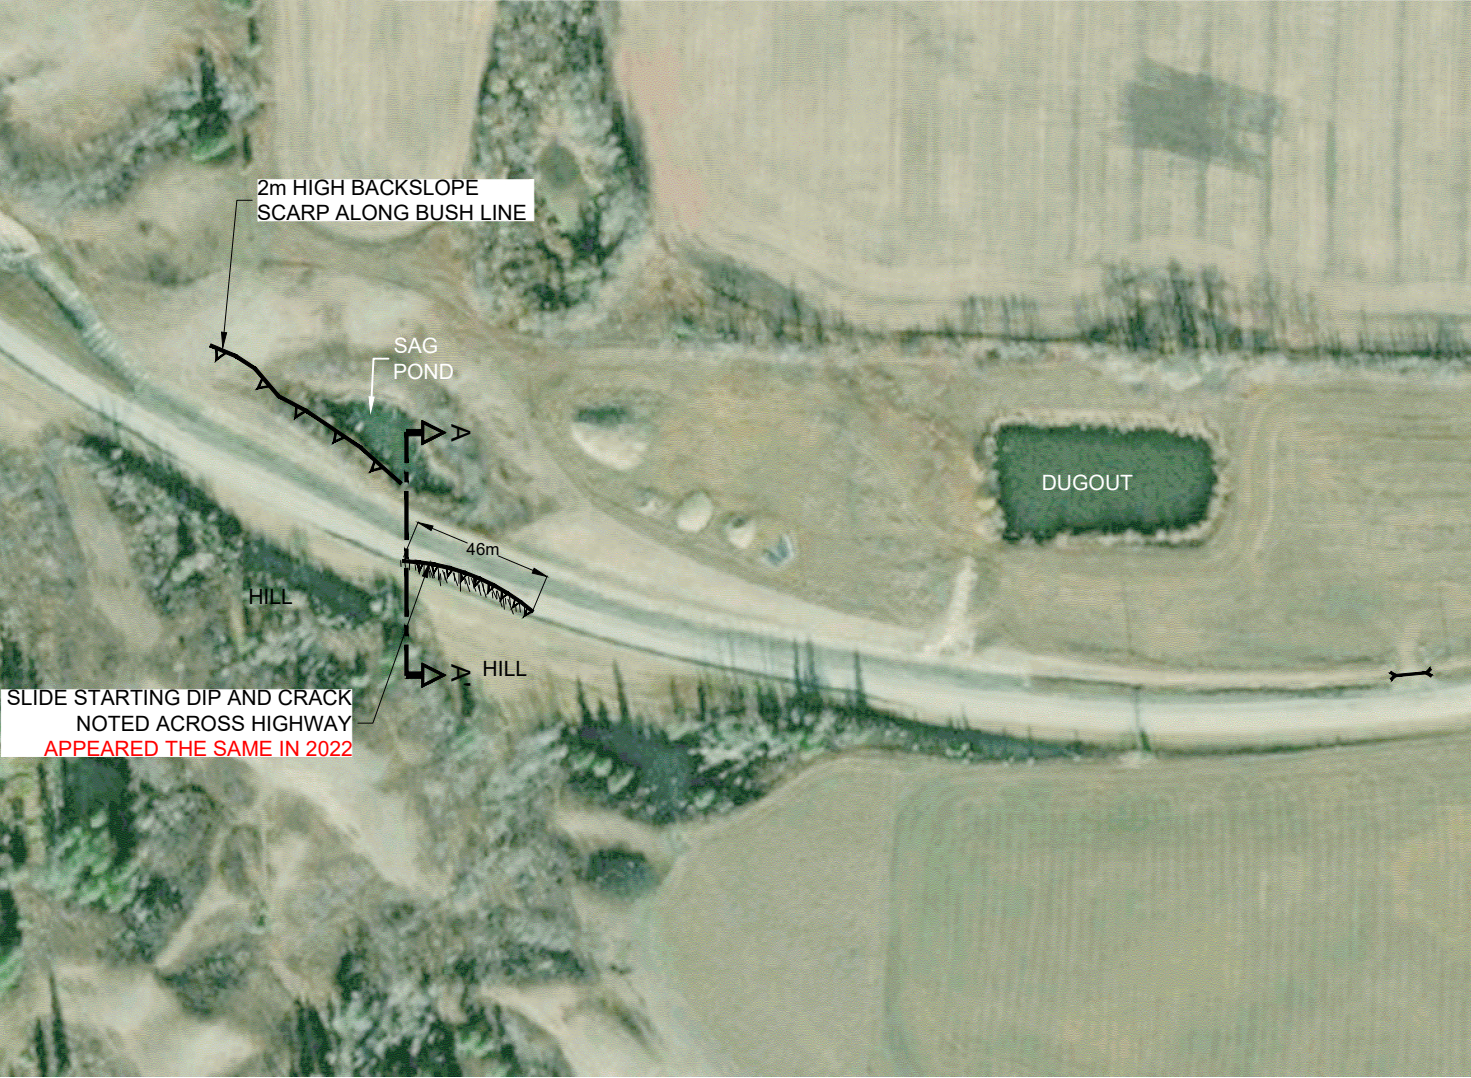
1. FEATURE LOCATIONS ARE APPROXIMATE
2. PREVIOUS OBSERVATIONS SHOWN IN BLACK
3. **MAY 17, 2022 FEATURES SHOWN IN RED**
4. ADVANCED ABRASION & SPALLING OF ACB MAT BLOCKS AND MANY BROKEN BLOCKS ALONG CENTER BASE OF CHANNEL; SOME MATS WORSE THAN OTHERS.
5. HIGHWAY SAND / SALT STAINING ALONG BASE & HIGHWAY SIDE OF ACB MATS IN CHANNEL.
