**ALBERTA TRANSPORTATION
GEOHAZARD ASSESSMENT PROGRAM
PEACE REGION – GRANDE PRAIRIE DISTRICT - NORTH
2021 INSPECTION**

Site Number	Location	Name	Hwy	km
PH077-1 and 77-2	West of Fairview	Sites E of Hines Creek Bridge	682:02	12.5-12.8
Legal Description		UTM Co-ordinates (NAD 83)		
NE35-81-5-W6		11V N 6215000	E 396650

Date	PF	CF	Total
Previous Inspection:	June 17, 2020	11	4	44 (PH077-1)
		13	4	52 (PH077-2)
Current Inspection:	July 13, 2021	13	4	52 (PH077-1)
		9	4	36 (PH077-2)
Road AADT:	160	Year:		2020
Inspected By:	Ed Szmata, AT Roger Skirrow, AT Rocky Wang, AT Max Shannon, AT Ken Szmata, AT		Barry Meays, Thurber Nicole Wilder Thurber	
Report Attachments:	<input checked="" type="checkbox"/> Photographs		<input checked="" type="checkbox"/> Plans	<input checked="" type="checkbox"/> Maintenance Items

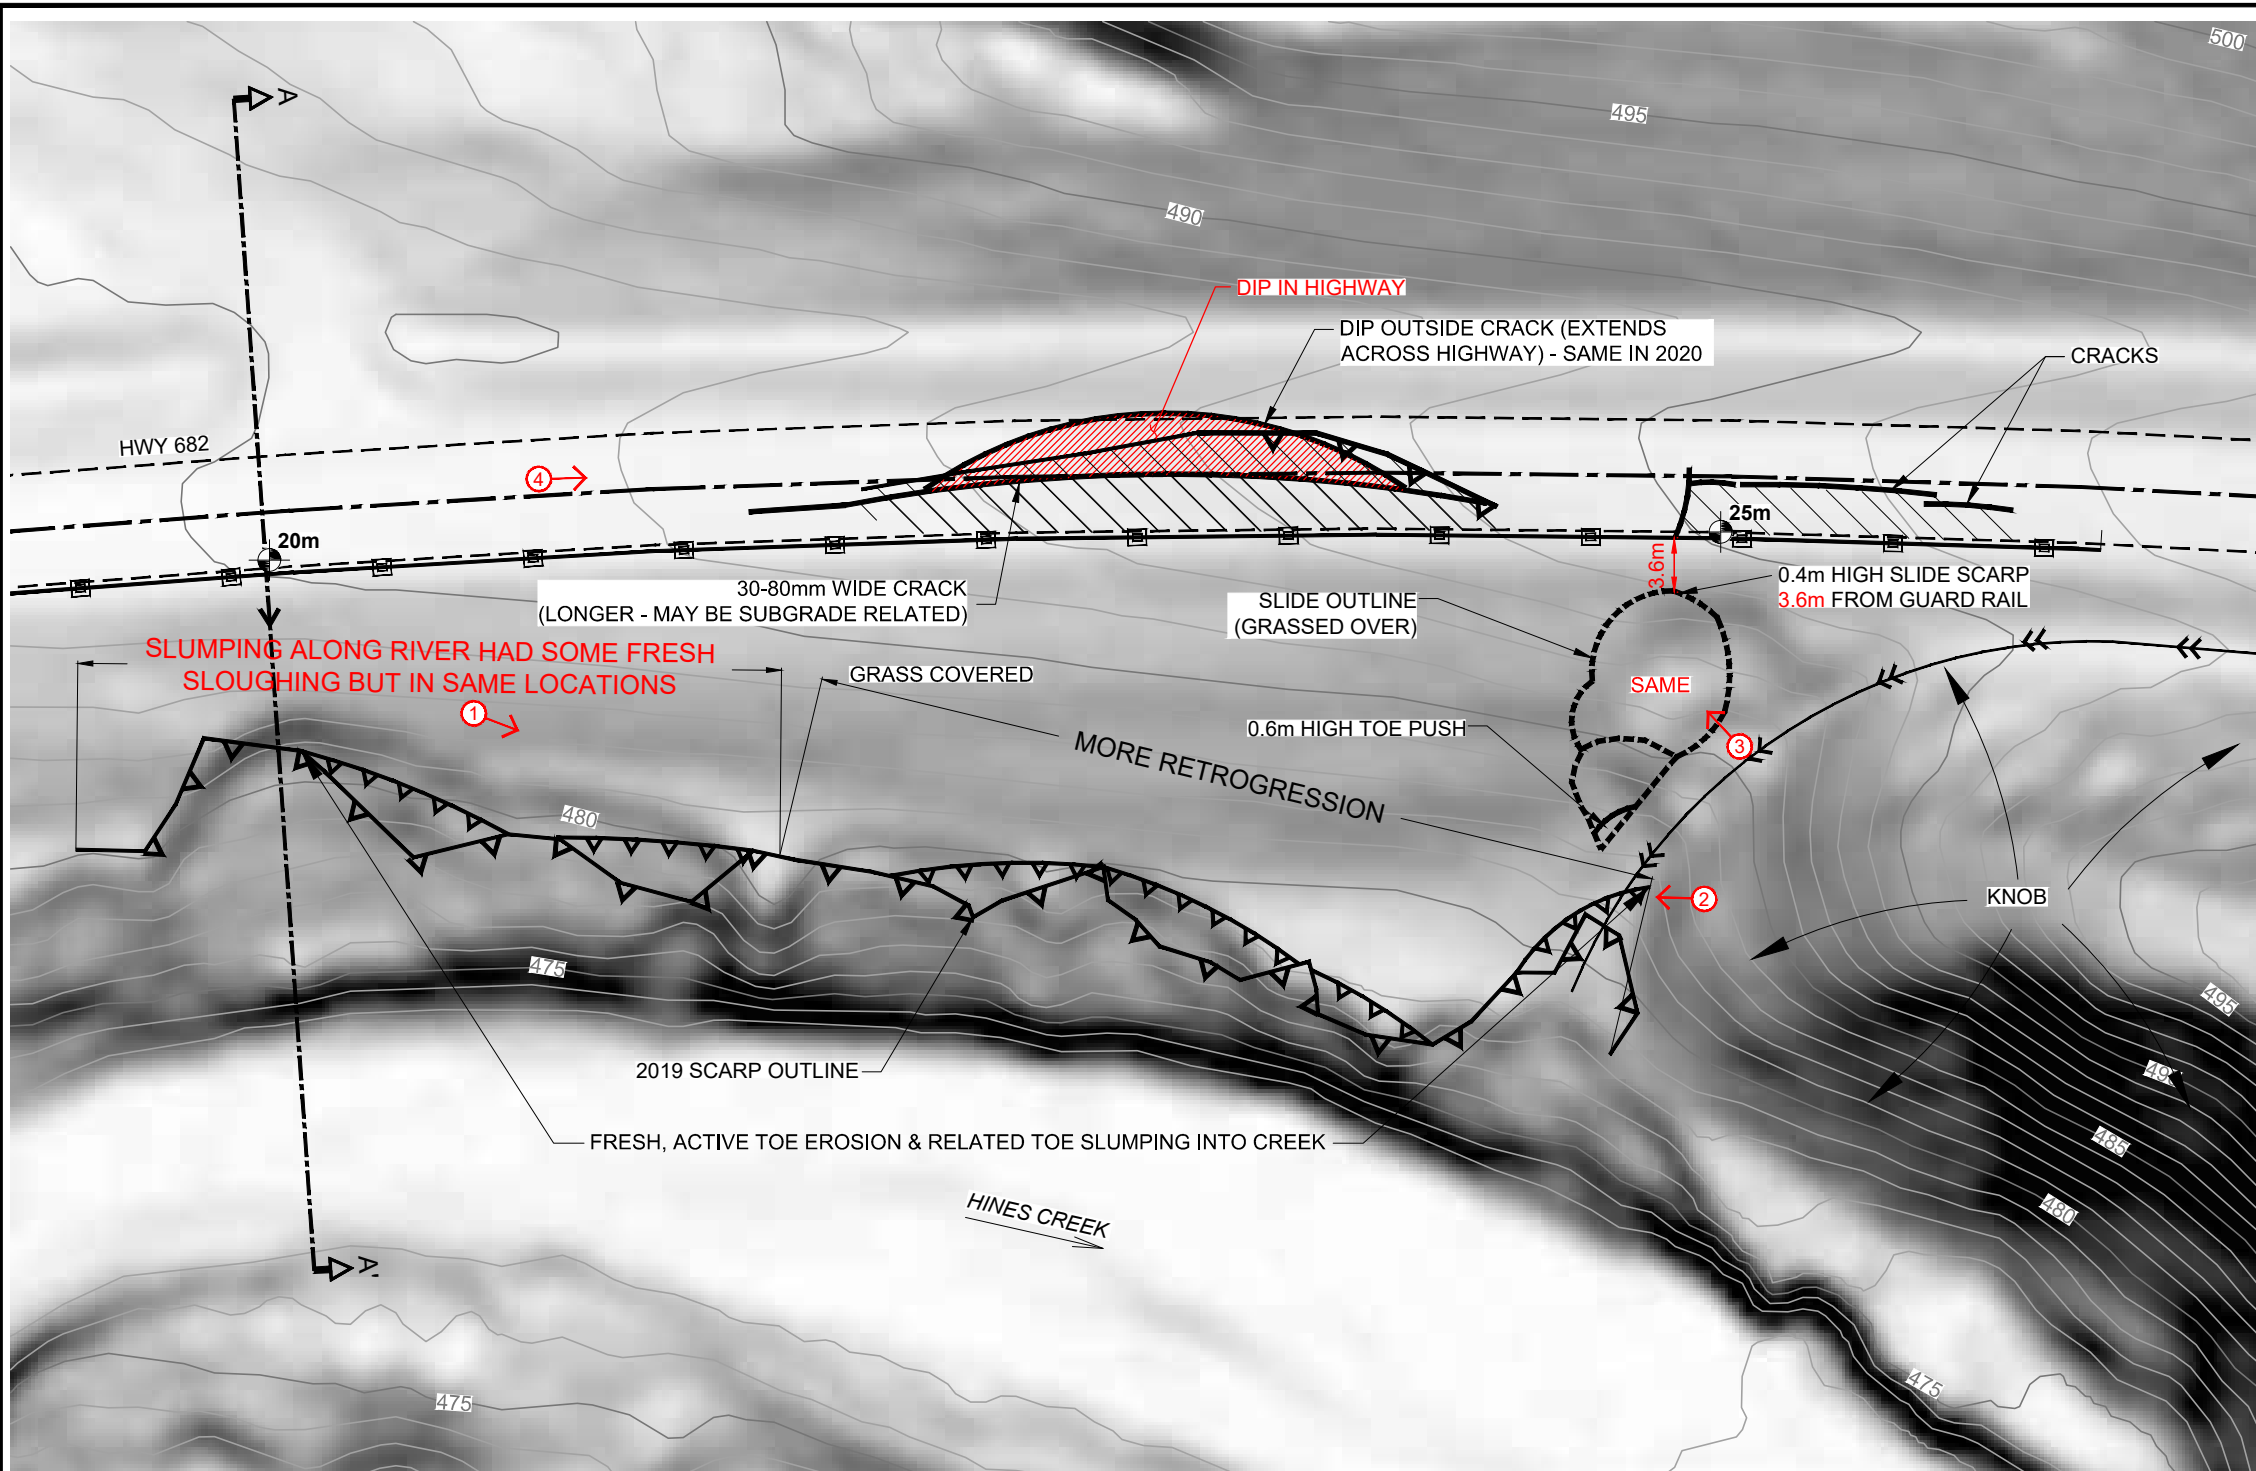
1. SITE RELATIVELY UNCHANGED.
2. GABIONS LACKING INTERMEDIATE BAFFLES AND LIDS NOT ADEQUATELY TIED.
3. JULY 13, 2021 OBSERVATIONS SHOWN IN RED.
