**ALBERTA TRANSPORTATION AND
ECONOMIC CORRIDORS
GEOHAZARD ASSESSMENT PROGRAM
PEACE REGION (GRANDE PRAIRIE DISTRICT - NORTH)
2025 INSPECTION**

Site Number	Location	Name	Hwy	km
PH010	Eureka River South Hill	Sites 1, 2 and 4	726:02	9.8
Legal Description		UTM Co-ordinates (NAD 83)		
NW12/SW13-86-8-W6		11	N	6258319
		E	368453

2025 PH010 INSPECTION PLAN

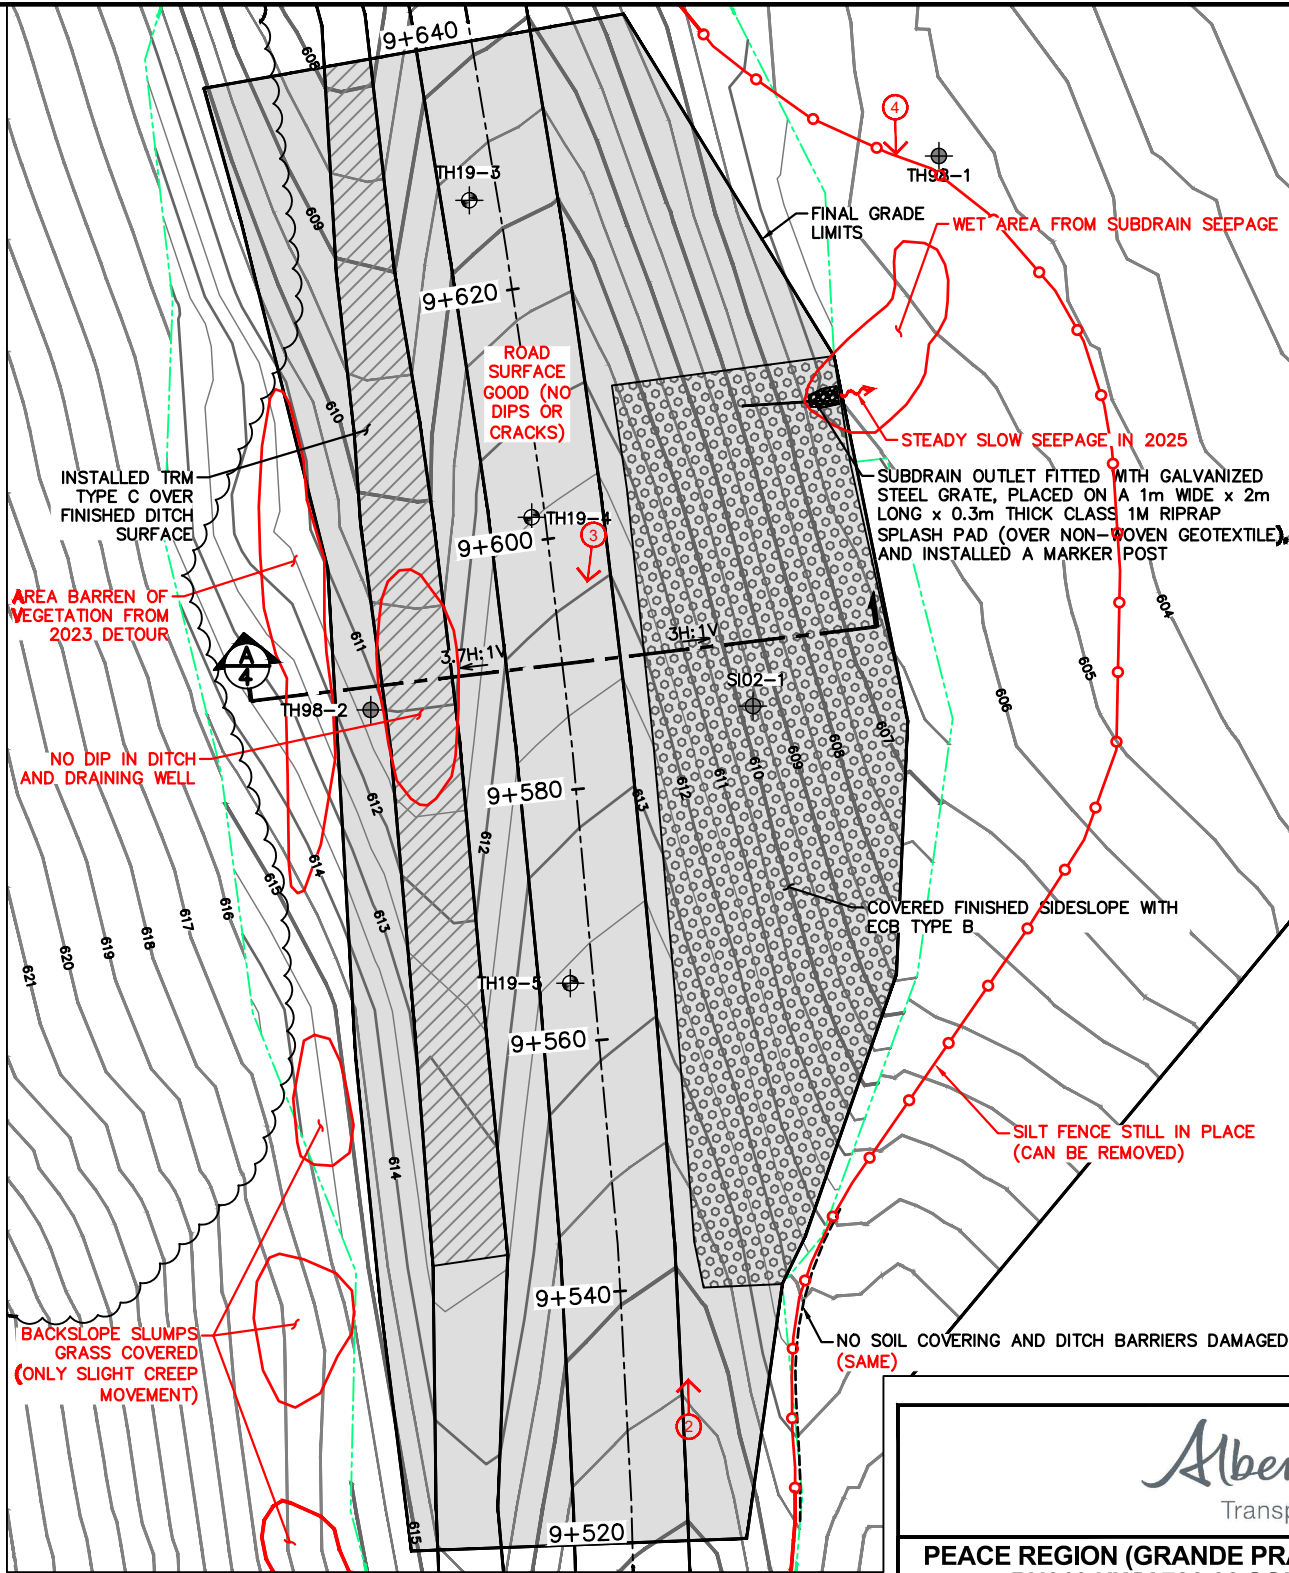
2023 AS-BUILT FINAL PLAN

1. ORIGINAL GROUND SURFACE SURVEYED BY MCINTOSH PERRY ON AUGUST 11, 2019. SITE FEATURES ONLY REFLECT THE SURVEY DATA, AND MAY VARY AT THE TIME OF TENDERING THE PROJECT.
2. AS-BUILT GROUND SURFACE SURVEYED BY MCINTOSH PERRY CONSULTING ENGINEERS LTD. ON SEPTEMBER 14, 2023
3. DETOUR OUTLINE IS APPROXIMATE, DESIGNED BY CONTRACTOR
4. EXCAVATION LIMITS AND OTHER FEATURES ARE APPROXIMATE
5. REPAIRS LOOK GOOD. ROAD SURFACE SMOOTH; NO CRACKS IN NEW PAVEMENT.
6. CONDITIONS ON MAY 8, 2024 SHOWN IN RED
