**ALBERTA TRANSPORTATION
GEOHAZARD ASSESSMENT PROGRAM
PEACE REGION (GRANDE PRAIRIE DISTRICT- NORTH)
2021 INSPECTION**

Site Number	Location	Name	Hwy	km
PH026	Eureka River North Hill	Sites #3, #5 and #6	726:02	10.1
Legal Description		UTM Co-ordinates (NAD83)		
SW13/SE14-86-8-W6		11 N 6258740	E 368408

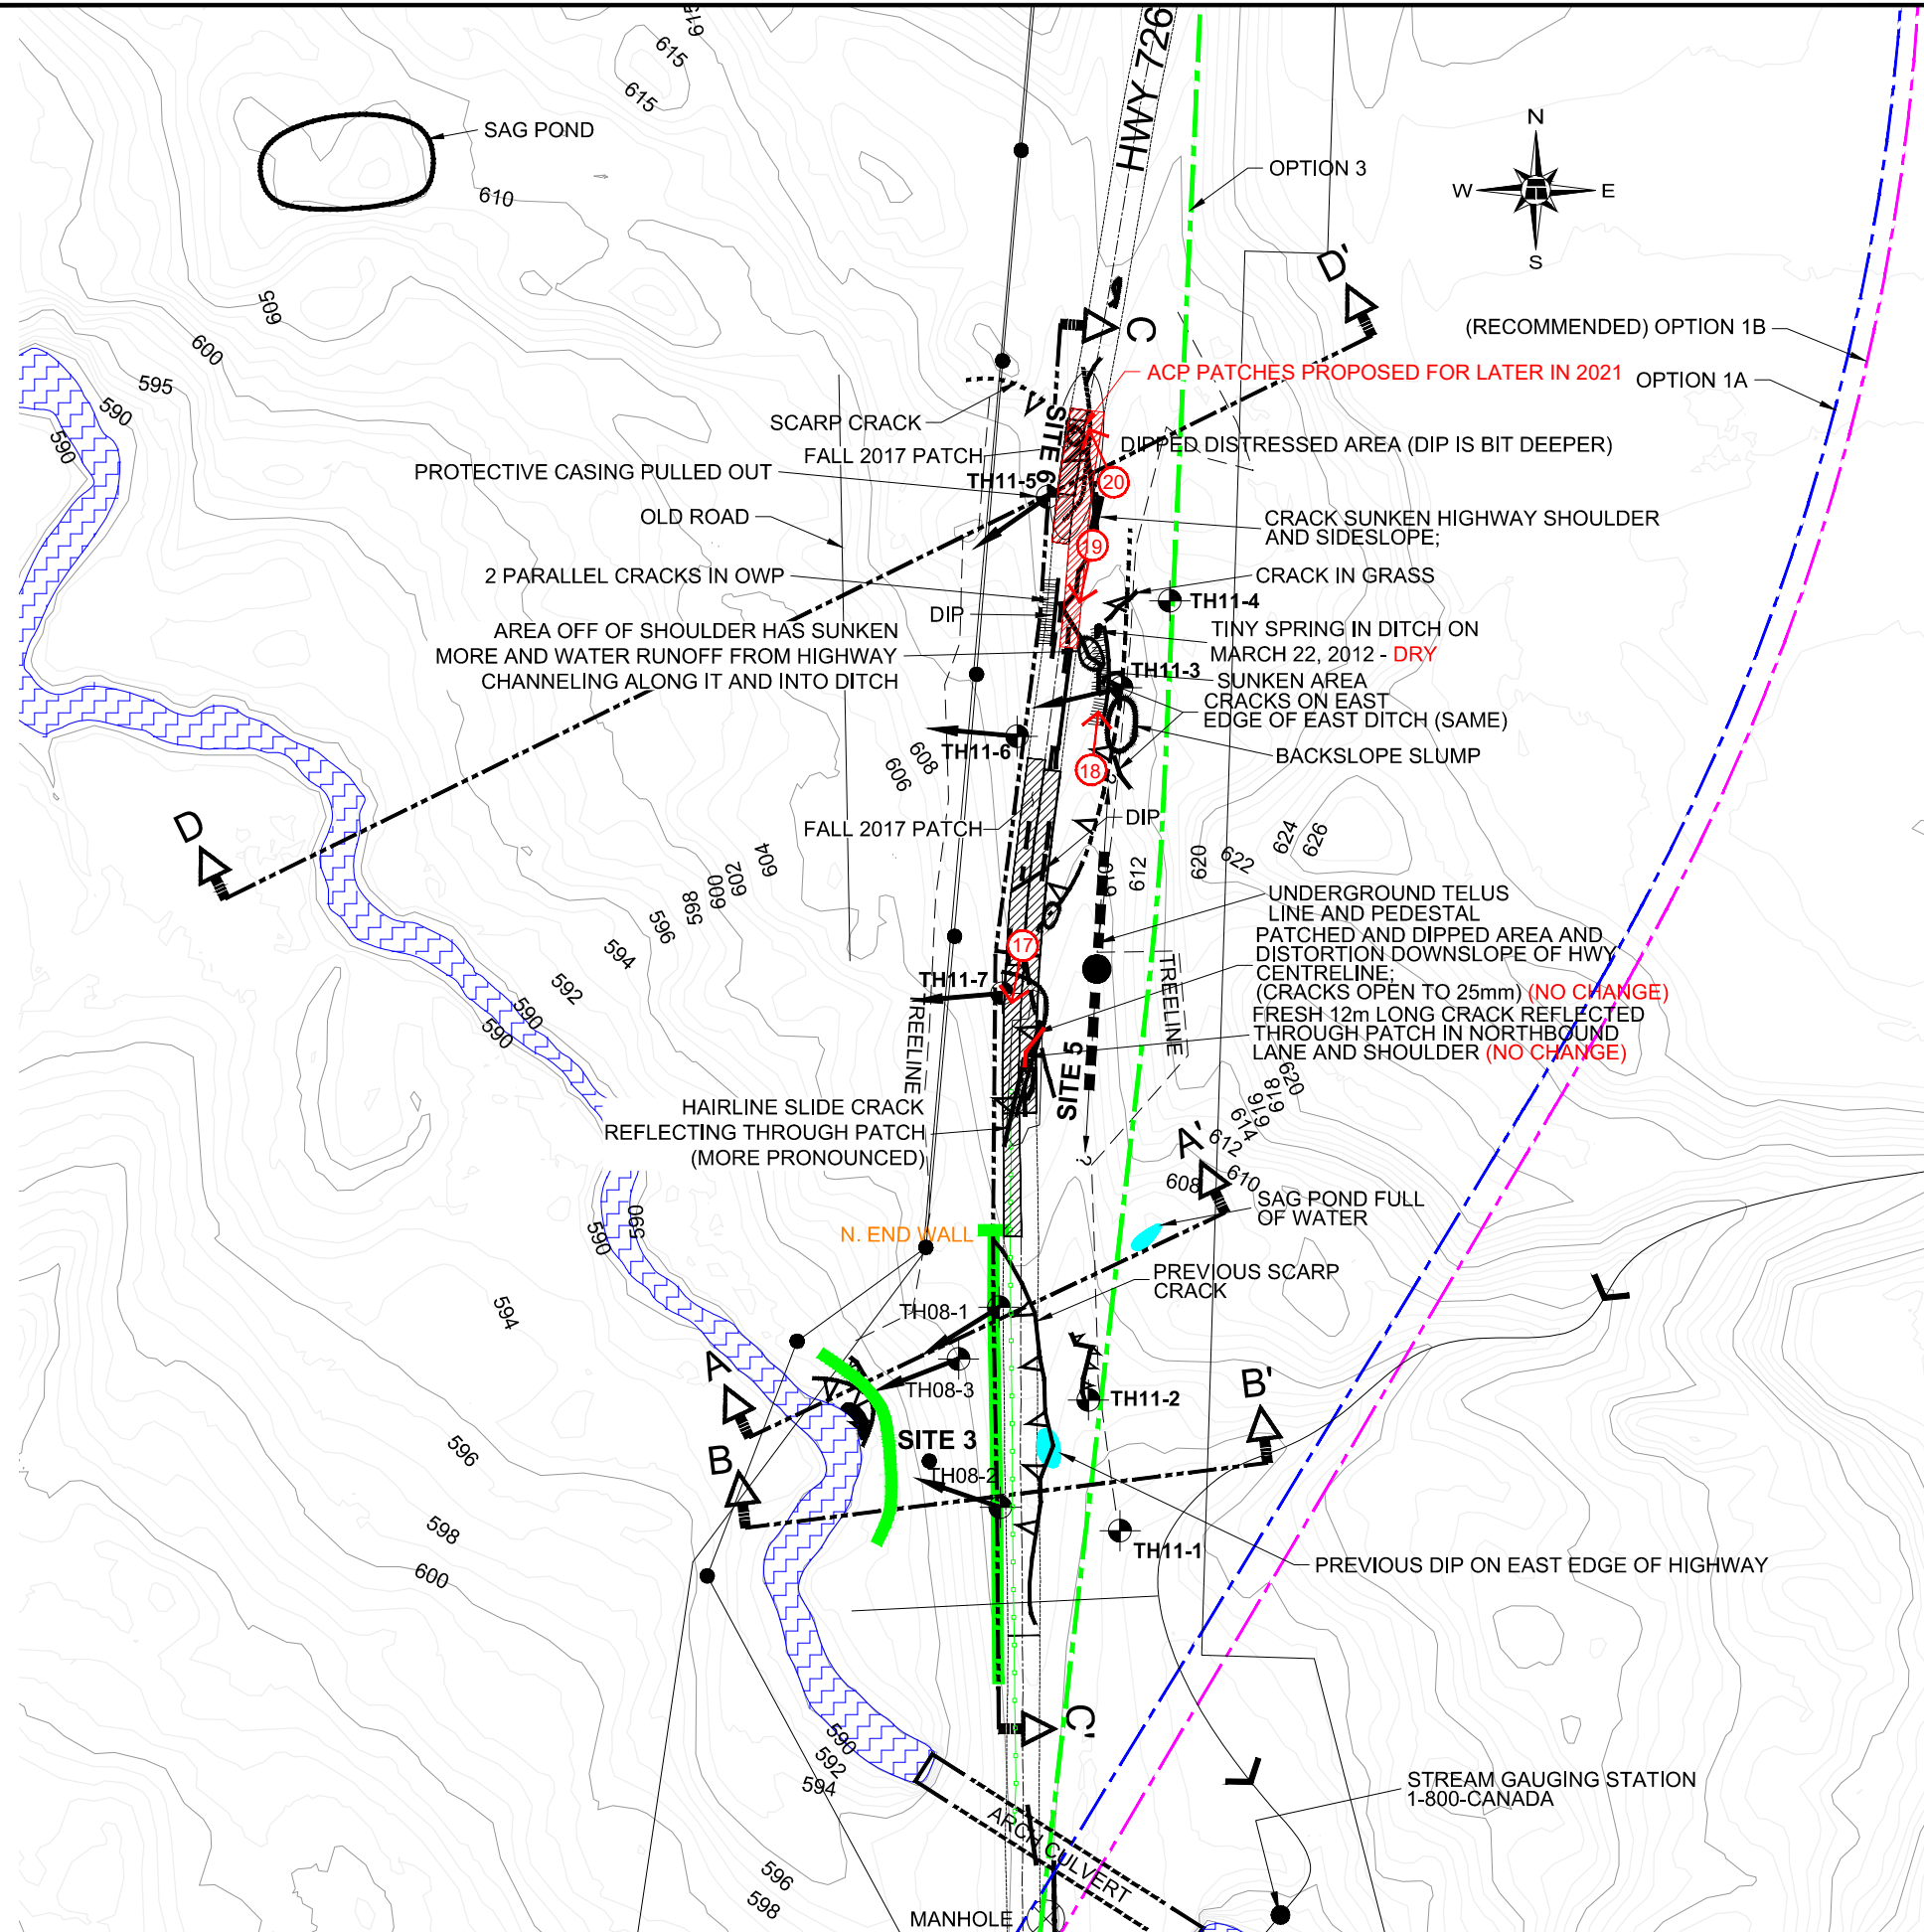
- NOTES**
1. SLIDE SITE FEATURES RECORDED USING A HAND HELD GPS.
 2. EXISTING PILE WALLS
 3. GROUND SURFACE CONDITIONS WERE DEVELOPED BASED ON LIDAR DATA.
 4. CONDITIONS ON JULY 13, 2021 SHOWN IN RED.
 5. SITE 5 AND SITE 6 MAY OUTLINE THE EDGE OF SINGLE SLIDE SPANNING BETWEEN THE TWO AREAS. NEGLIGIBLE MOVEMENT AT BOTH SITES 5 & 6 IN 2021.
 6. SEE DWG No. 32123-PH026-1-5 FOR SITE 3 NOTES.
