**ALBERTA TRANSPORTATION
GEOHAZARD ASSESSMENT PROGRAM
PEACE REGION (GRANDE PRAIRIE DISTRICT- NORTH)
2022 INSPECTION**

Site Number	Location	Name	Hwy	km
PH026	Eureka River North Hill	Sites #3, #5 and #6	726:02	10.1
Legal Description		UTM Co-ordinates (NAD83)		
SW13/SE14-86-8-W6		11 N 6258740	E 368408

2022 PH026-1 INSPECTION PLAN

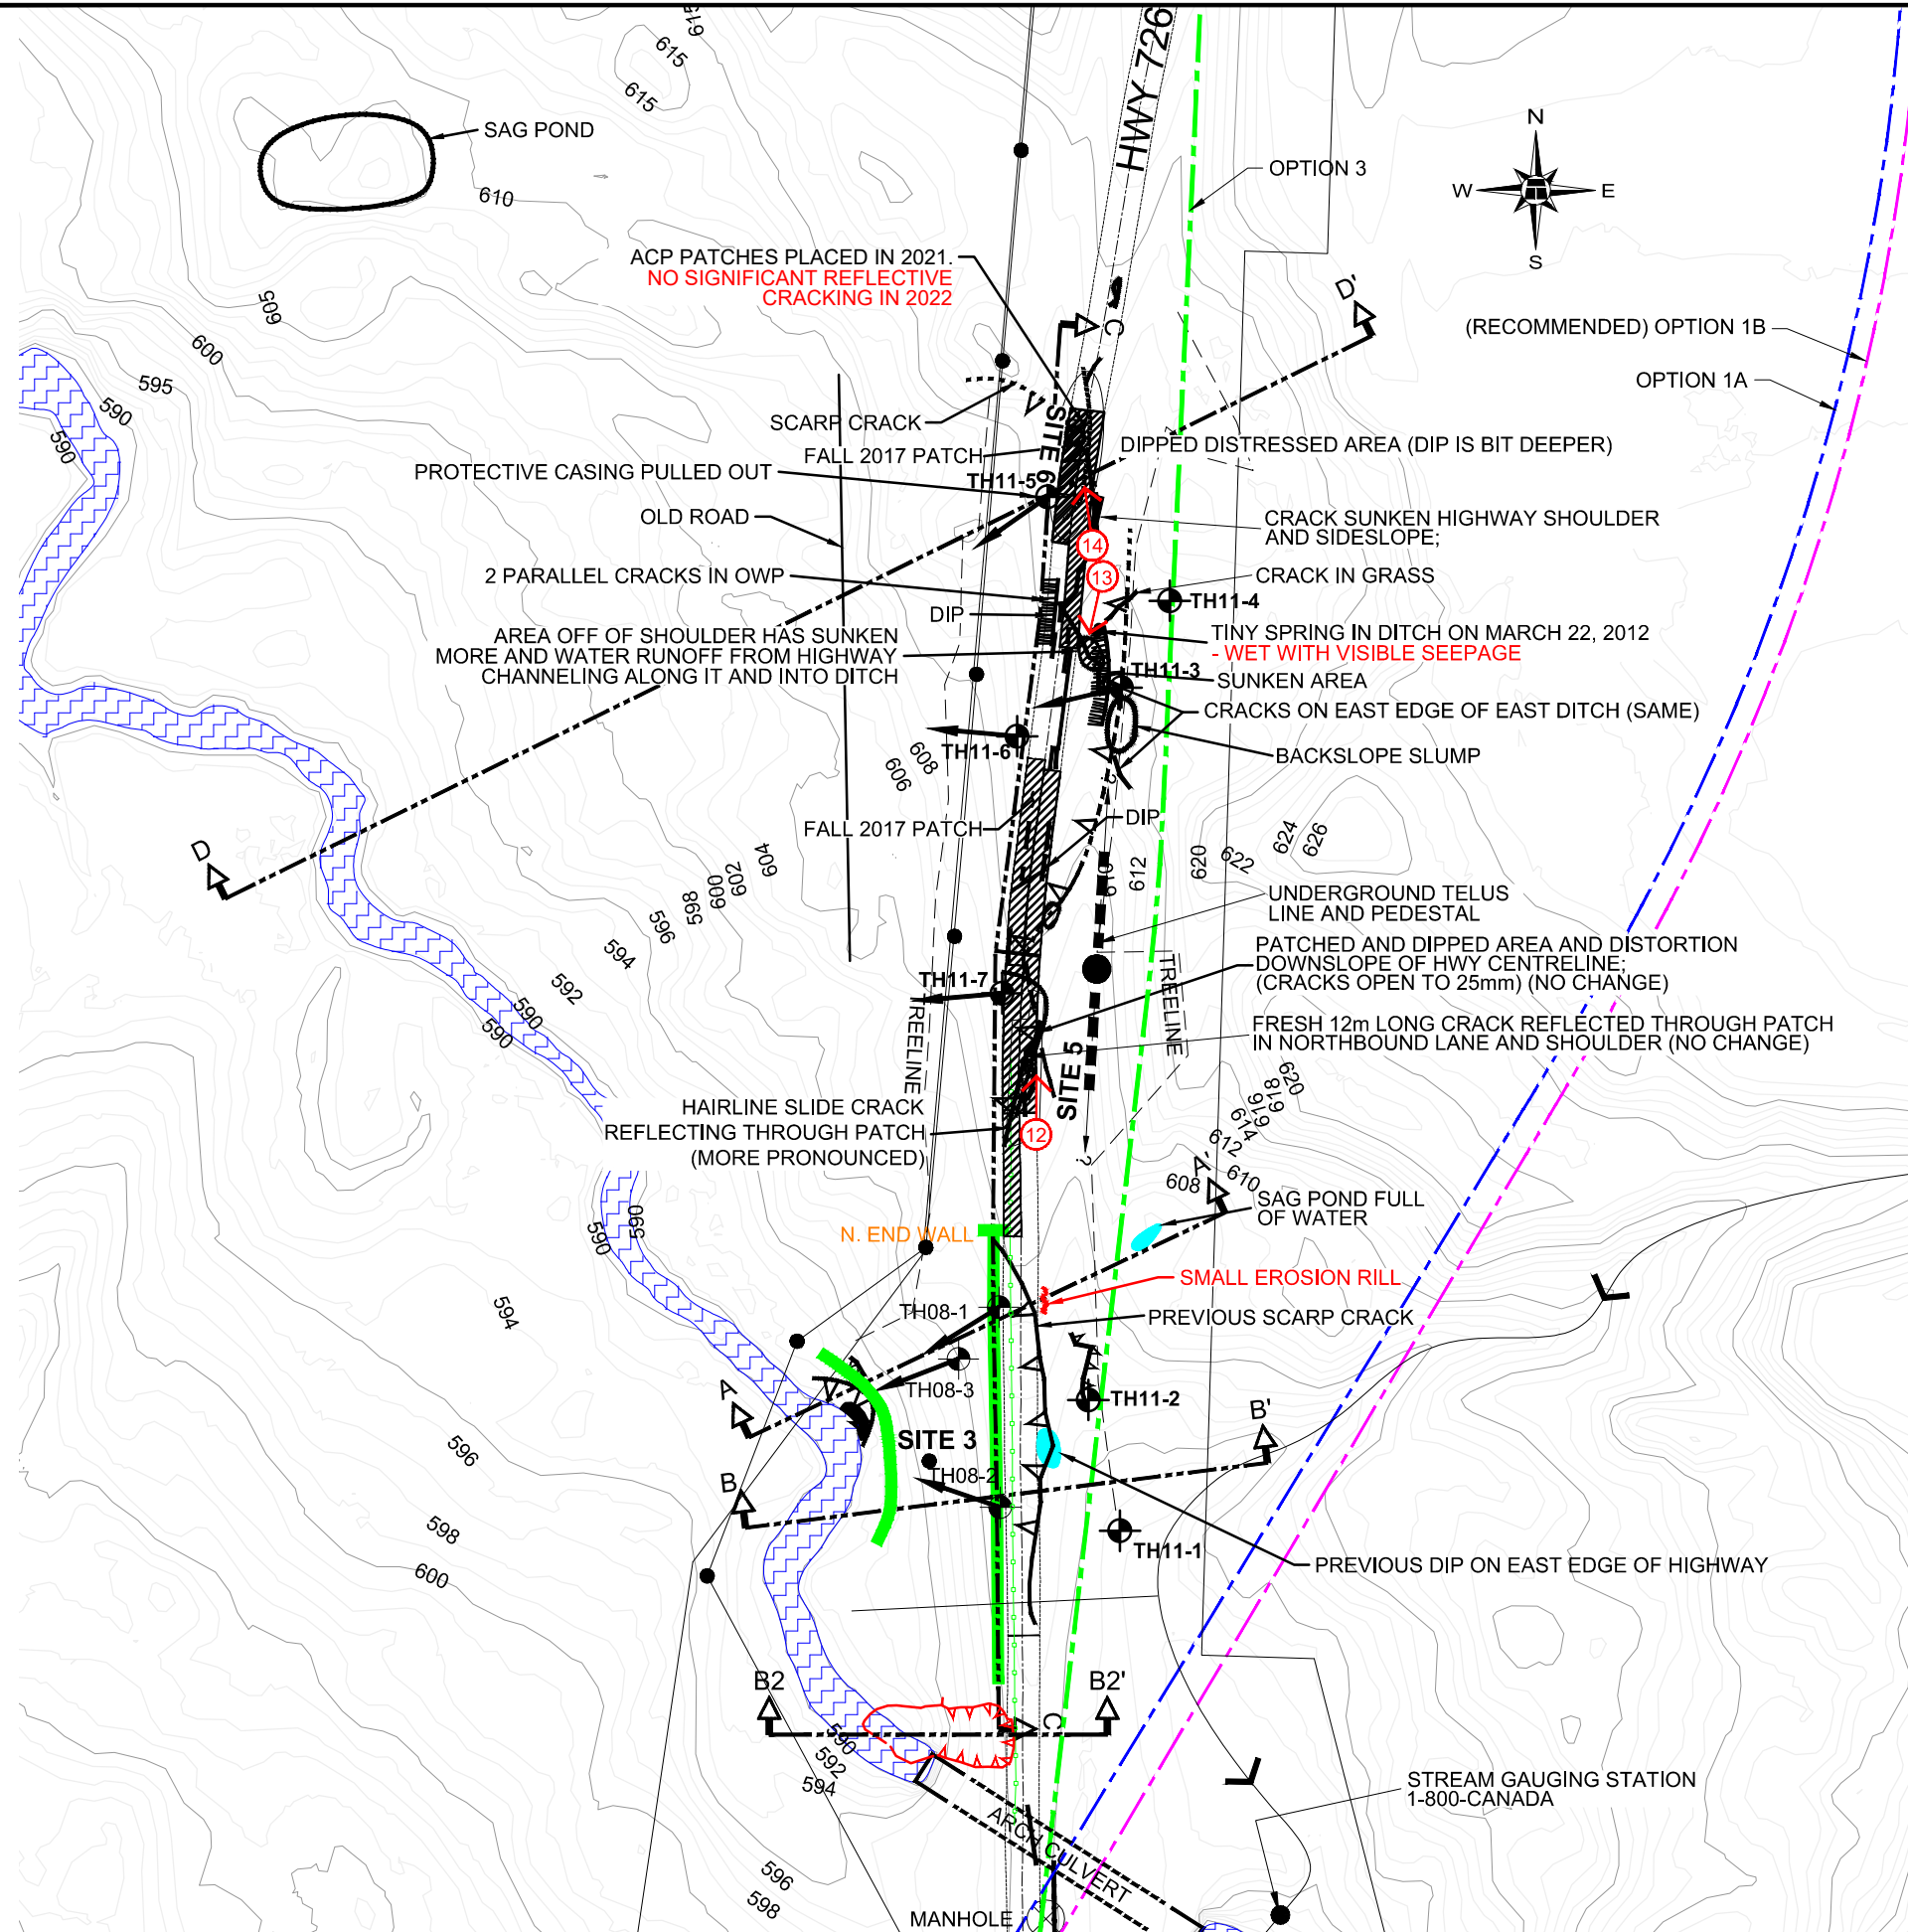
- NOTES**
1. SLIDE SITE FEATURES RECORDED USING A HAND HELD GPS.
 2. EXISTING PILE WALLS
 3. GROUND SURFACE CONDITIONS WERE DEVELOPED BASED ON LIDAR DATA.
 4. CONDITIONS ON MAY 16, 2022 SHOWN IN RED.
 5. SITE 5 AND SITE 6 MAY OUTLINE THE EDGE OF SINGLE SLIDE SPANNING BETWEEN THE TWO AREAS. NEGLIGIBLE MOVEMENT AT BOTH SITES 5 & 6 IN 2021.
 6. SEE DWG No. 32123-PH026-1-3 FOR SITE 3 NOTES.
