ALBERTA TRANSPORTATION AND ECONOMIC CORRIDORS GRMP PEACE RIVER REGION – (GRANDE PRAIRIE DISTRICT - NORTH) INSTRUMENTATION MONITORING - SPRING 2025

Site Number	Location	Name	Hwy	km
GP024	HWY 725:02 C1 17.41	Hamelin Creek	725:02	Km 17.4
Legal Description	n: 11-5-81-8 W6	UTM Co-ordinates		
		11U E 361702.73	N 62	07568.73

Current Monitoring:	13-June-2025	Previous Monitoring	29-May-2024
Instruments Read By:	Mr. Niraj Regmi, G.	I.T and Mr. Godfred Etiendem, of Thur	ber

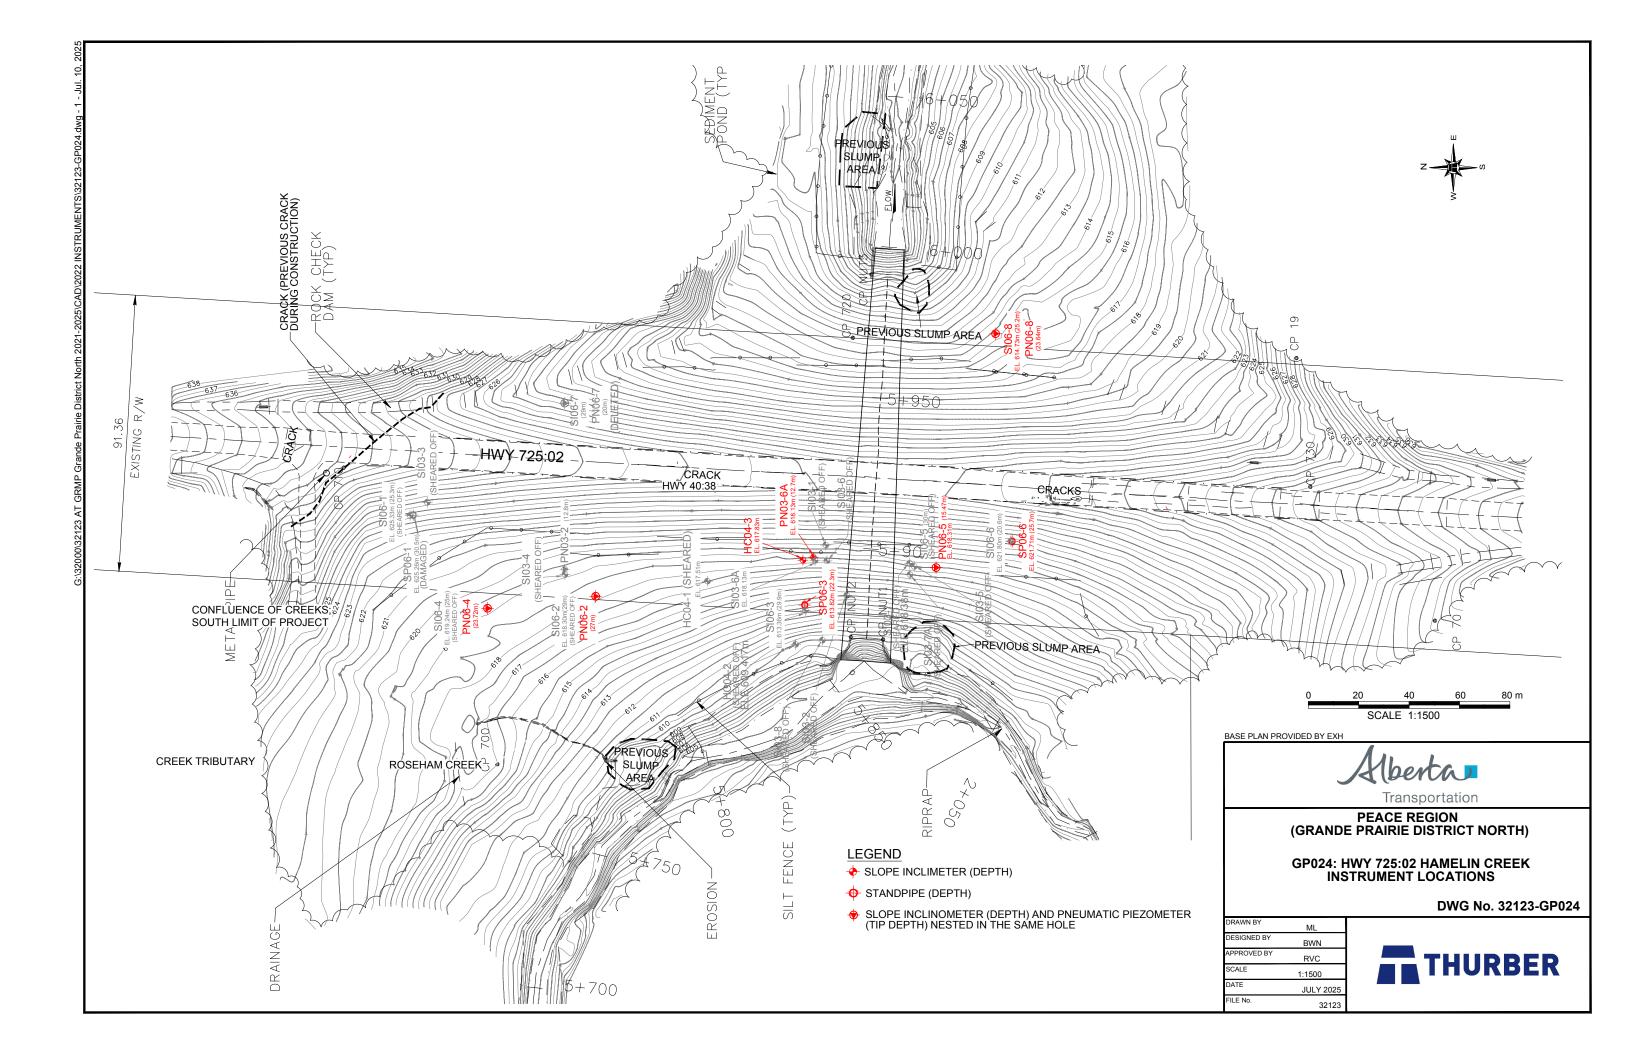
GP024 Hamelin Creek, Inclinometer HC04-3

Discussion
Zones of New Movement:	None
	Slope inclinometer HC04-3, located on the west embankment slope, showed rates of movement less than 0.1 mm/yr over 5.7 m to 13.0 m depth and 19.7 m to 24.0 m depth, since the spring of 2024 readings.
	SI06-08, located on the east embankment slope, showed a rate of movement of 0.6 mm/yr over 2.8 m to 5.2 m depth since the spring of 2024 readings. Both remaining SIs at this site have shown an overall consistent trend of movement for the past several years.
Interpretation of Monitoring Results:	Pneumatic piezometer PN03-06A and PN06-05 showed decreases in groundwater level of 0.03 m and 0.11 m, respectively since the spring of 2024 readings. Pneumatic piezometers PN06-2 and PN06-04 showed increases in groundwater level of 0.02 m and 0.13 m, respectively, since the spring of 2024 readings. Pneumatic piezometer PN06-08 showed no change in groundwater level since the spring of 2024.
