Slide Name: (GP 26) Ditch Erosion South of Grande Cache
(GP 27) Ditch Erosion North of Grande Cache
Inspection Date: May 6, 2005
Inspection by: Alberta Infrastructure & Transportation and EBA staff listed on Page 1

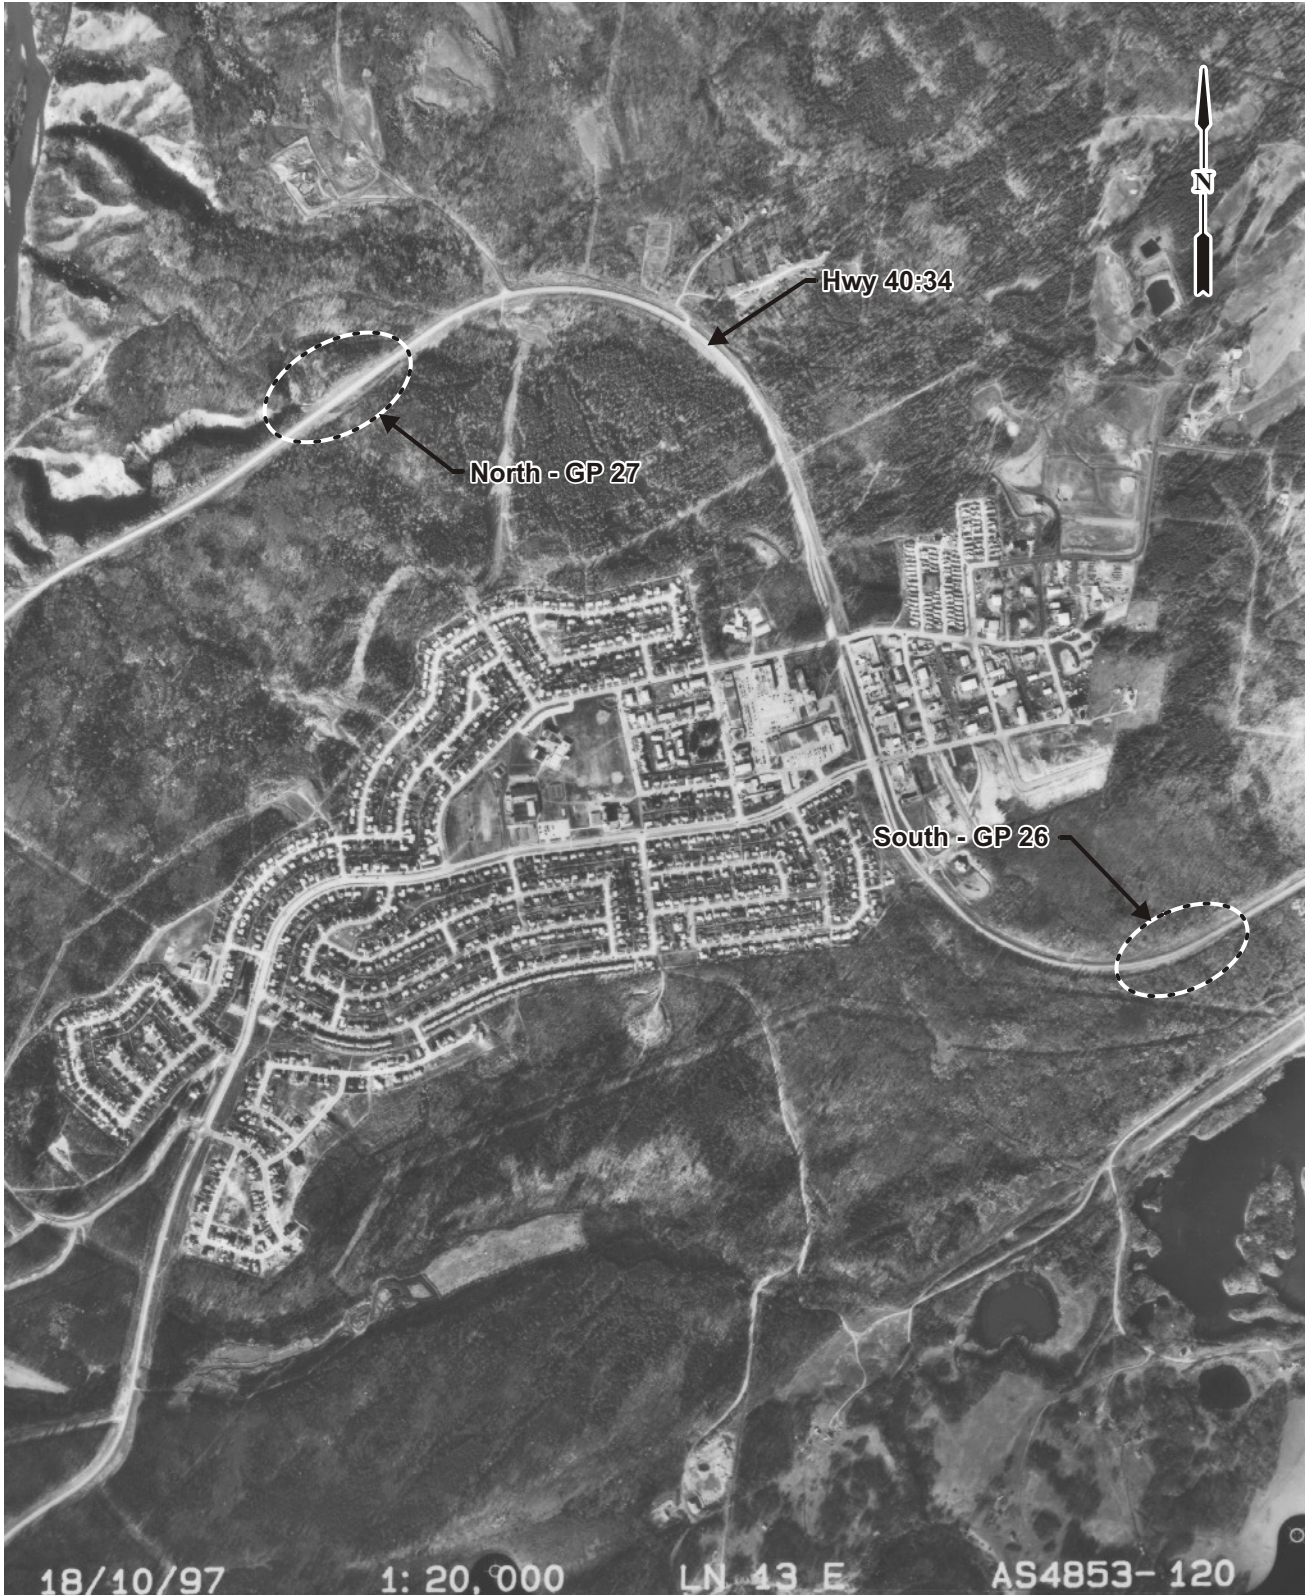
Based on 1997 Aerial Photograph

- Along the north approach
 - The affected ditch area is a 200 to 300 m stretch of steep grade V-ditch, of which about 150 m entails vertical erosion scarps along the shoulder line and sideslope.
 - The vertical scarps are a safety hazard for vehicles running off the road.
- Along the south approach
 - The affected ditch area is a 200 to 300 m stretch of steep grade V-ditch, of which about 100 m entails vertical erosion scarps along the shoulder line and sideslope.
 - The vertical scarps are a safety hazard for vehicles running off the road.

- A new ditch design should be considered. The possible design of drop structures to step down the steepness of the ditch grade and a new ditch cross-section design may be required. The use of hard armouring may be appropriate for this site.
