Slide Name: (GP 2) Hwy 40:38 Kakwa Slide (20 km S. of Kakwa River)

Inspection Date: June 21, 2006

Inspection by: Alberta Infrastructure & Transportation and KarlEng Staff listed on Page 1

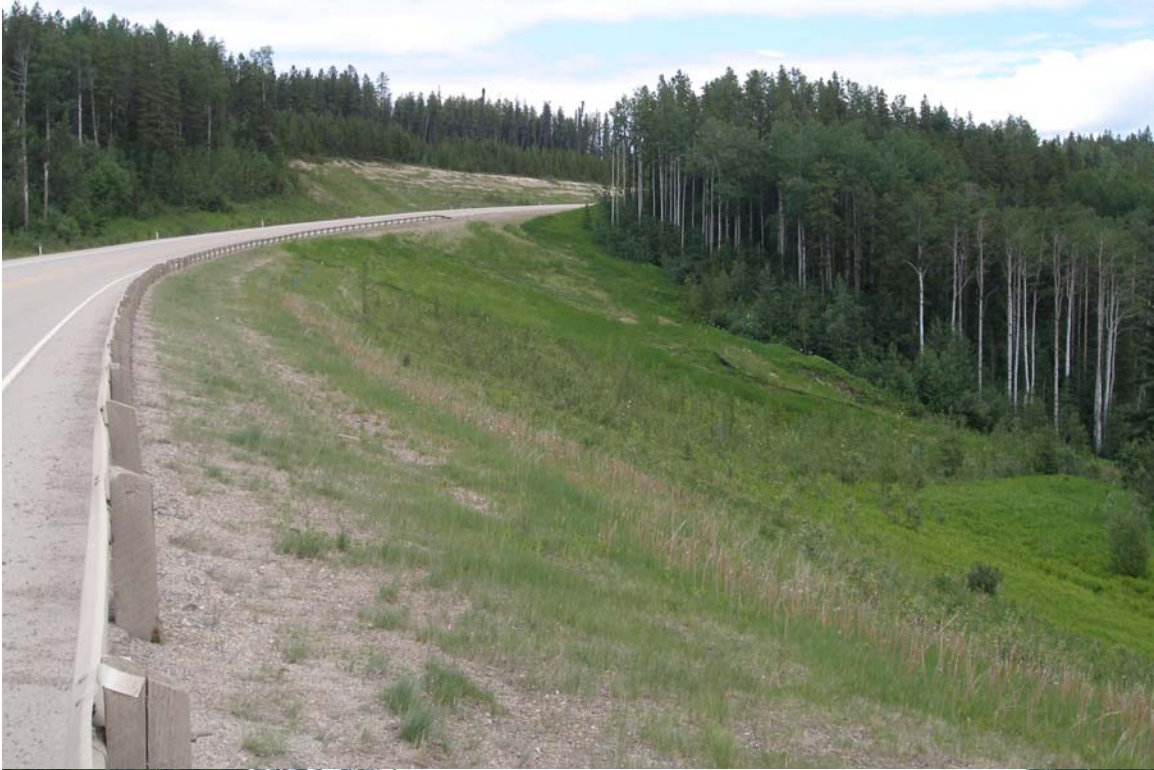
- Repaired slope well vegetated
- Slope reconstructed with granular material
- 2 drainage outlets at toe of slope (lower outlet and upper outlet)

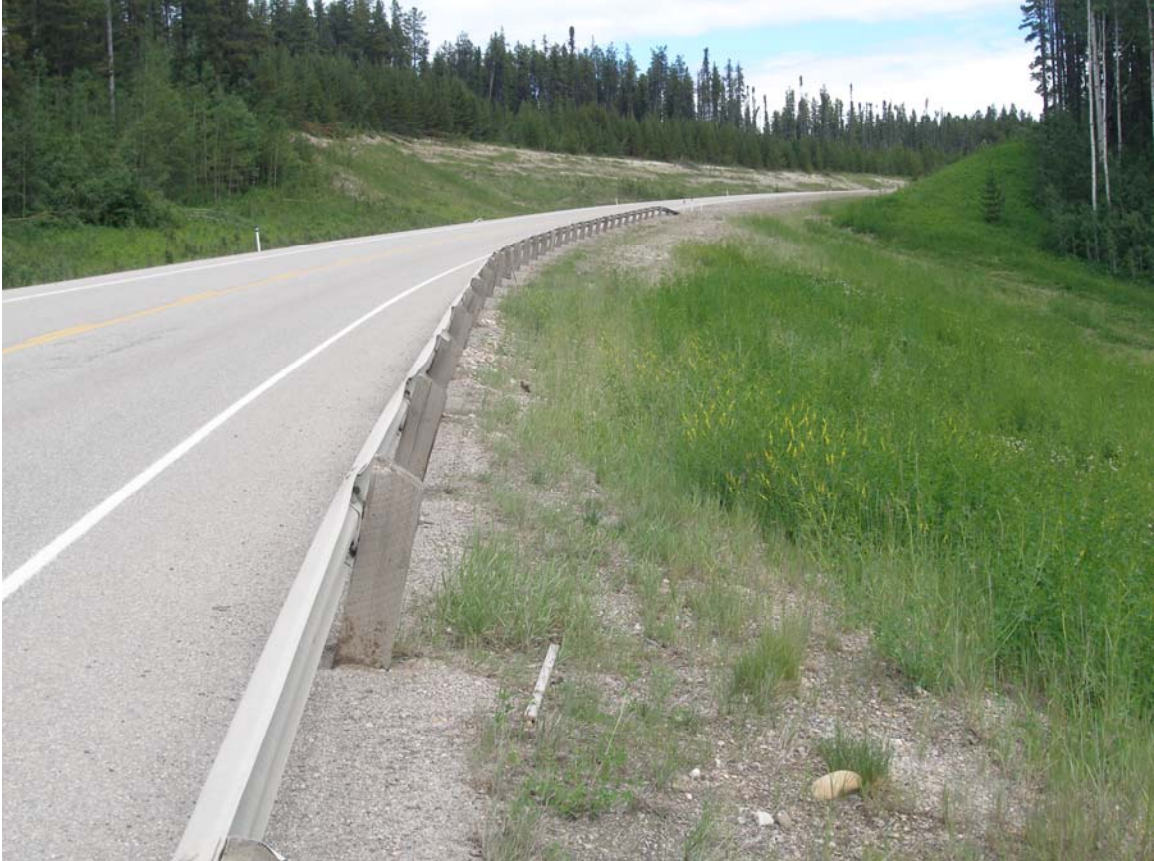
- Steady water outflow from lower drainage normal outlet
- Perforated pipe were incorporated at base of granular slope reconstruction for groundwater drainage
  - Steady water outflow observed over 3 years since slope reconstruction (in winter 2004)

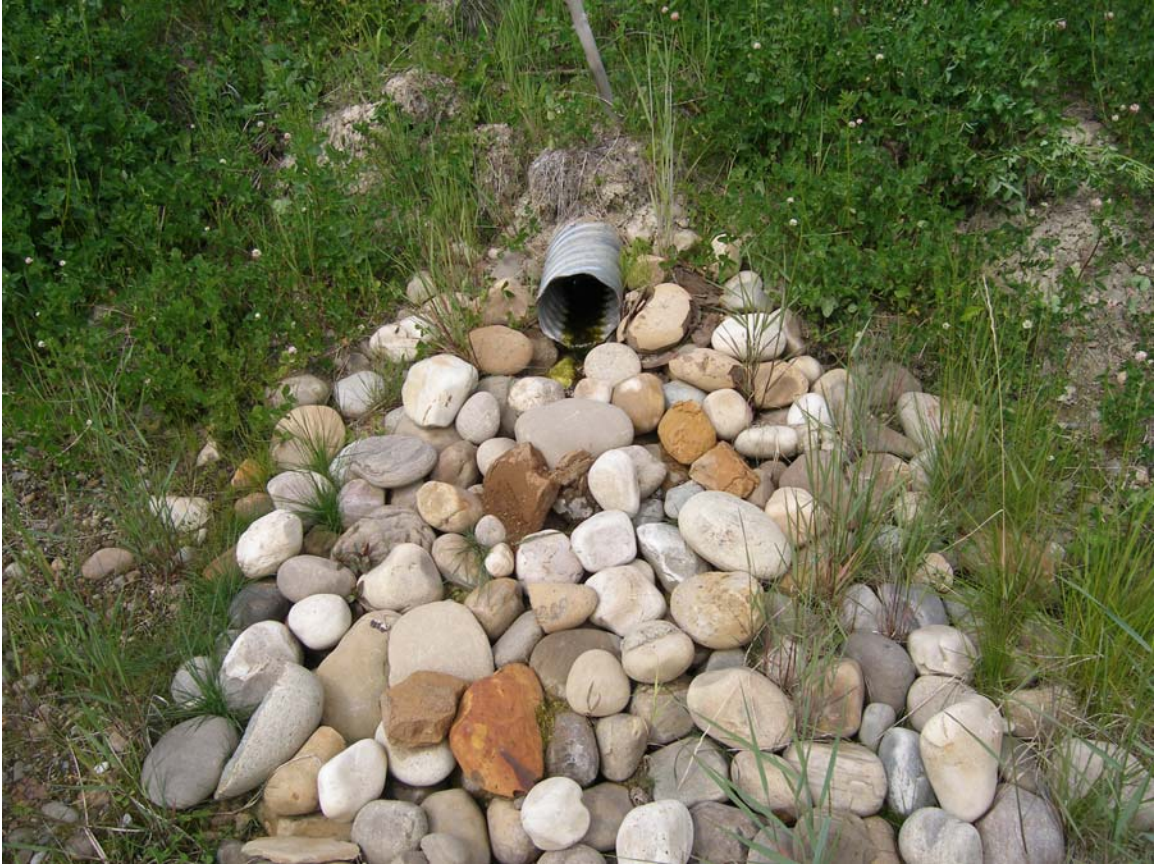
- Entrapped water at upper (2<sup>nd</sup>) drainage safety outlet
- Cleanout of debris (sediment) at 2<sup>nd</sup> outlet yields drainage outflow
  - Constant clean out inspection is required at outlet of subsurface drains to ensure its proper function to prevent buildup of pore water pressure to destabilize the slope
  - This upper outlet was installed as redundancy outlet for high excessive groundwater condition and in the event of any plugging of the lower outlet
