File: 2006-1002h

Date July 8, 2007(prelim)

Re: **Call-out Inspection Report**
Hwy 43:00 (1 mile east of B.C. border)
Embankment Slide at Spring Creek Culvert (BF 73565) ISW 8-75-13-6

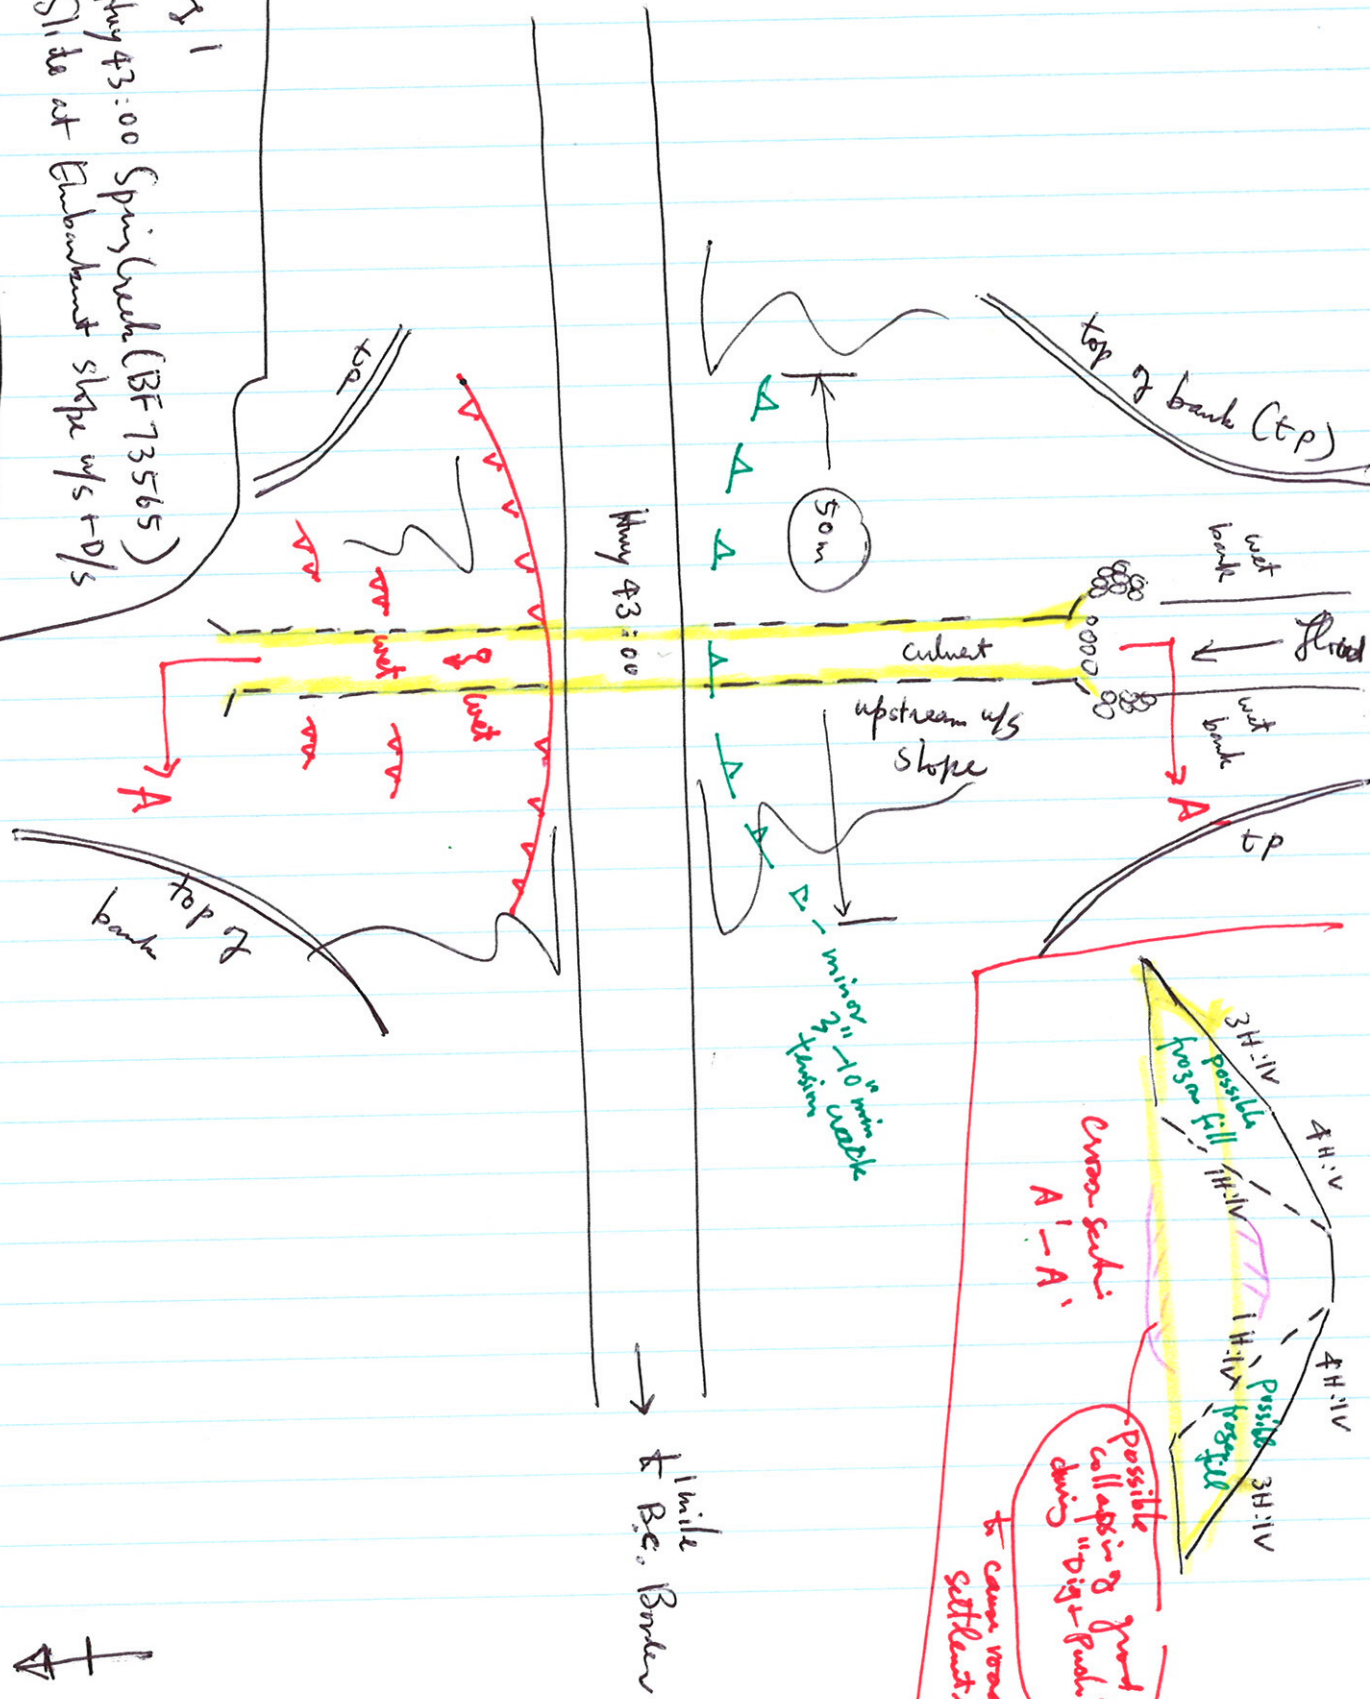
Fig 1
 May 43:00 Spring Creek (BF 73565)
 Slide at Embankment slope w/s + D/s

3H:1V
 4H:1V
 1H:1V
 4H:1V
 possible fill
 possible forest fill
 even-socks
 A-A
 possible erosion & ground collapse during "dig-a-ruck"
 to cause roadway settlements
