November 19, 2021

CON0022166 Peace Region (Grande Prairie District – South) GRMP Instrumentation Monitoring Site GP042; H40:36, km 37.524 Slide 9 km North of Wanyandie Road Section C – 2021 Fall Readings

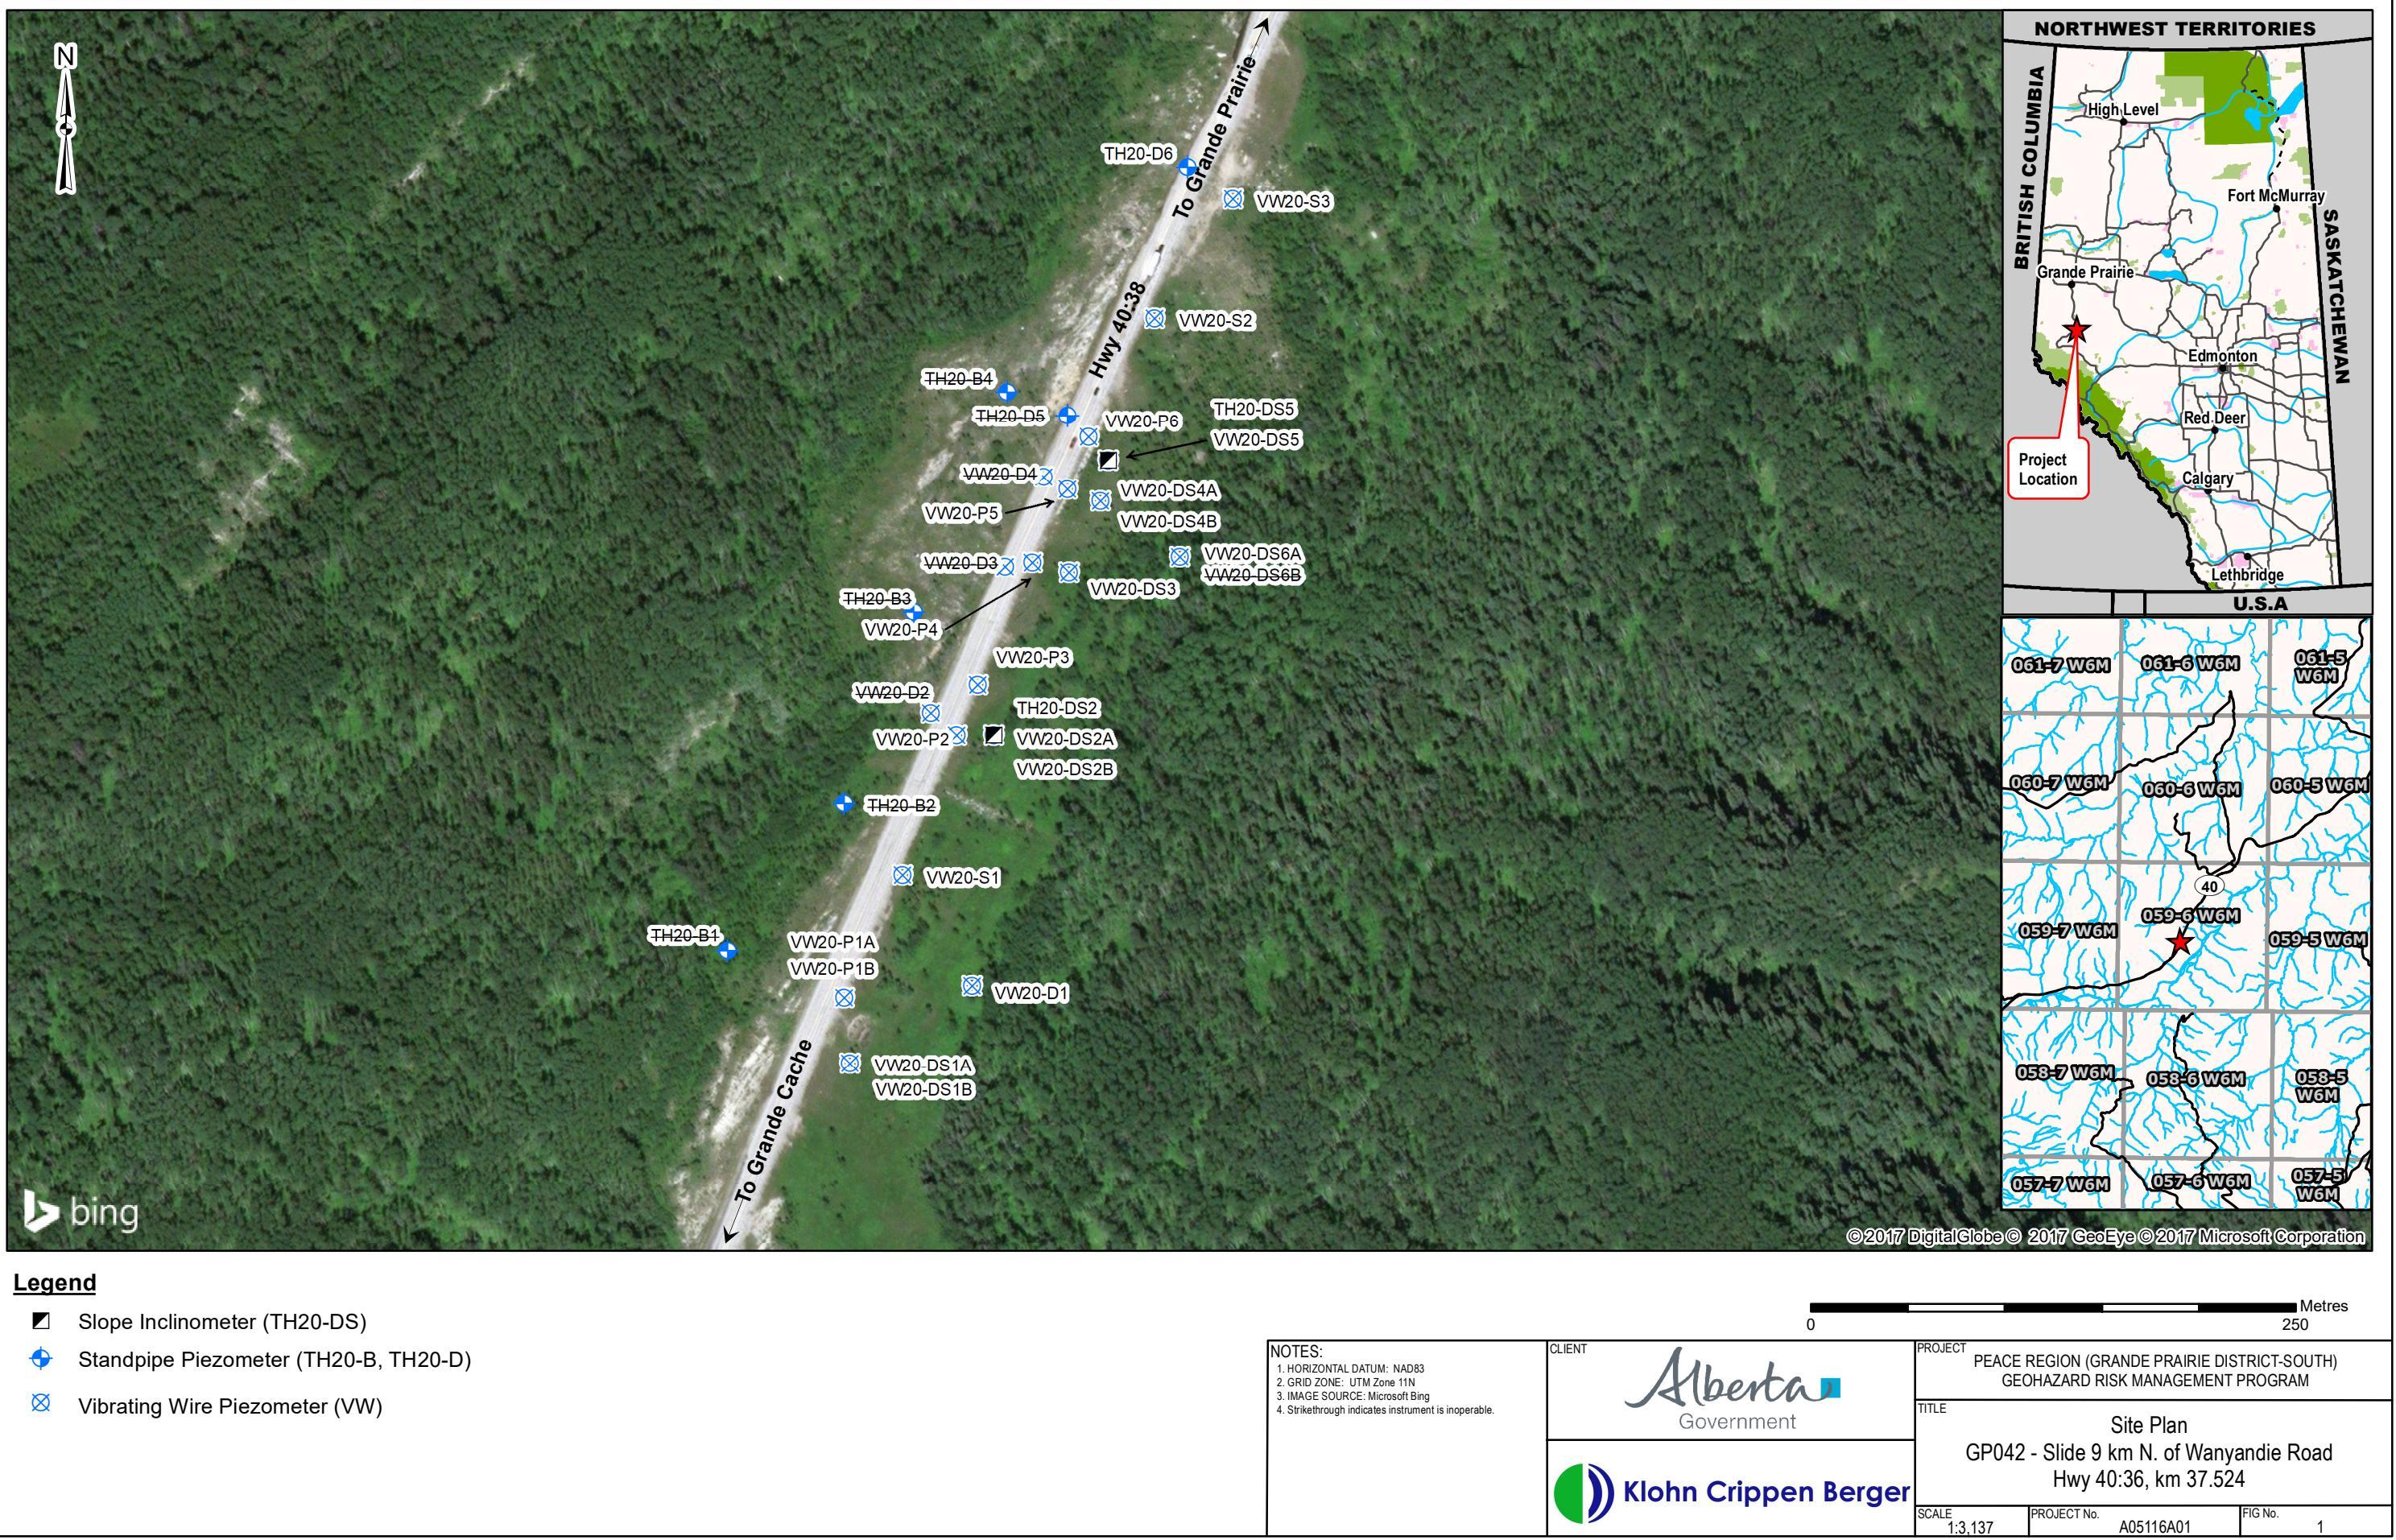
FIGURE

Two slope inclinometers (SIs) (TH20-DS2 and TH20-DS5), twenty vibrating wire piezometers (VWPs) (VW20-P1A andP1B; VW20-P2 through P6; VW20-S1 through S3; VW20-D1; VW20-DS1A through DS4A; VW20-DS1B, DS2B, and DS4B; VW20-5; and VW20-DS6A), and one standpipe piezometer (SP) (TH20-D6) were read at the GP042 site in the peace region (Grande Prairie District – South) (GP South region) on September 10, 2021 by Messrs. James Lyons, E.I.T. and Jacques Bernier, E.I.T. of Klohn Crippen Berger Ltd. (KCB). These instruments were read as part of the GP South region geohazard risk management program (GRMP). The site is located on Hwy 40:36, km 37.524. The approximate site coordinates are 5996853 N, 379884 E (UTM Zone 11, NAD 83). A site plan is presented in Figure 1.
