November 30, 2022

Alberta Transportation
Main Floor, Provincial Building
9621 – 96th Avenue
Peace River, Alberta
T8S 1T4

CON0022166 Peace Region (Grande Prairie District – South) GRMP Instrumentation Monitoring Site GP006; H40:36, km 21.779 Sheep Creek Embankment (Three Teardrops Slide) Section C – 2022 Fall Readings

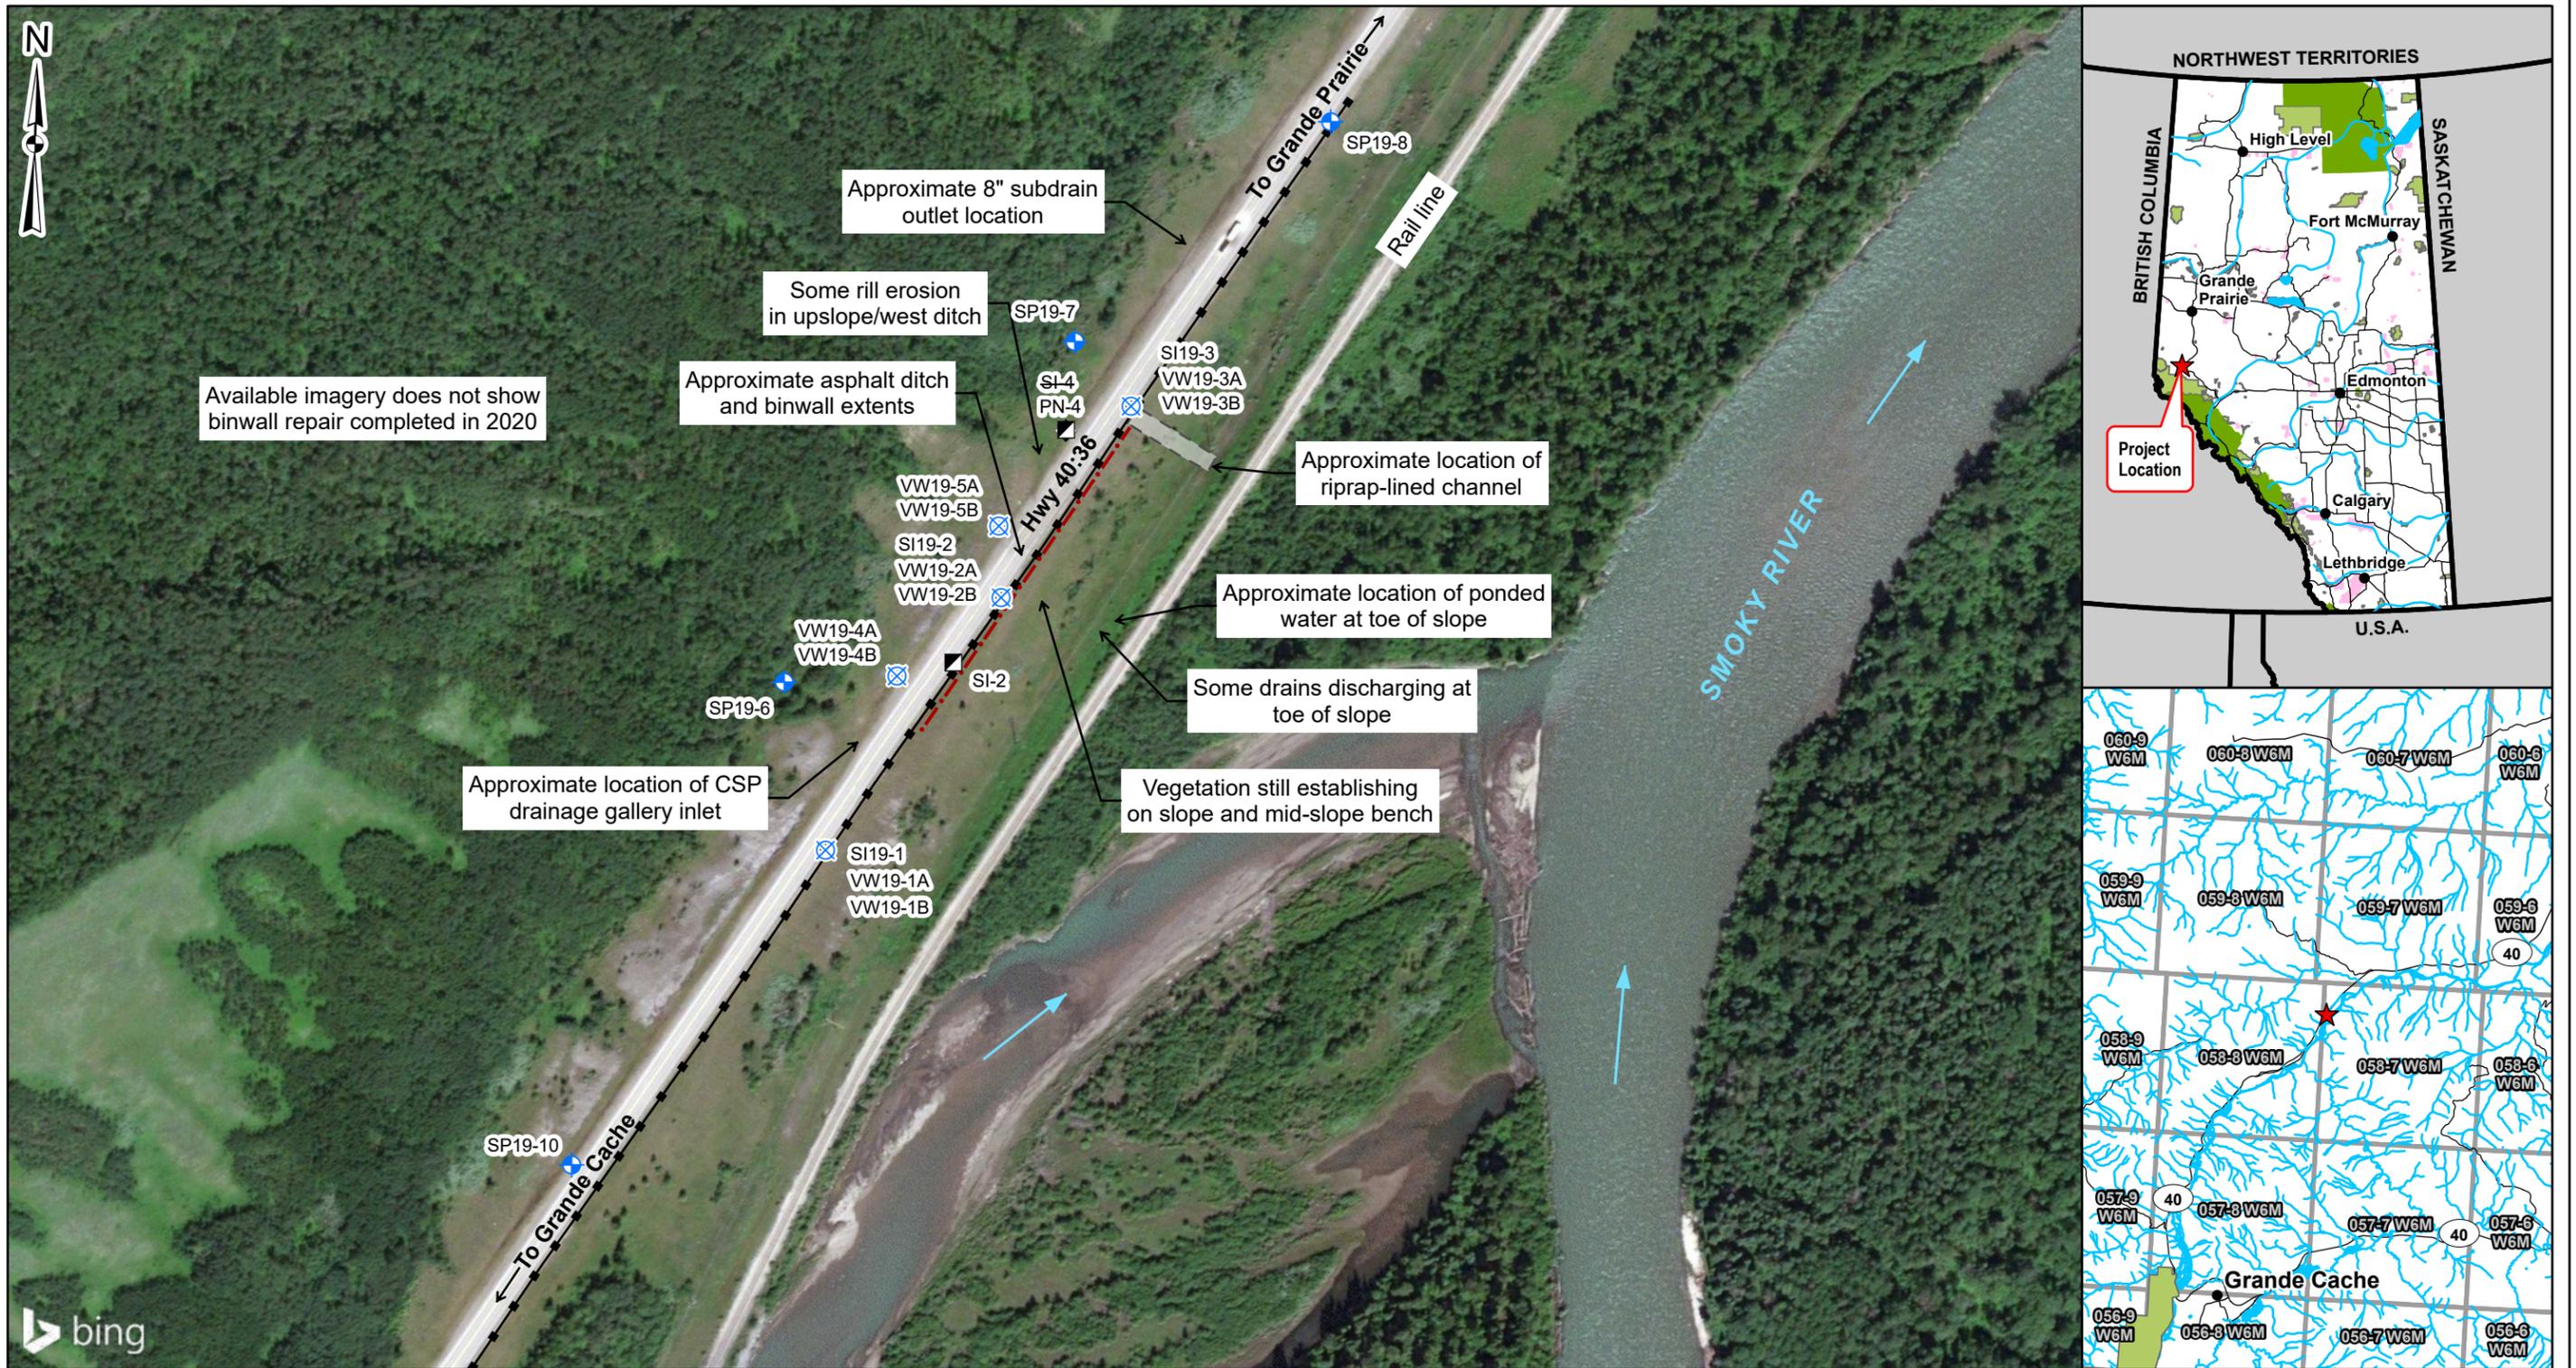
FIG No. 1

Four slope inclinometers (SIs) (SI-2, SI19-1 through SI19-3), one pneumatic piezometer (PN) (PN-4), ten vibrating wire piezometers (VWPs) (VW19-1A/1B through 5A/5B), and four standpipe piezometers (SPs) (SP19-6, SP19-7, SP19-8, and SP19-10) were read at the GP006 site in the Peace Region (Grande Prairie District – South) (GP South Region) on September 28, 2022 by Messrs. Gabriel Bonot, E.I.T. and Guerin White, E.I.T. of Klohn Crippen Berger Ltd. (KCB). These instruments were read as part of the GP South Geohazard Risk Management Program (GRMP). The site is located on Hwy 40:36, km 21.779, on the Sheep Creek Embankment approximately 7 km north of the former McIntyre Mine. The approximate site coordinates are 5990716 N, 366584 E (UTM Zone 11, NAD 83). A site plan is presented in Figure 1.
