July 15, 2024

CON0022166 Peace Region (Grande Prairie District – South) GRMP Instrumentation Monitoring Site GP006; H40:36, km 21.779 Sheep Creek Embankment (Three Teardrops Slide) Section C – 2024 Spring Readings

Site Plan
 GP006 - Sheep Creek Embankment
 (Three Teardrops Slide)
 Hwy 40:36, km 21.779

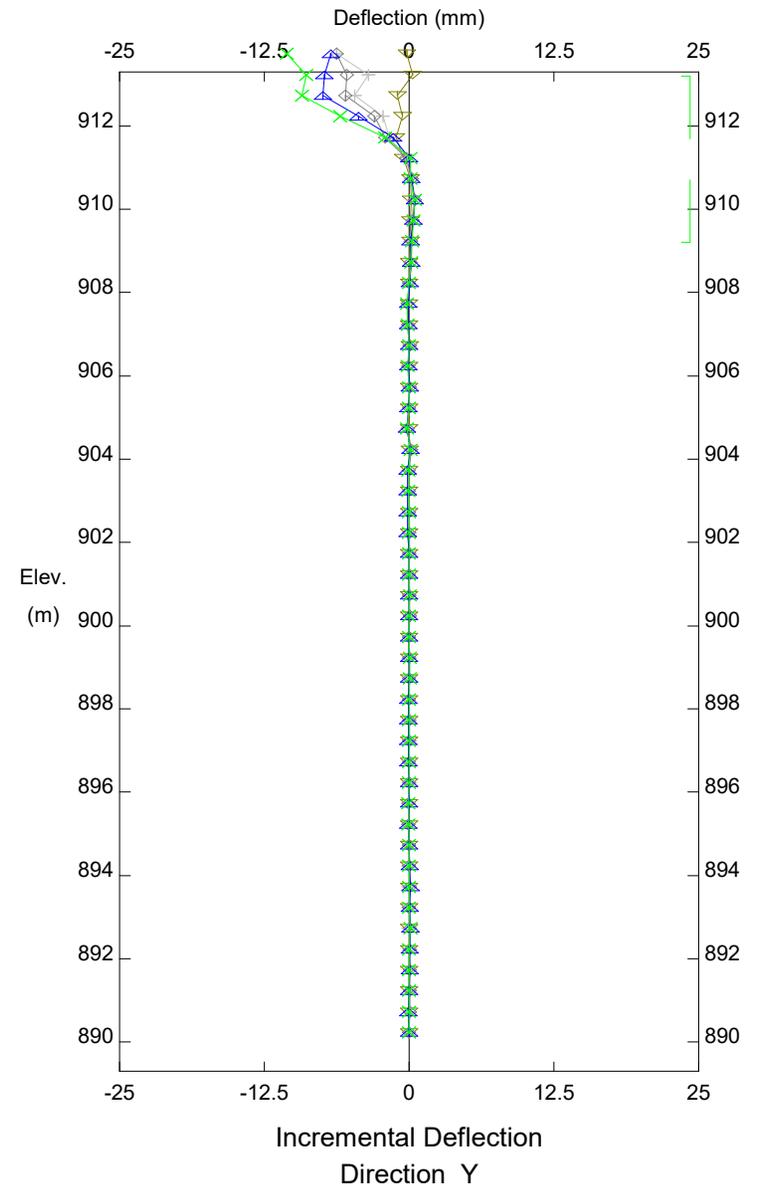
GP006; H40:36, Sheep Creek Embankment, Inclinator SI19-3

- Large deflections that were recorded in the tops of SI-2, SI19-2, and SI19-3 up to an approximate depth of 6 m below ground surface. The deflections are likely due to binwall construction in late 2020. It is noted that SI-2 and SI19-2 were shortened to the binwall bench level and then later raised through the bin wall fill during construction. It also appears the instruments were raised again after the previous consultant took their last reading in October 2020. The exact length of casing added is unknown but was estimated to be 2.5 m. KCB has subsequently extended the data files for SI-2 and SI19-2 by 2.5 m. The instruments have been read to the adjusted depth since June 2022, and the data aligns with the new reading depth. Due to the large deflections, KCB re-initialized the SI data plots to the June 2021 readings. It is noted that the data for SI19-2 is noisy and difficult to interpret, and the instrument may need to be re-initialized again. Based on the absolute plot, SI19-2 is tilted approximately 1.0 m and 2.4 m in the A- and B-directions, respectively.

No discernible movement had previously (i.e., before bin wall construction) been recorded in SI19-2 or SI19-3. However, since construction, large deflections have been recorded in the tops of these instruments to an approximate depth of 4 m below ground surface. These large deflections are believed to have been caused by cutting back (lowering) and raising the instrument casing during construction. KCB re-initialized the SI data plots to the June 2021 readings because these large deflections were complicating review of the SI data and potentially masking smaller movements that may be occurring. Since June 2021, distributed movement has been recorded in SI19-2 and SI19-3 up to an approximate depth of 9.3 m and 2.5 m, respectively. Since June 2022, some discrete movement has been recorded in SI19-2 at an approximate depth of 3.5 m below ground surface.
