July 15, 2025

CON0022166 Peace Region (Grande Prairie District – South) GRMP Instrumentation Monitoring Site GP006; H40:36, km 21.779 Sheep Creek Embankment (Three Teardrops Slide) Section C – 2025 Spring Readings

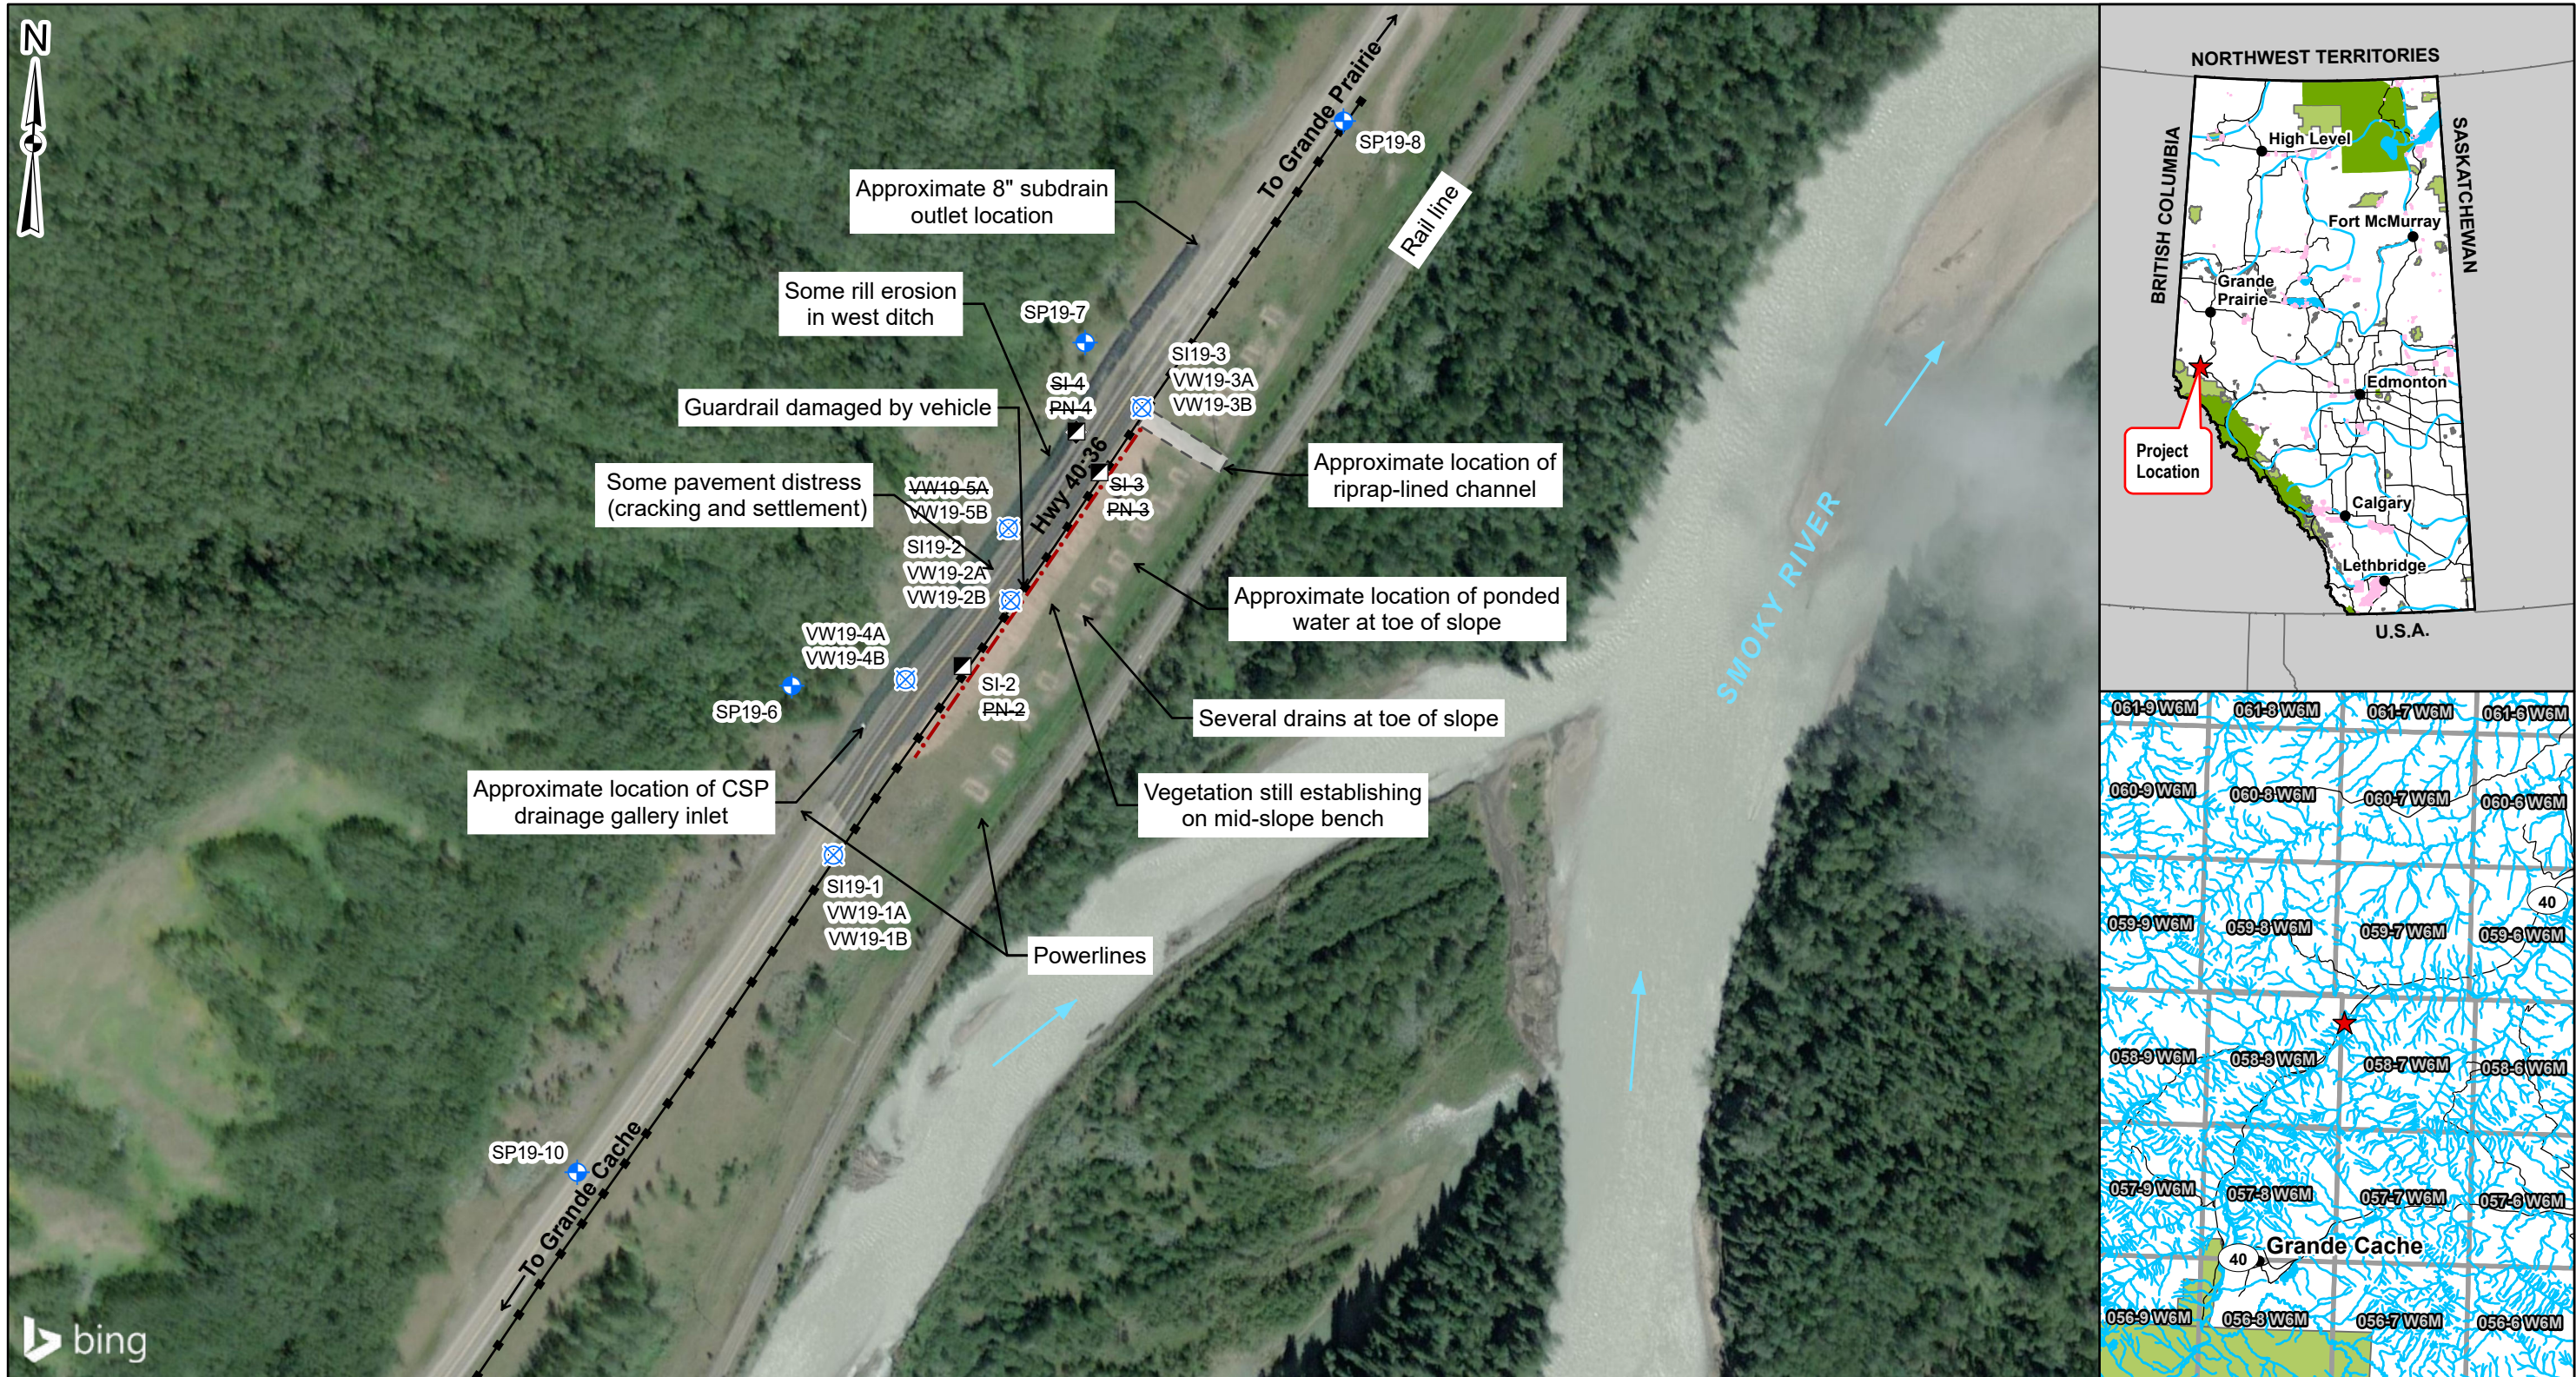
FIGURE

Four slope inclinometers (SIs) (SI-2, SI19-1, SI19-2, and SI19-3), nine vibrating wire piezometers (VWPs) (VW19-1A/1B through 4A/B, and VW19-5B), and four standpipe piezometers (SPs) (SP19-6 through SP19-10) were read at the GP006 site in the Peace Region (Grande Prairie District – South) (GP South Region) on June 3, 2025, by Evan Hergott, E.I.T. and Min Hou, E.I.T. of Klohn Crippen Berger Ltd. (KCB). These instruments were read as part of the GP South Region Geohazard Risk Management Program (GRMP). The site is located on Hwy 40:36, km 21.779, on the Sheep Creek Embankment. The approximate site coordinates are 5990716 N, 366584 E (UTM Zone 11, NAD 83). A site plan is presented on Figure 1.

- PN-4 was found to be inoperable (appeared to have been chewed off to ground surface) and could not be repaired. This instrument will not be read again. Since the water levels recorded in PN-4 were typically above or near ground surface and higher than those recorded in nearby VW19-03B (water level approximately 8.5 m to 9.0 m below ground surface), a replacement instrument should be considered.
- VW19-5A was found to be inoperable and no reading was obtained even after the readout cables were inspected, cutback, and stripped. This instrument will not be read again. A replacement instrument is not recommended at this time since the deeper nested piezometer (VW19-5B) is still operable and provides comparable data.

The instruments are protected by above-ground casing protectors, except SI-2, SI19-2, and SI19-3.

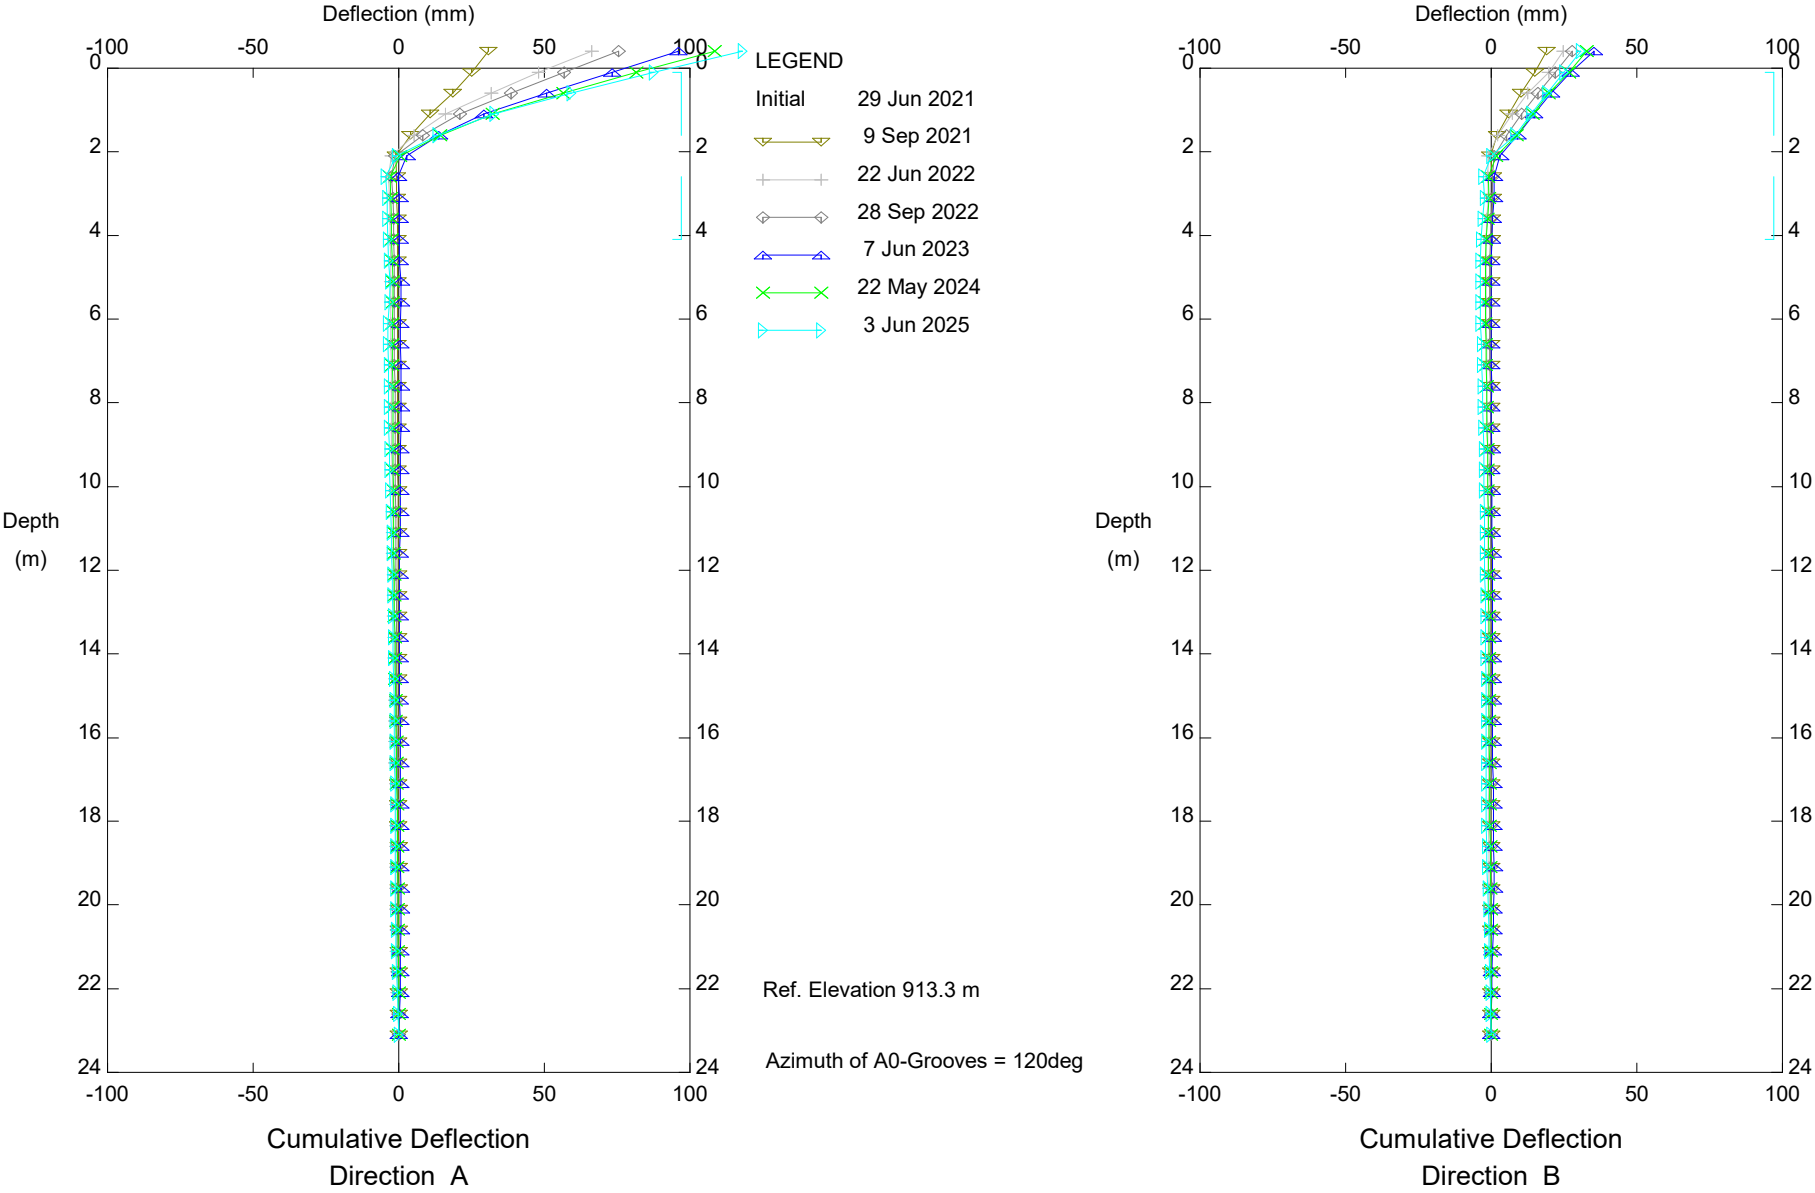
- Large deflections that were recorded in the tops of SI-2, SI19-2, and SI19-3 up to an approximate depth of 6 m below ground surface. The deflections are likely due to binwall construction in late 2020. It is noted that SI-2 and SI19-2 were shortened to the binwall bench level and then later raised through the bin wall fill during construction. It also appears the instruments were raised again after the previous consultant took their last reading in October 2020. The exact length of casing added is unknown but was estimated to be 2.5 m. KCB has subsequently extended the data files for SI-2 and SI19-2 by 2.5 m. The instruments have been read to the adjusted depth since June 2022, and the data aligns with the new reading depth. Due to the large deflections, KCB re-initialized the SI data plots to the June 2021 readings. It is noted that the data for SI19-2 is noisy and difficult to interpret, and the instrument may need to be re-initialized again. Based on the absolute plot, SI19-2 is tilted approximately 1.0 m and 2.4 m in the A- and B-directions, respectively.

A relatively large amount of displacement (up to approximately 30 mm) has been recorded in the B-direction of SI-2 from ground surface to an approximate depth of 5.1 m. The direction of movement varies from positive to negative indicating the displacement may be attributed to movement in the fill placed in 2020, or seasonal temperature fluctuations (i.e., frost penetration).

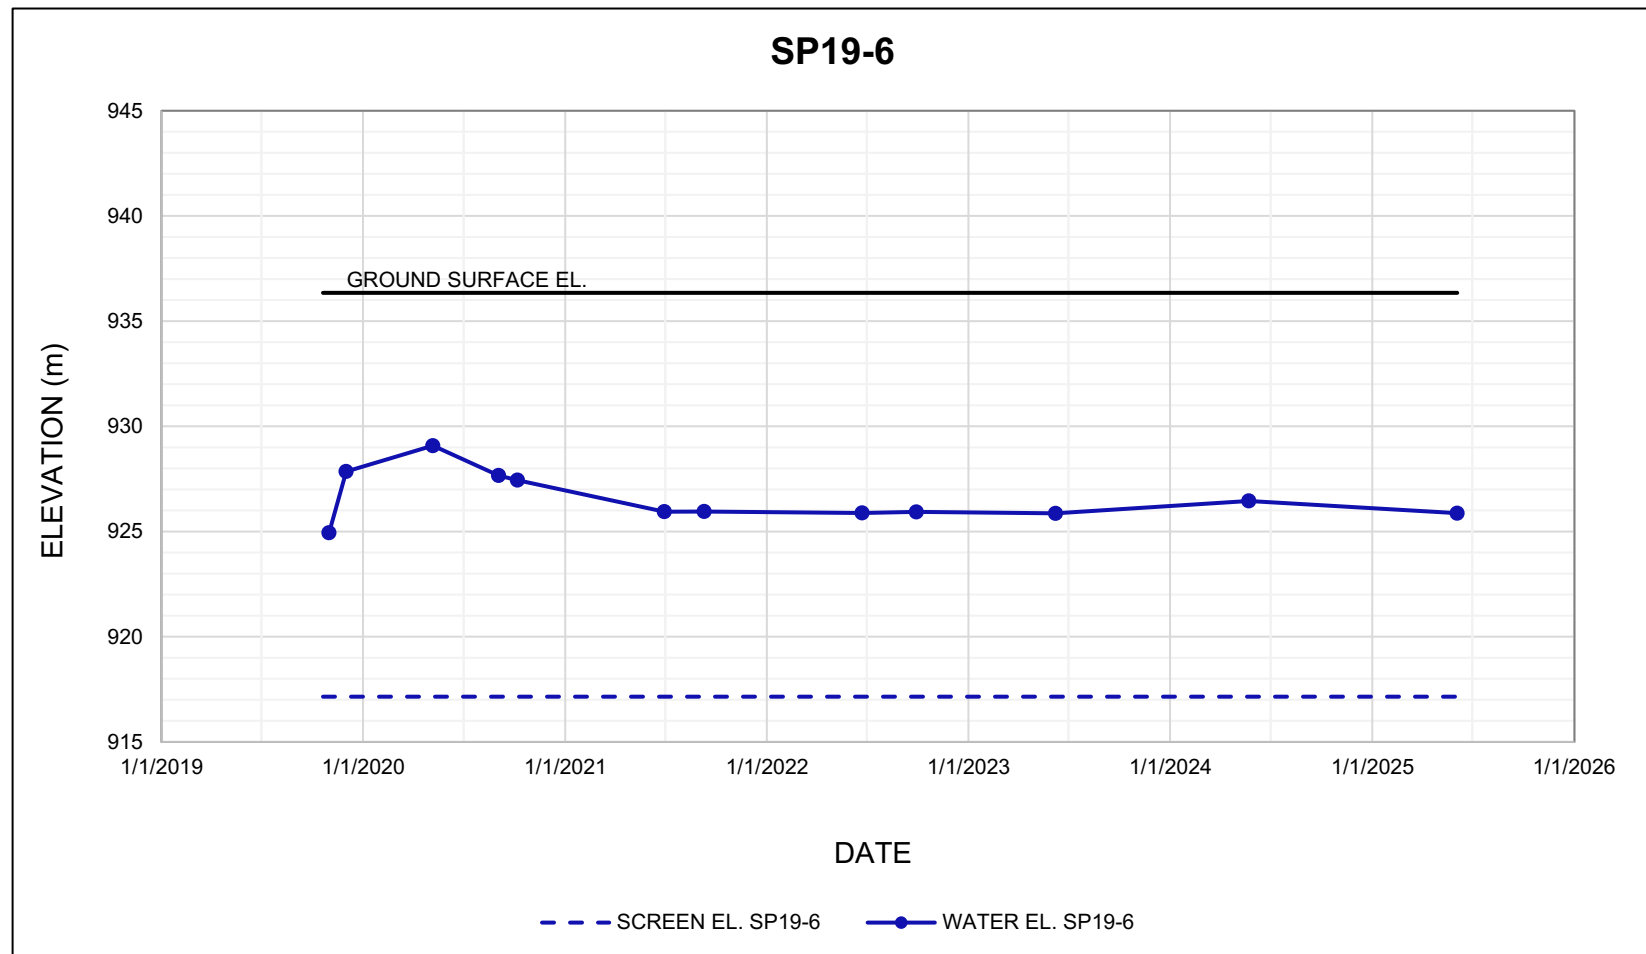
Between mid to late-2020 and mid-2021, a large decrease in water level (between approximately 2.5 m and 6.0 m) was recorded in all the piezometers installed along the repaired section of highway (PN-4, SP19-6, SP19-7, VW19-2A/B through VW19-5A/B), excluding VW19-2A and VW19-3A, which have been dry or near dry (i.e., at or near tip elevation) since installation. The recorded decreases could be attributed to the installation of drains during binwall construction in late 2020. During the June 2022 Section B inspection, some of the subdrains at the toe of the highway embankment were observed to be flowing and others to be wet around their outlets (site was not inspected during the 2023 through 2025 Section B inspection tours). It is KCB's understanding that the rate of flow from the subdrains has decreased since binwall construction. Since 2021, water levels recorded in these piezometers have been relatively steady (± 1 m), except in SP19-7 where they continue to decrease as discussed above. It is noted that VW19-4B has been dry since late-2022/early-2023, and PN-4 and VW19-5A have been inoperable since fall 2024.

VW19-1A/B are installed outside of the repaired section of highway. VW19-1A has been dry since installation (installed approximately 5 m below ground surface), and the porewater pressure recorded in VW19-1B has been relatively steady since installation (fluctuates between an approximate depth of 9.2 m and 11.4 m below ground surface).

PN-4 was found to be broken (appeared to be chewed off to ground surface) in spring 2025 and could not be read or repaired. Since the water levels recorded in PN-4 were typically above or near ground surface and higher than those recorded in nearby VW19-03B (water level approximately 8.5 m to 9.0 m below ground surface), a replacement instrument should be considered.
