November 30, 2022

Alberta Transportation
Main Floor, Provincial Building
9621 – 96th Avenue
Peace River, Alberta
T8S 1T4

CON0022166 Peace Region (Grande Prairie District – South) GRMP Instrumentation Monitoring Site GP007; H40:36, km 29.339 Wanyandie Road Slide Section C – 2022 Fall Readings

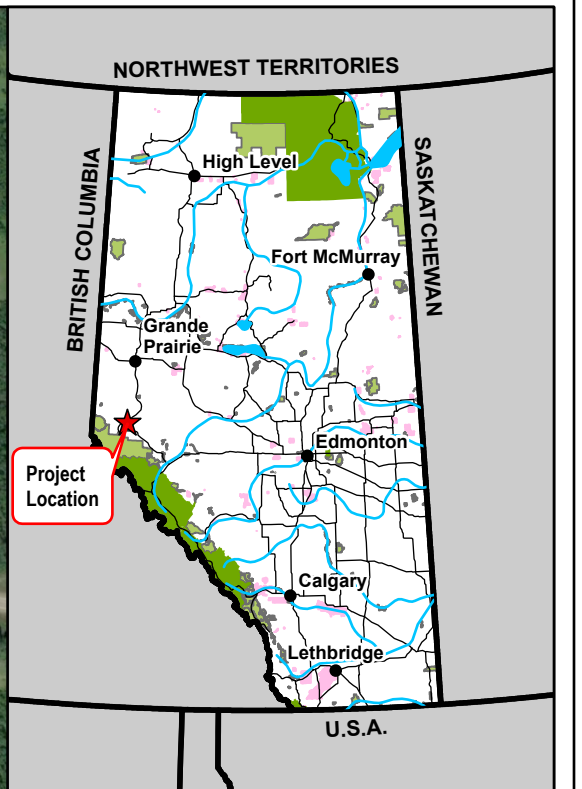
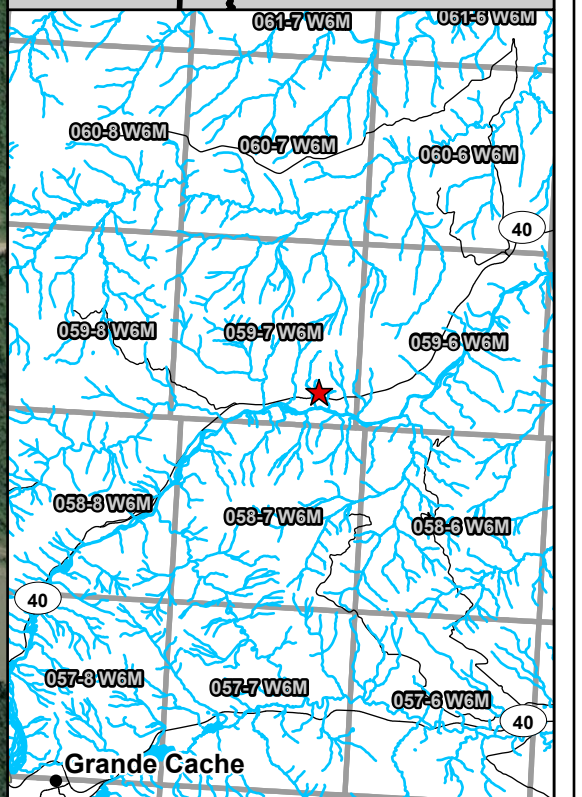
SCALE 1:6,000 PROJECT No. A05116A01 FIG No. 1

Based on the surface expression of the 2005 bare-earth LiDAR data and historic air photos, the most active slide terrain is located downslope of Hwy 40:36 and Wanyandie Road at the western site limit as shown in Figure 1. KCB hiked to this area during our March 2022 site reconnaissance and the 2022 Section B inspection with AT. A series of ridges and troughs were observed, which could be the result of blocks sliding and eroding overtime with vegetation growth, becoming more rounded. The direction of movement recorded in SI98-2 and SI98-5 was towards the area of ridges and troughs before they sheared.

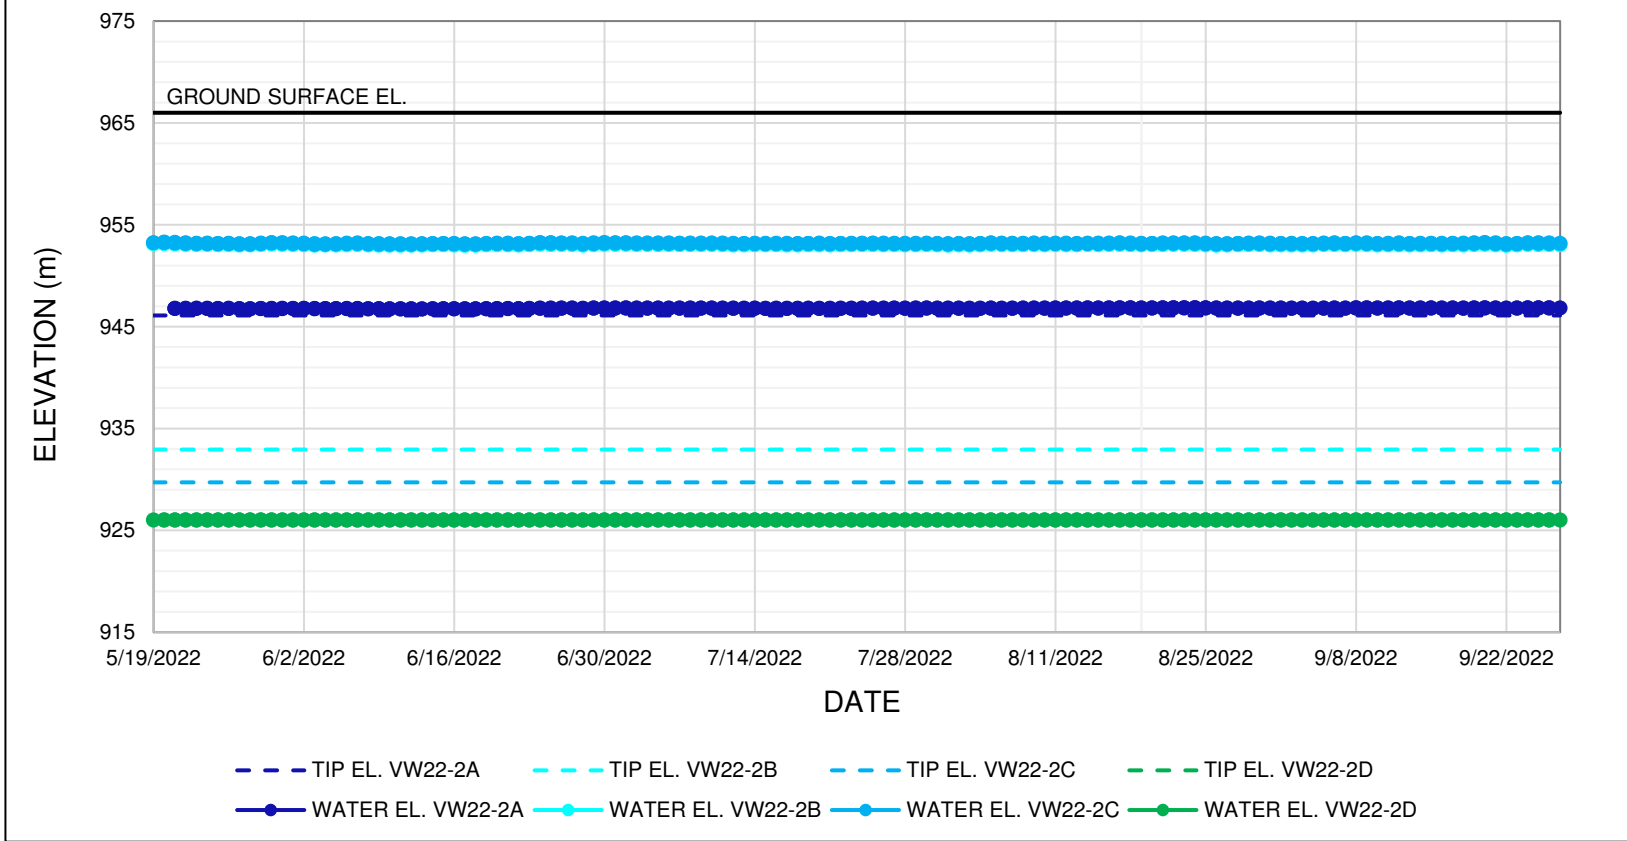
VW22-2A, 2B, 2C, AND 2D

VWP22-1B/C have been dry since installation and are installed in bedrock (siltstone and sandstone, respectively). VW22-1B was installed near a possible shear zone observed near the top of the siltstone unit. VW22-2D and -3D have been dry since installation and are both installed in clay shale.
