November 28, 2025

Alberta Transportation and Economic Corridors
Main Floor, Provincial Building
9621 – 96th Avenue
Peace River, Alberta
T8S 1T4

**CON0022166 Peace Region (Grande Prairie District – South) GRMP Instrumentation Monitoring
Site GP007; H40:36, km 29.339 Wanyandie Road Slide
Section C – 2025 Fall Readings**

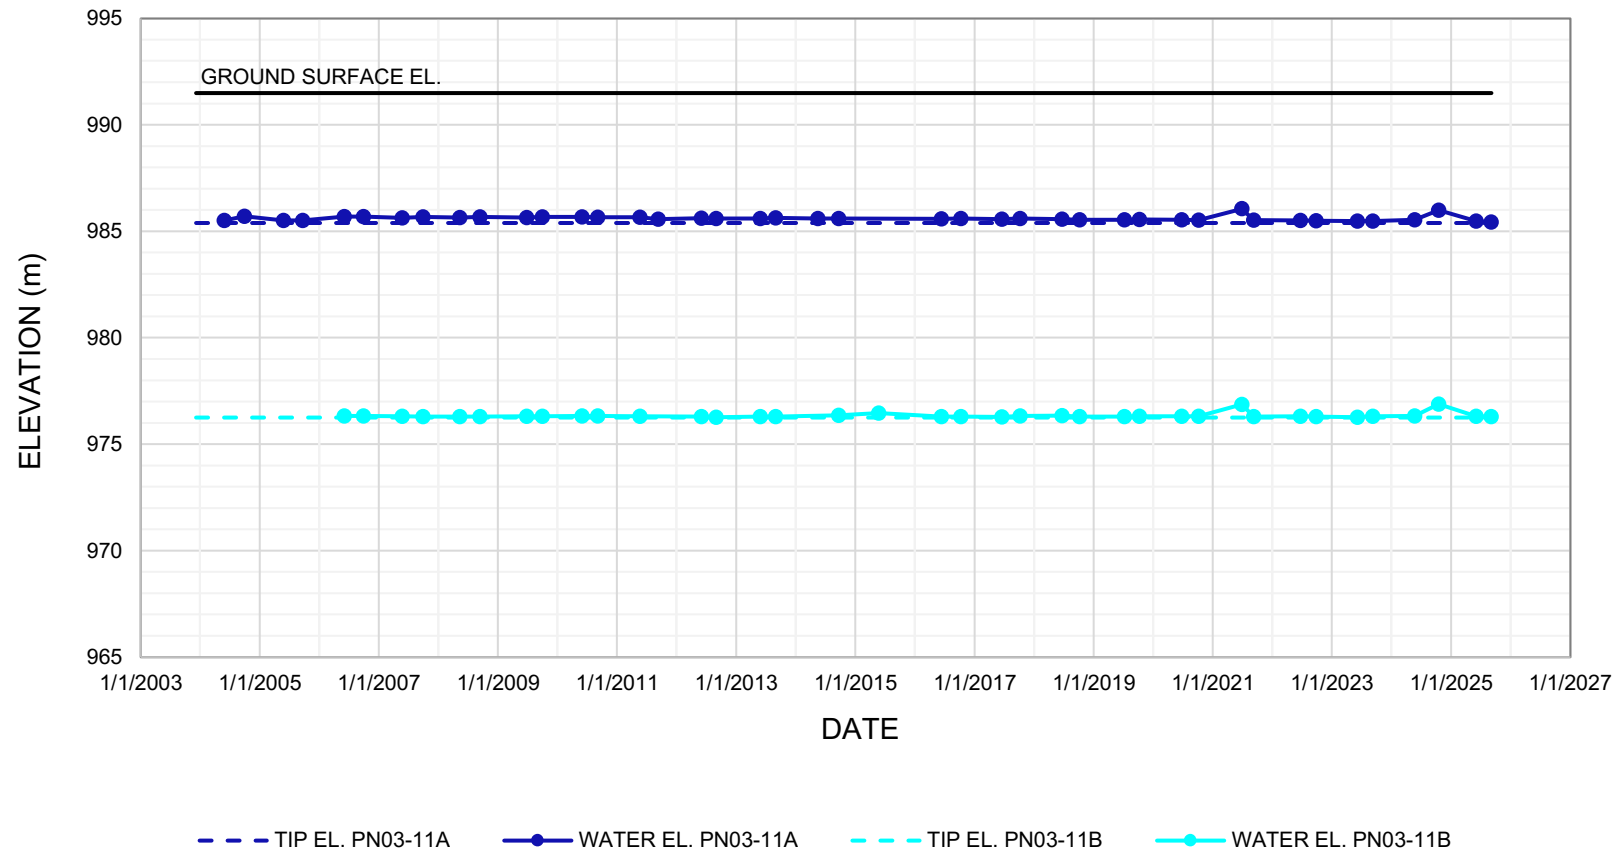
PN03-11A and PN03-11B

No instrument repairs or maintenance is required. However, it is noted that the PNs are 22 years to 27 years old and more variability has been observed in the data recorded in these instruments in the past five years, which could indicate they are either sensitive to the reading equipment being used or perhaps starting to fail.

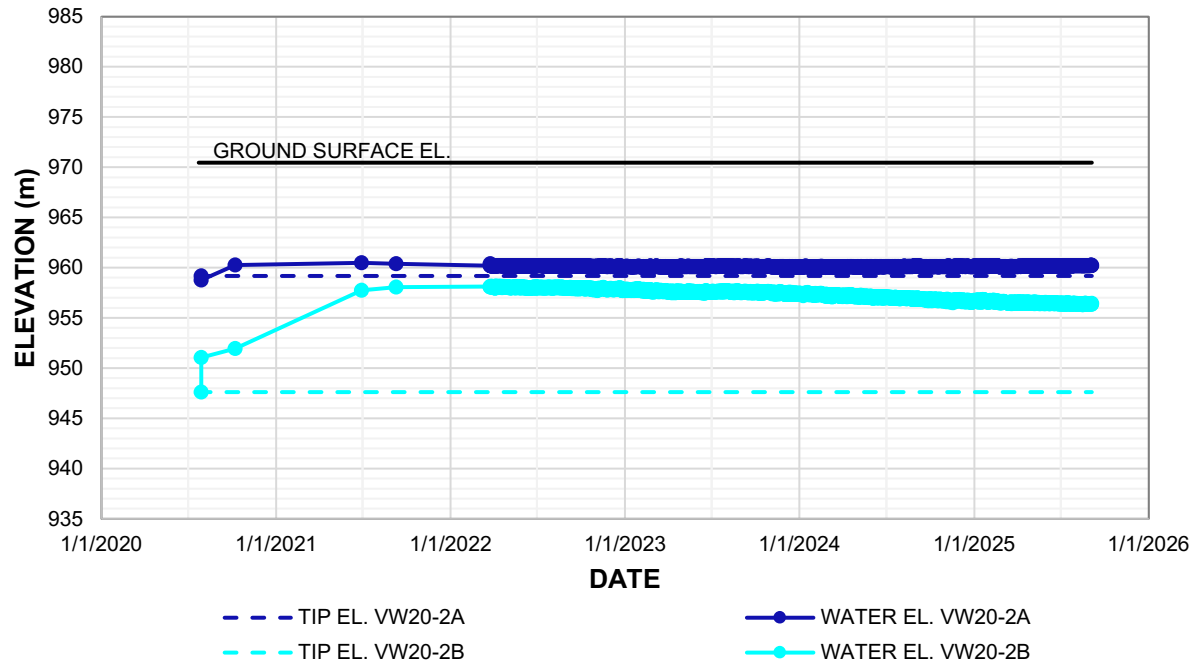
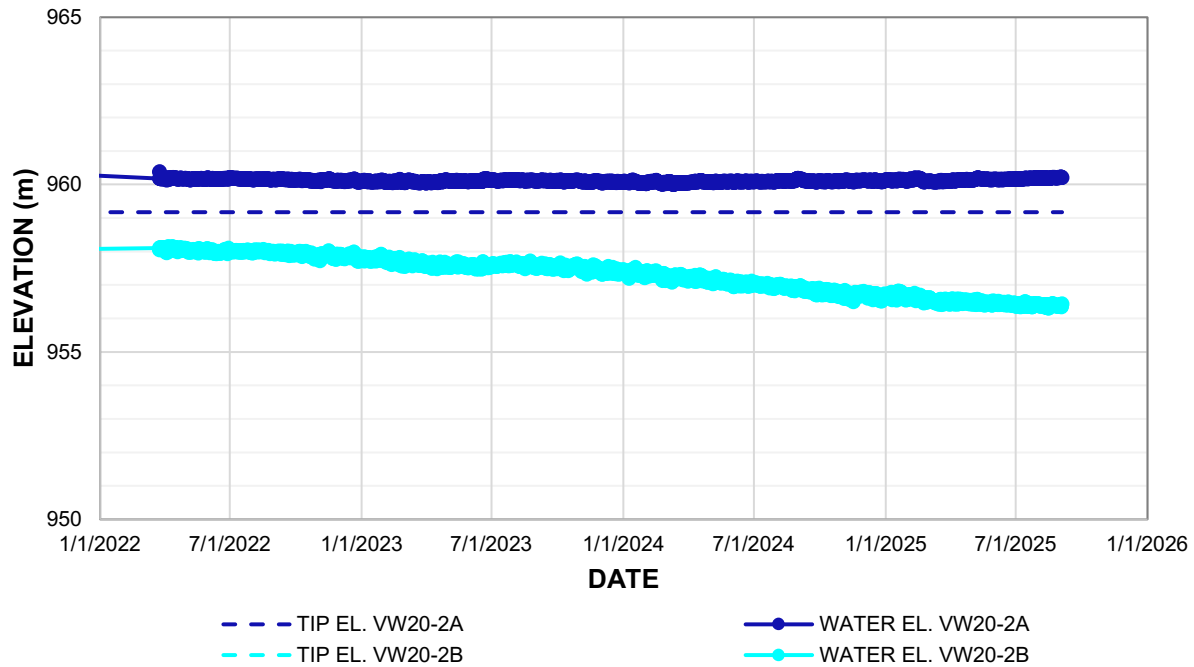
VW20-2A AND 2B (2020 TO CURRENT)

The grout used to backfill the 2020 and 2022 boreholes may be muting the response of the VWPs to changing groundwater levels, or the groundwater level variations are too rapid (e.g., occurring in bedrock fractures or joints) to be recorded by the data loggers. However, the data loggers installed in SP20-4 and SP20-8, in February 2023, have also not captured short-term water level variations. As discussed in Section 2.6, additional sand-packed piezometers with data loggers could be installed to assess for short-term (e.g., seasonal) groundwater level variations in the overburden soils and bedrock.
