CON0022166 Peace Region (Grande Prairie District – South) GRMP Instrumentation Monitoring Site GP007; H40:36, km 29.339 Wanyandie Road Slide Section C – 2025 Spring Readings

2025 GP007 Spring Report
A05116A01

PEACE REGION (GRANDE PRAIRIE DISTRICT-SOUTH)
GEOHAZARD RISK MANAGEMENT PROGRAM

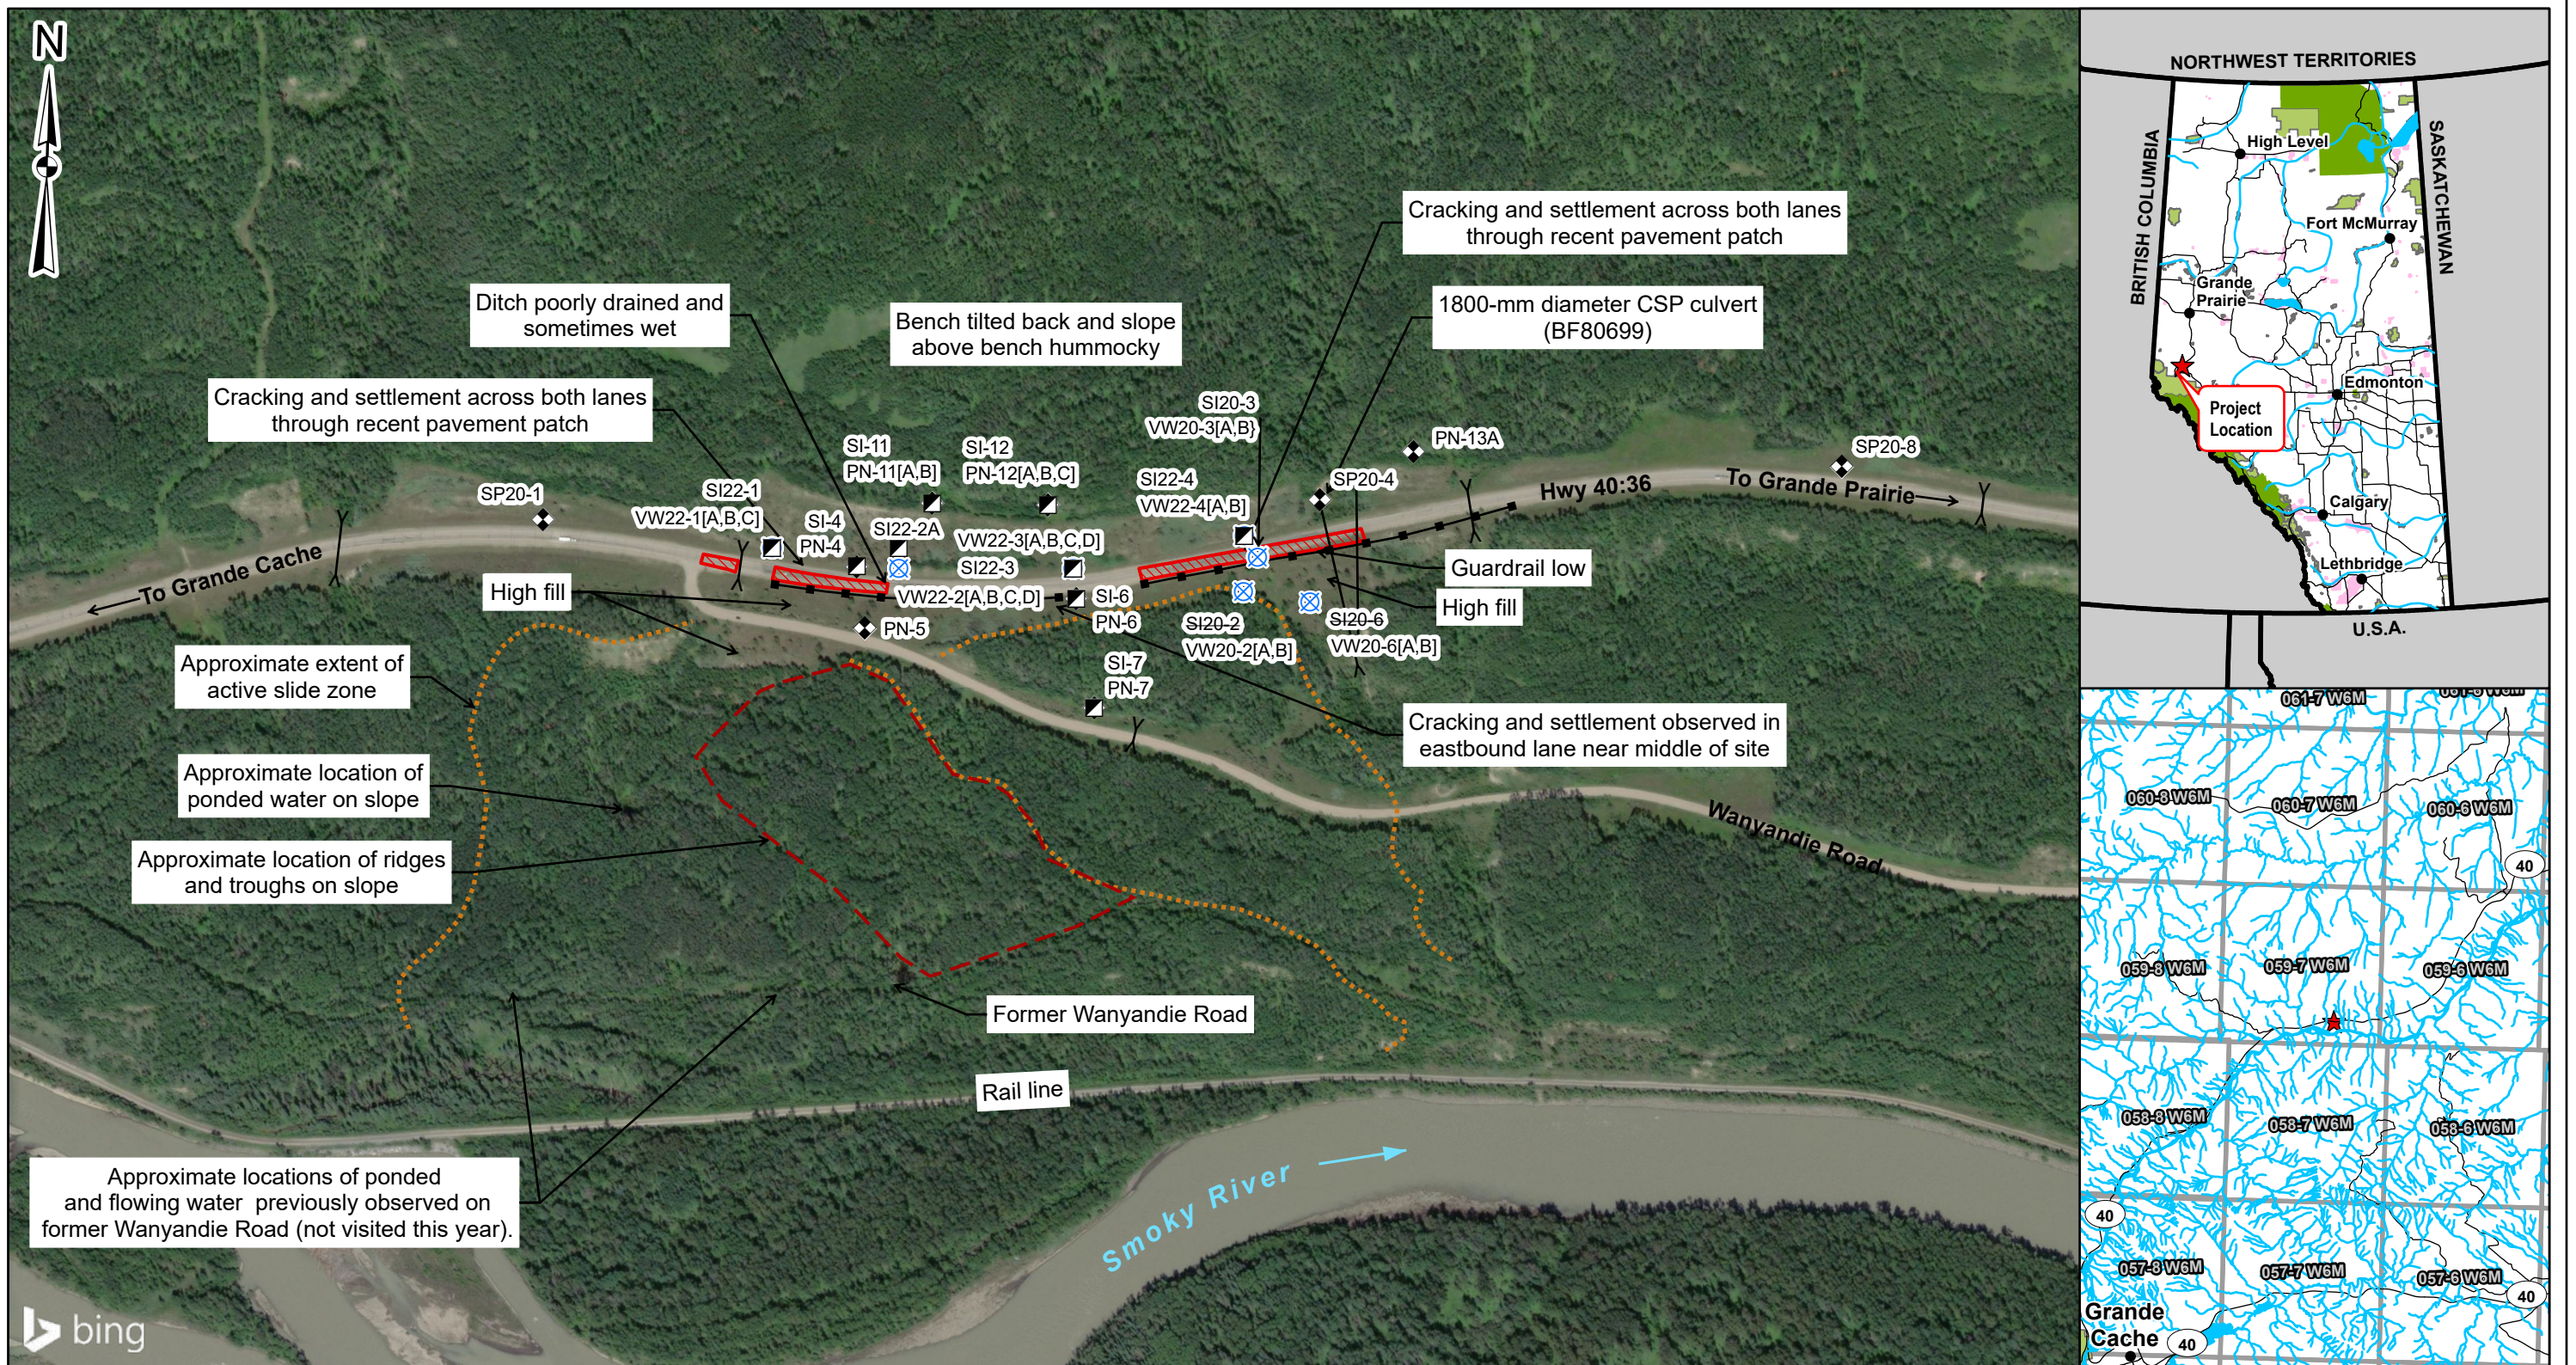
Based on the surface expression of the 2005 bare-earth LiDAR data and historic air photos, the landslide appears most active downslope of Hwy 40:36 and Wanyandie Road at the west end of the site as shown on Figure 1. In 2022, a series of ridges and troughs were observed, which could be the result of blocks sliding and eroding overtime with vegetation growth, becoming more rounded. The direction of movement recorded in SI98-2 and SI98-5 (before they sheared) was towards the area of ridges and troughs.

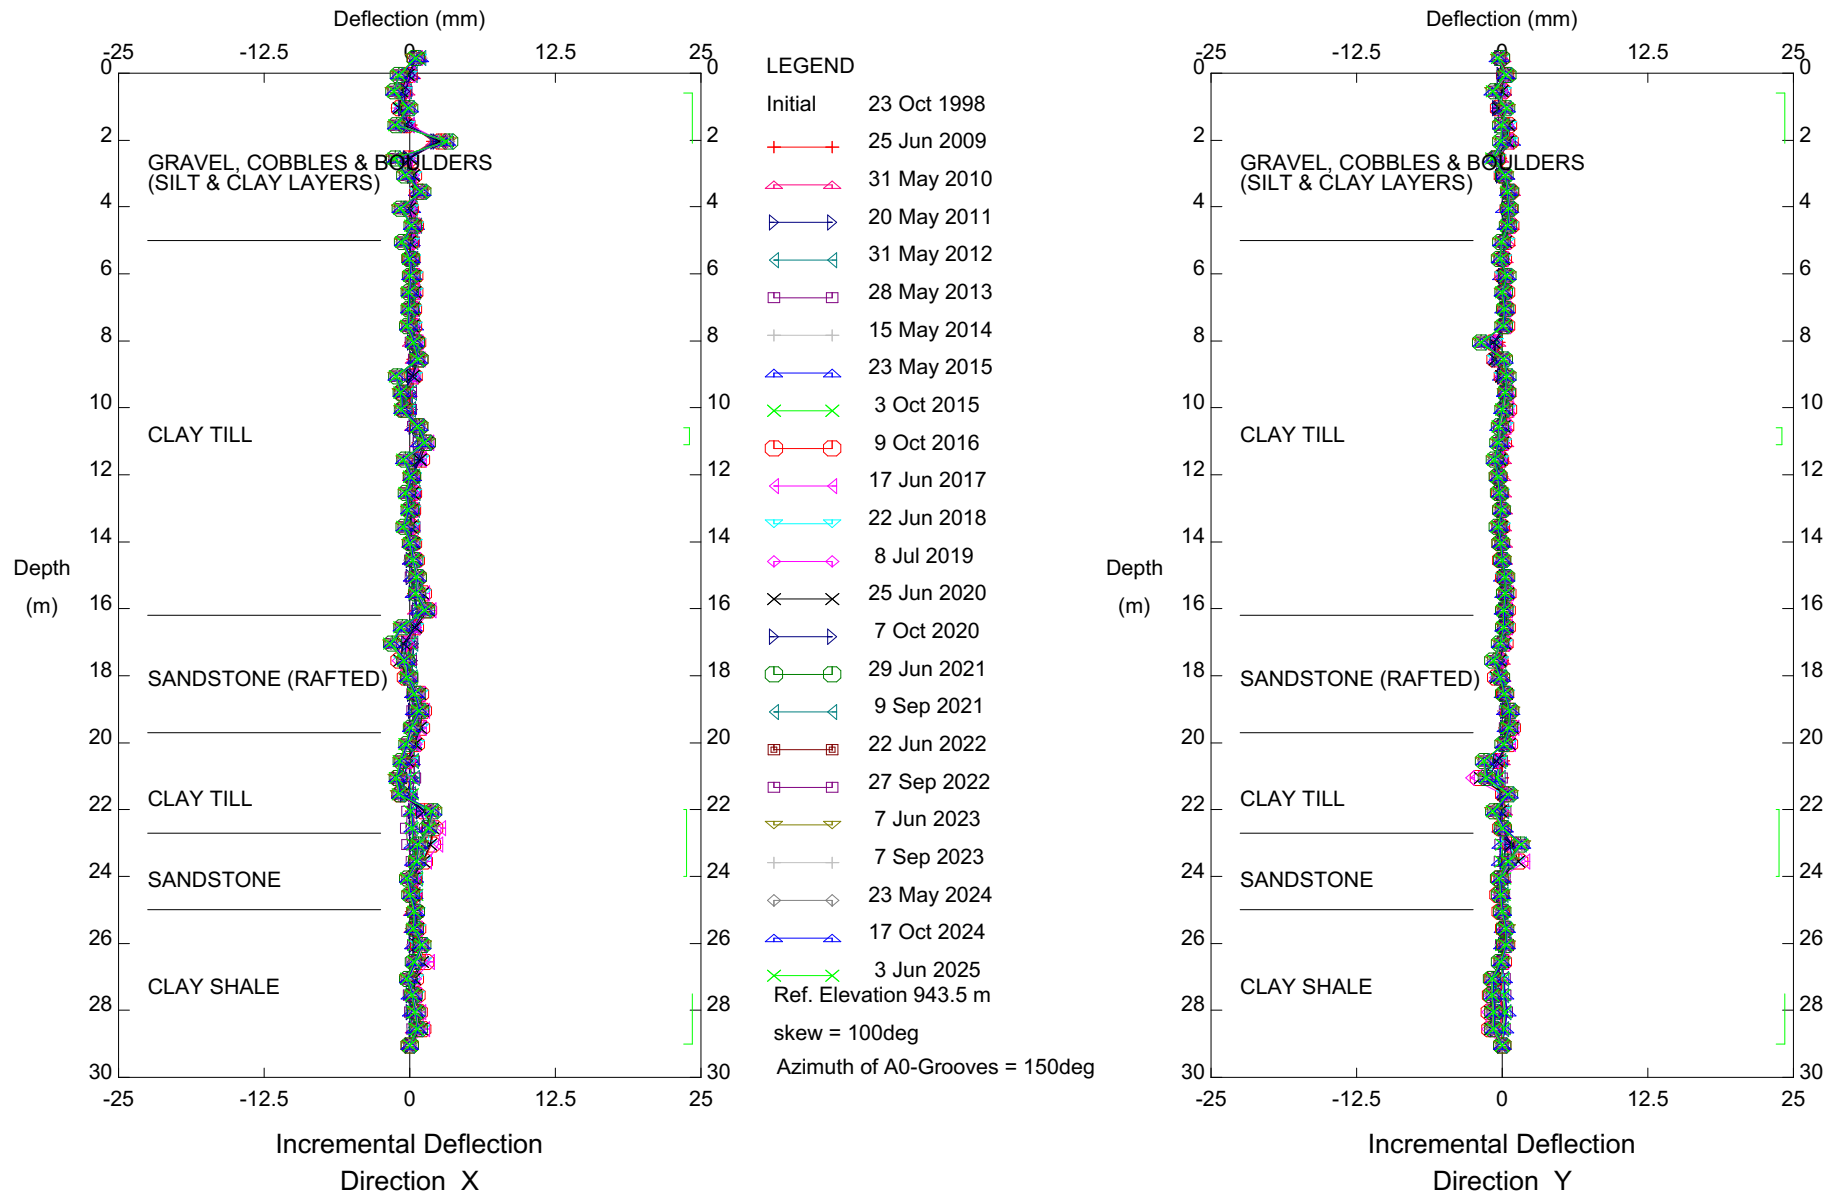
GP007; H40:36, Wanyandie Road Slide, Inclinometer SI98-07

It is noted that the data for SI98-6, SI98-7, and SI03-12 is noisy and difficult to interpret. Based on the absolute plots for these instruments, SI98-6 has kinks in the casing at an approximate depth of 11.9 m and 13.9 m below ground surface (mbgs), and SI98-7 and SI03-12 are tilted approximately 1.3 m and 1.5 m in the A direction, respectively. SI98-12 has also been re-sleeved twice (i.e., had a small-diameter casing installed in it) (dates unknown)

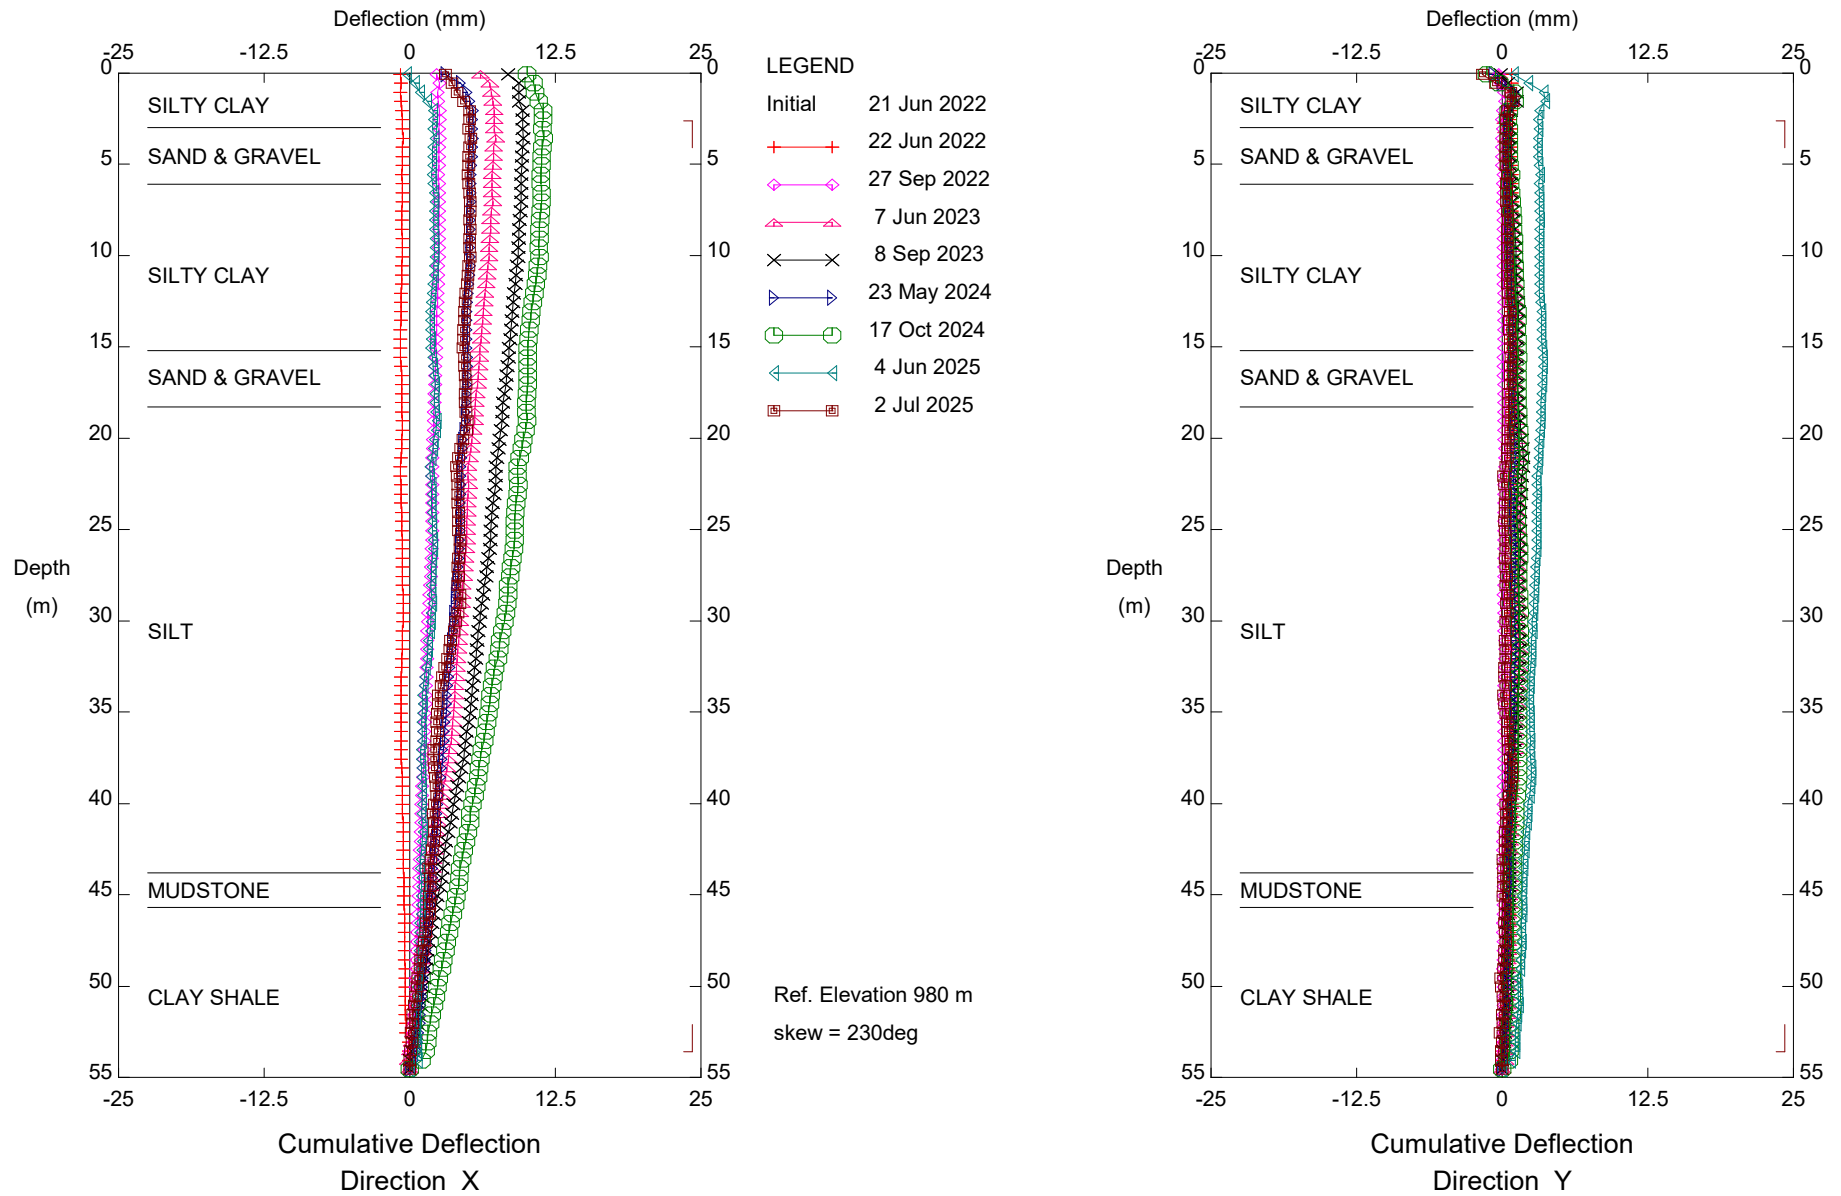
GP007; H40:36, Wanyandie Road Slide, Inclinator SI22-04

In May 2022, a deeper SI (SI22-4) was installed on the north side of the highway to assess if deeper movements are occurring at the east end of the site. Distributed movement is being recorded along the entire length of the instrument (i.e., from near ground surface to the base of the instrument) since installation, with no discrete movement zones. It is noted that data recorded in SI22-4 is fluctuating with negative displacement sometimes being recorded.

Overall, the data recorded in SI22-4 does not reflect the increased pavement distress (cracking and settlement) observed near the east end of the site and this instrument in fall 2024 or spring 2025.
