**ALBERTA TRANSPORTATION  
GEOHAZARD ASSESSMENT PROGRAM  
PEACE REGION – GRANDE PRAIRIE DISTRICT  
2020 INSPECTION**

Site Number	Location	Name	Hwy	km
GP03	NW of Grande Cache	Cutbank River S (Roseham Crk)	40:38	51.8
Legal Description		UTM Co-ordinates (NAD 83)		
NE16-65-5-W6		11U N 6,054,425	E 390,990

**2020 SITE INSPECTION**

**2020 SITE INSPECTION (NORTH HALF)**

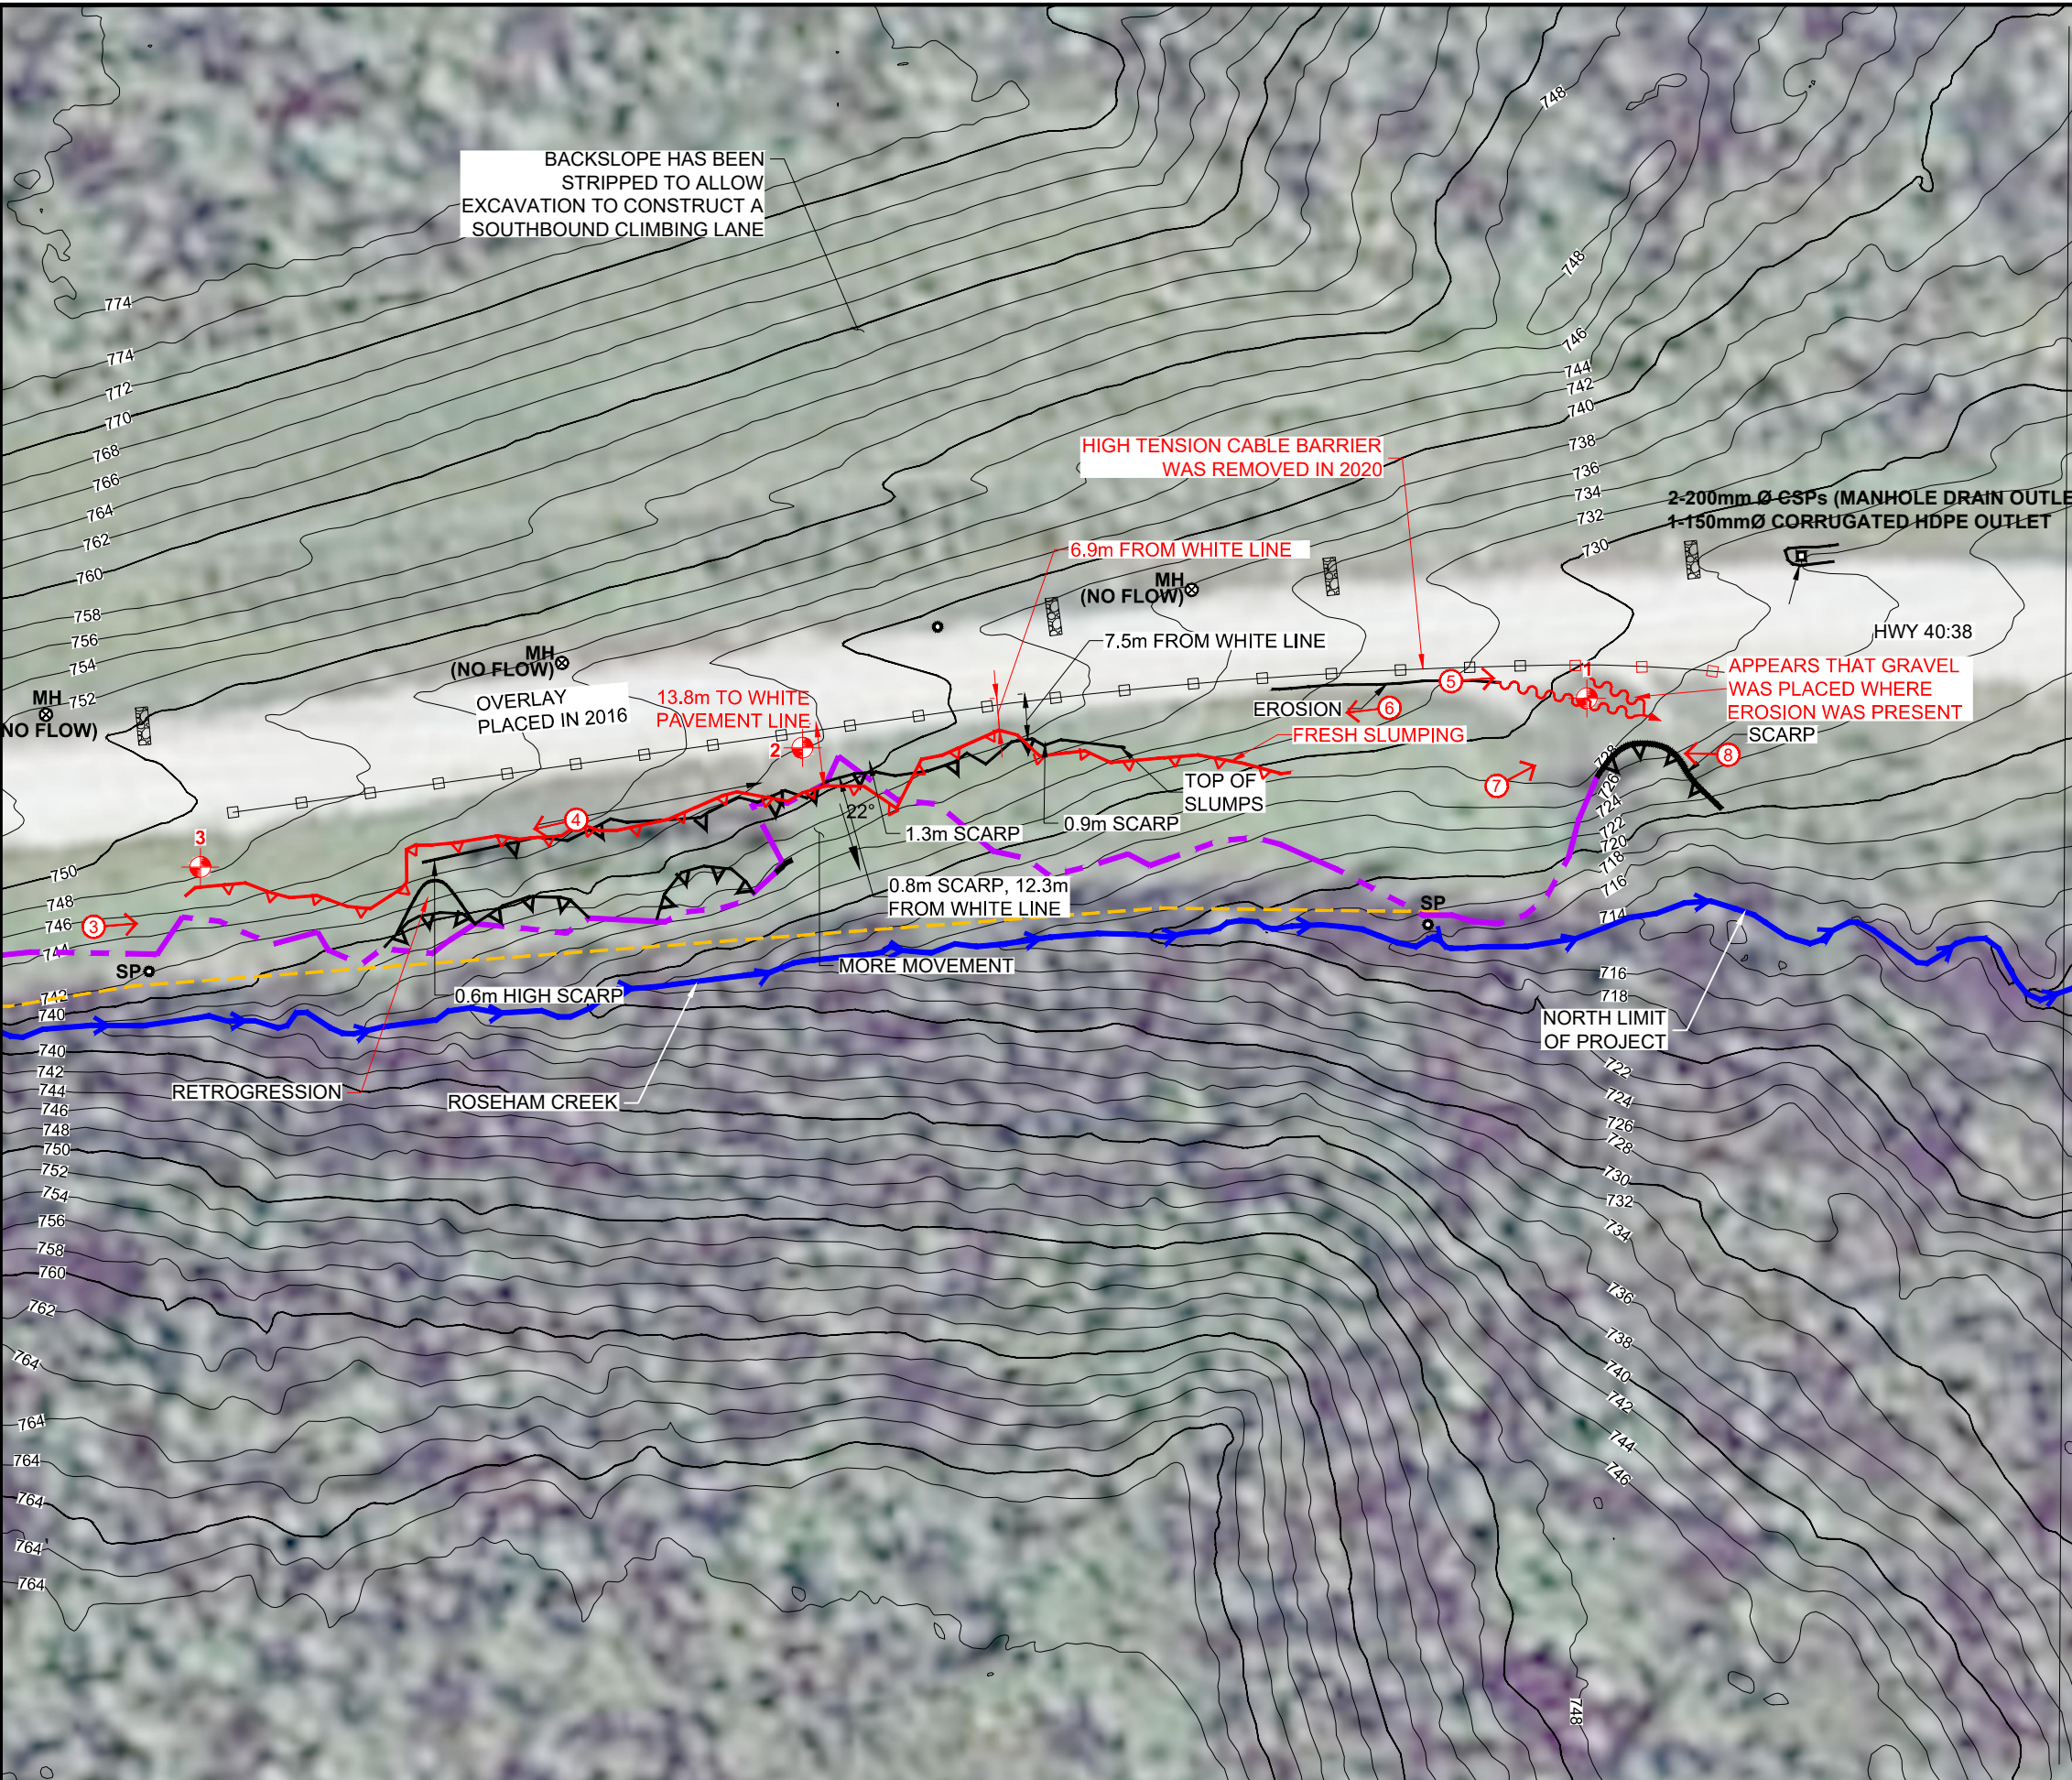
Drill 6 test holes complete with slope inclinometers and piezometers on the downslope edge of the highway with one directly below the one at the south end (as shown on Figure GP03-1-2/3) to depths of between 15 to 25 m to provide information on the soil and groundwater conditions at this location, and to confirm slope stabilization design measures. There should also be some surficial samples taken (using a backhoe or a hand auger/spade) to assess base channel soil characteristics, for liners/anchor/cut-off design. Detailed hydrological design will also be required prior to preparing a detailed design and tender document.
