Alberta Transportation  
Main Floor, Provincial Building  
9621 96 Avenue  
Peace River, Alberta  
T8S 1T4

**CON0022166 Peace Region (Grande Prairie District – South) GRMP Instrumentation Monitoring Site GP003; H40:38; km 52.134 Cutbank River (South) Section C – 2021 Spring Readings**

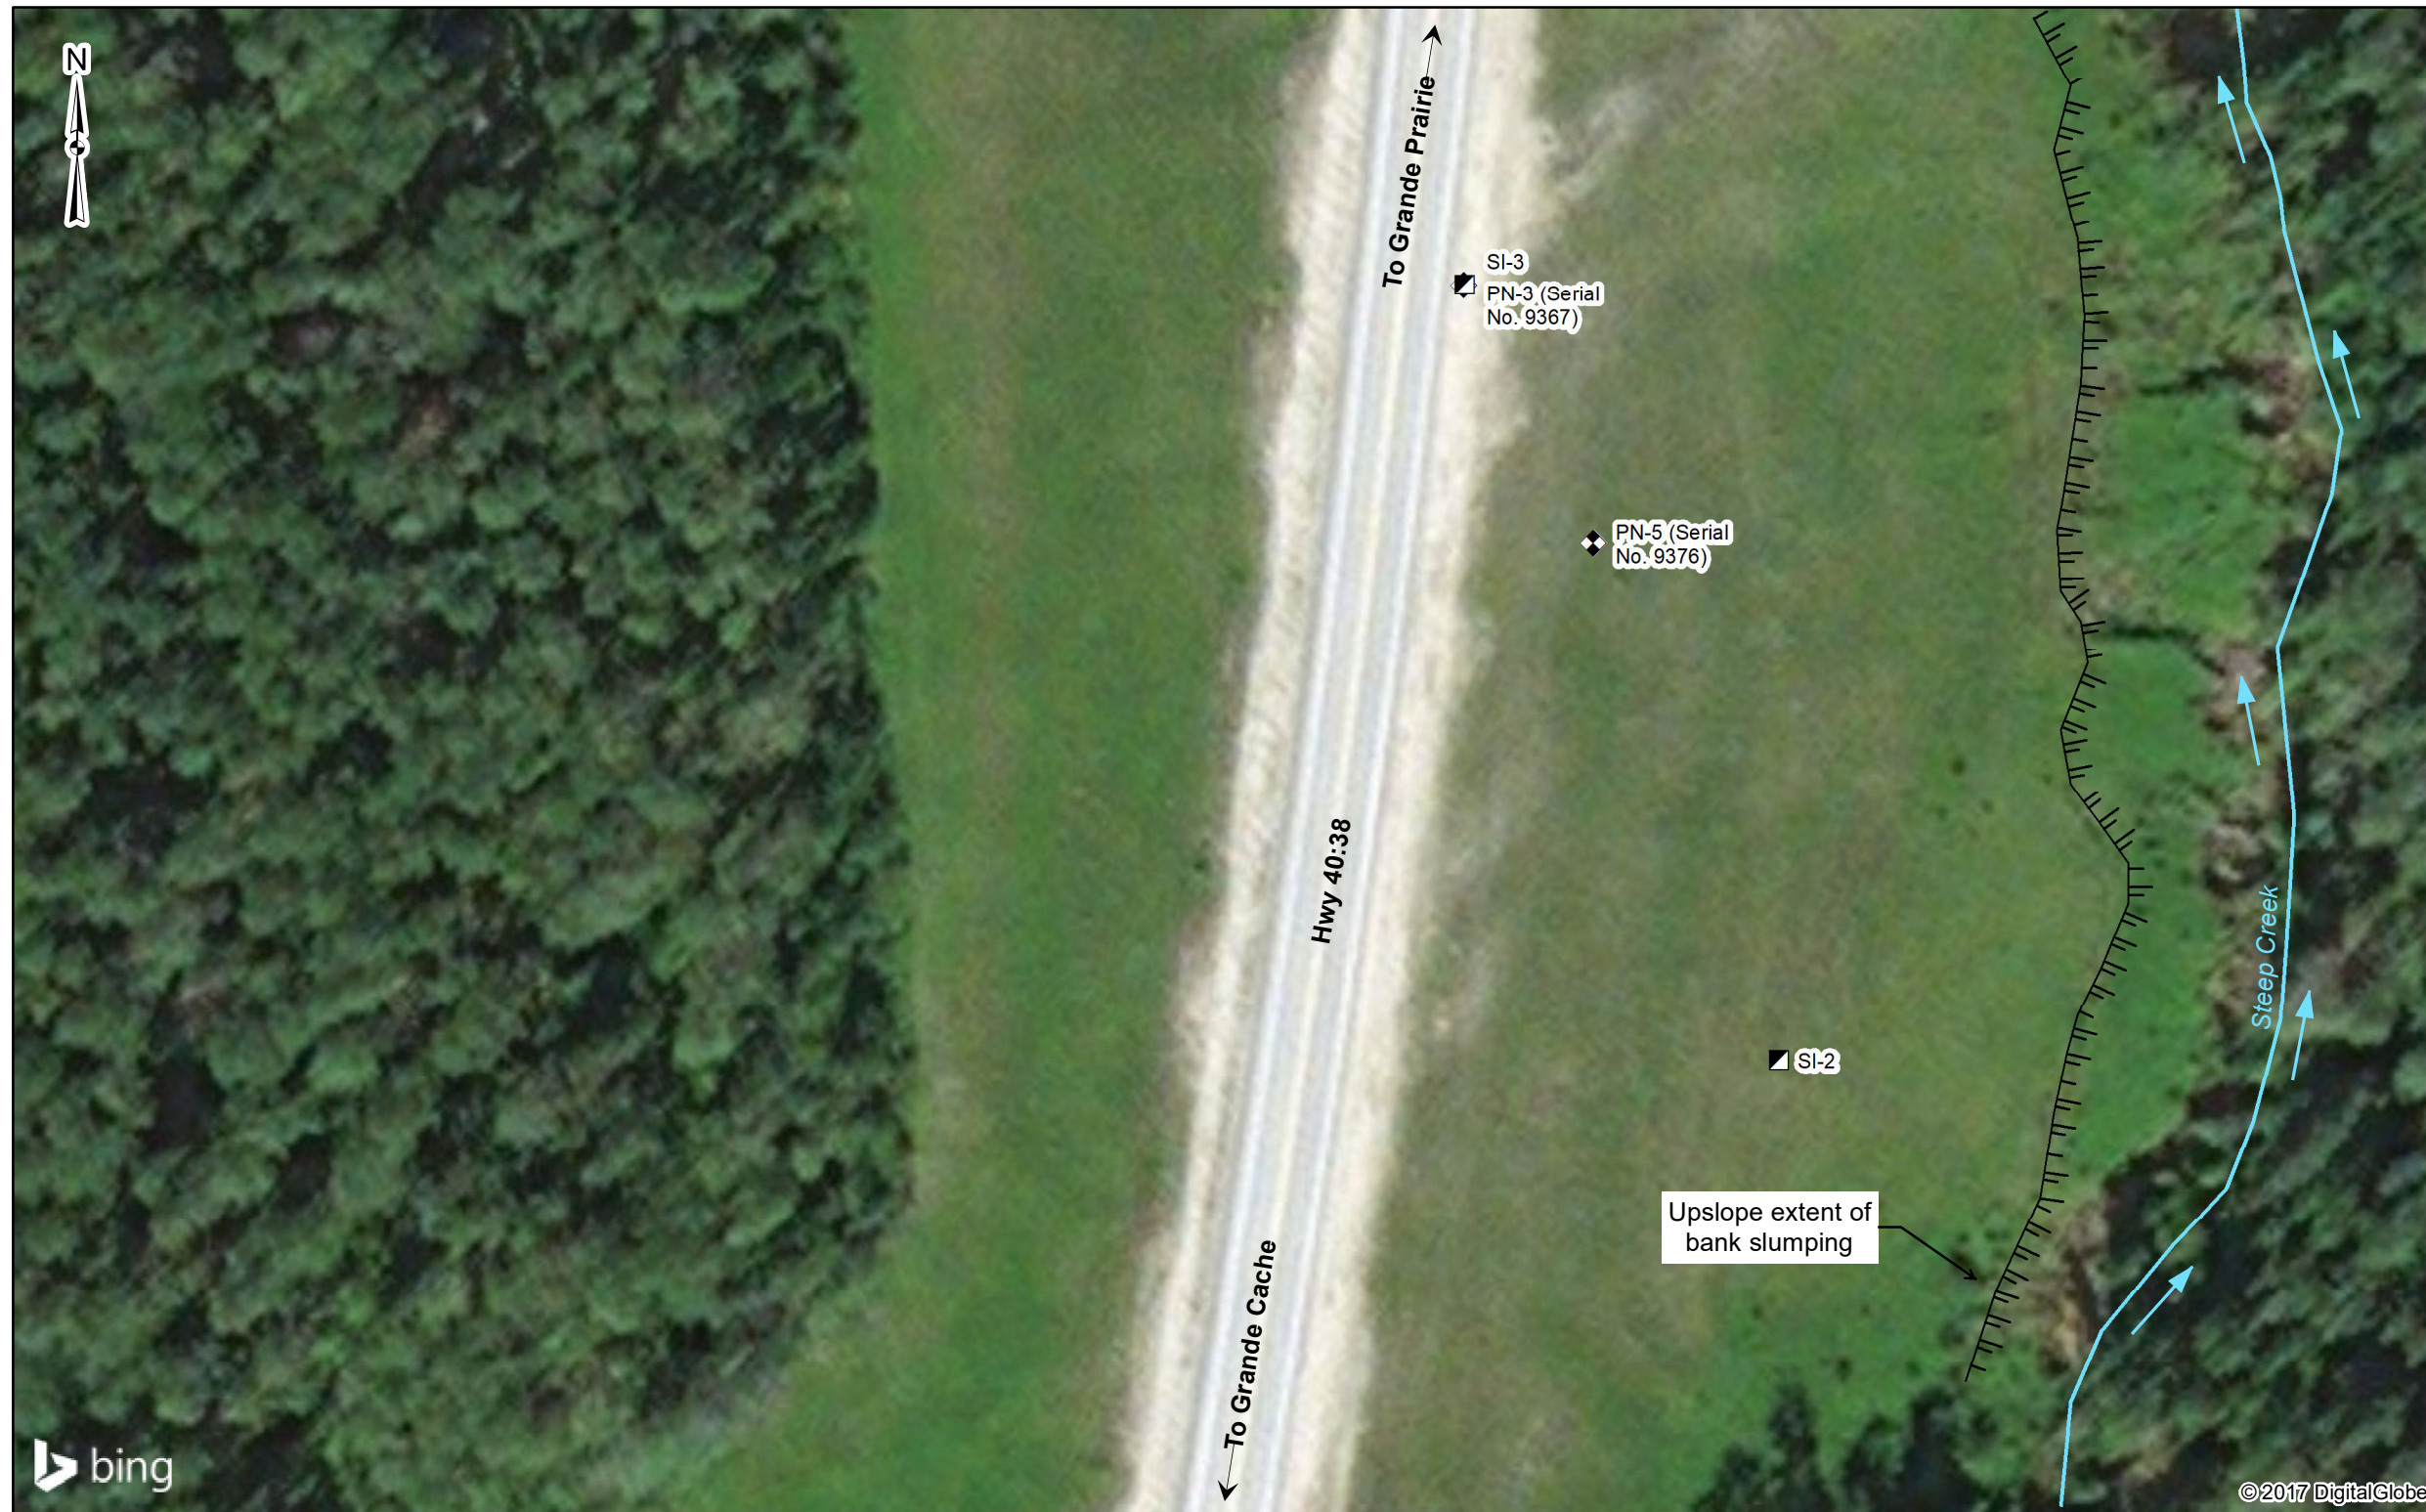
Two slope inclinometers (SIs) (SI-2 and SI-3) and two pneumatic piezometers (PNs) (PN-3 and PN-5) were read at the GP003 site in the Peace Region (Grande Prairie District – South) (GP South) on June 28, 2021 by Mr. James Lyons, E.I.T. and Ms. Amy Miller, E.I.T. of Klohn Crippen Berger Ltd. (KCB). These instruments were read as part of the GP South geohazard-risk-management program (GRMP). The site is located on Hwy 40:38, km 52.134, south of the Cutbank River. The site coordinates are 6054593 N, 391085 E (UTM zone 11, NAD 83). A site plan is presented in Figure 1.

Instrumentation installation details are tabulated in Table 1.1. Locations of operable instruments are shown in Figure 1.
