**ALBERTA TRANSPORTATION
GEOHAZARD ASSESSMENT PROGRAM
PEACE REGION – GRANDE PRAIRIE DISTRICT
2018 INSPECTION**

Site Number	Location	Name	Hwy	km
GP34	NW of Grande Cache	2.9 km S of Kakwa River Bridge	40:38	21.0
Legal Description		UTM Co-ordinates (NAD 83)		
NW28-62-4-W6		11U N 6,028,660	E 399,845

Date	PF	CF	Total
Previous Inspection:	May 30, 2017	13	4	52
Current Inspection:	May 23, 2018	13	4	52
Road AADT:	1,160	Year:	2016	
Inspected By:	Don Proudfoot, Nicole Wilder (Thurber) Ed Szmata, Rocky Wang, Dwayne Lowen (AT)			
Report Attachments:	<input checked="" type="checkbox"/> Photographs <input checked="" type="checkbox"/> Plans <input type="checkbox"/> Maintenance Items

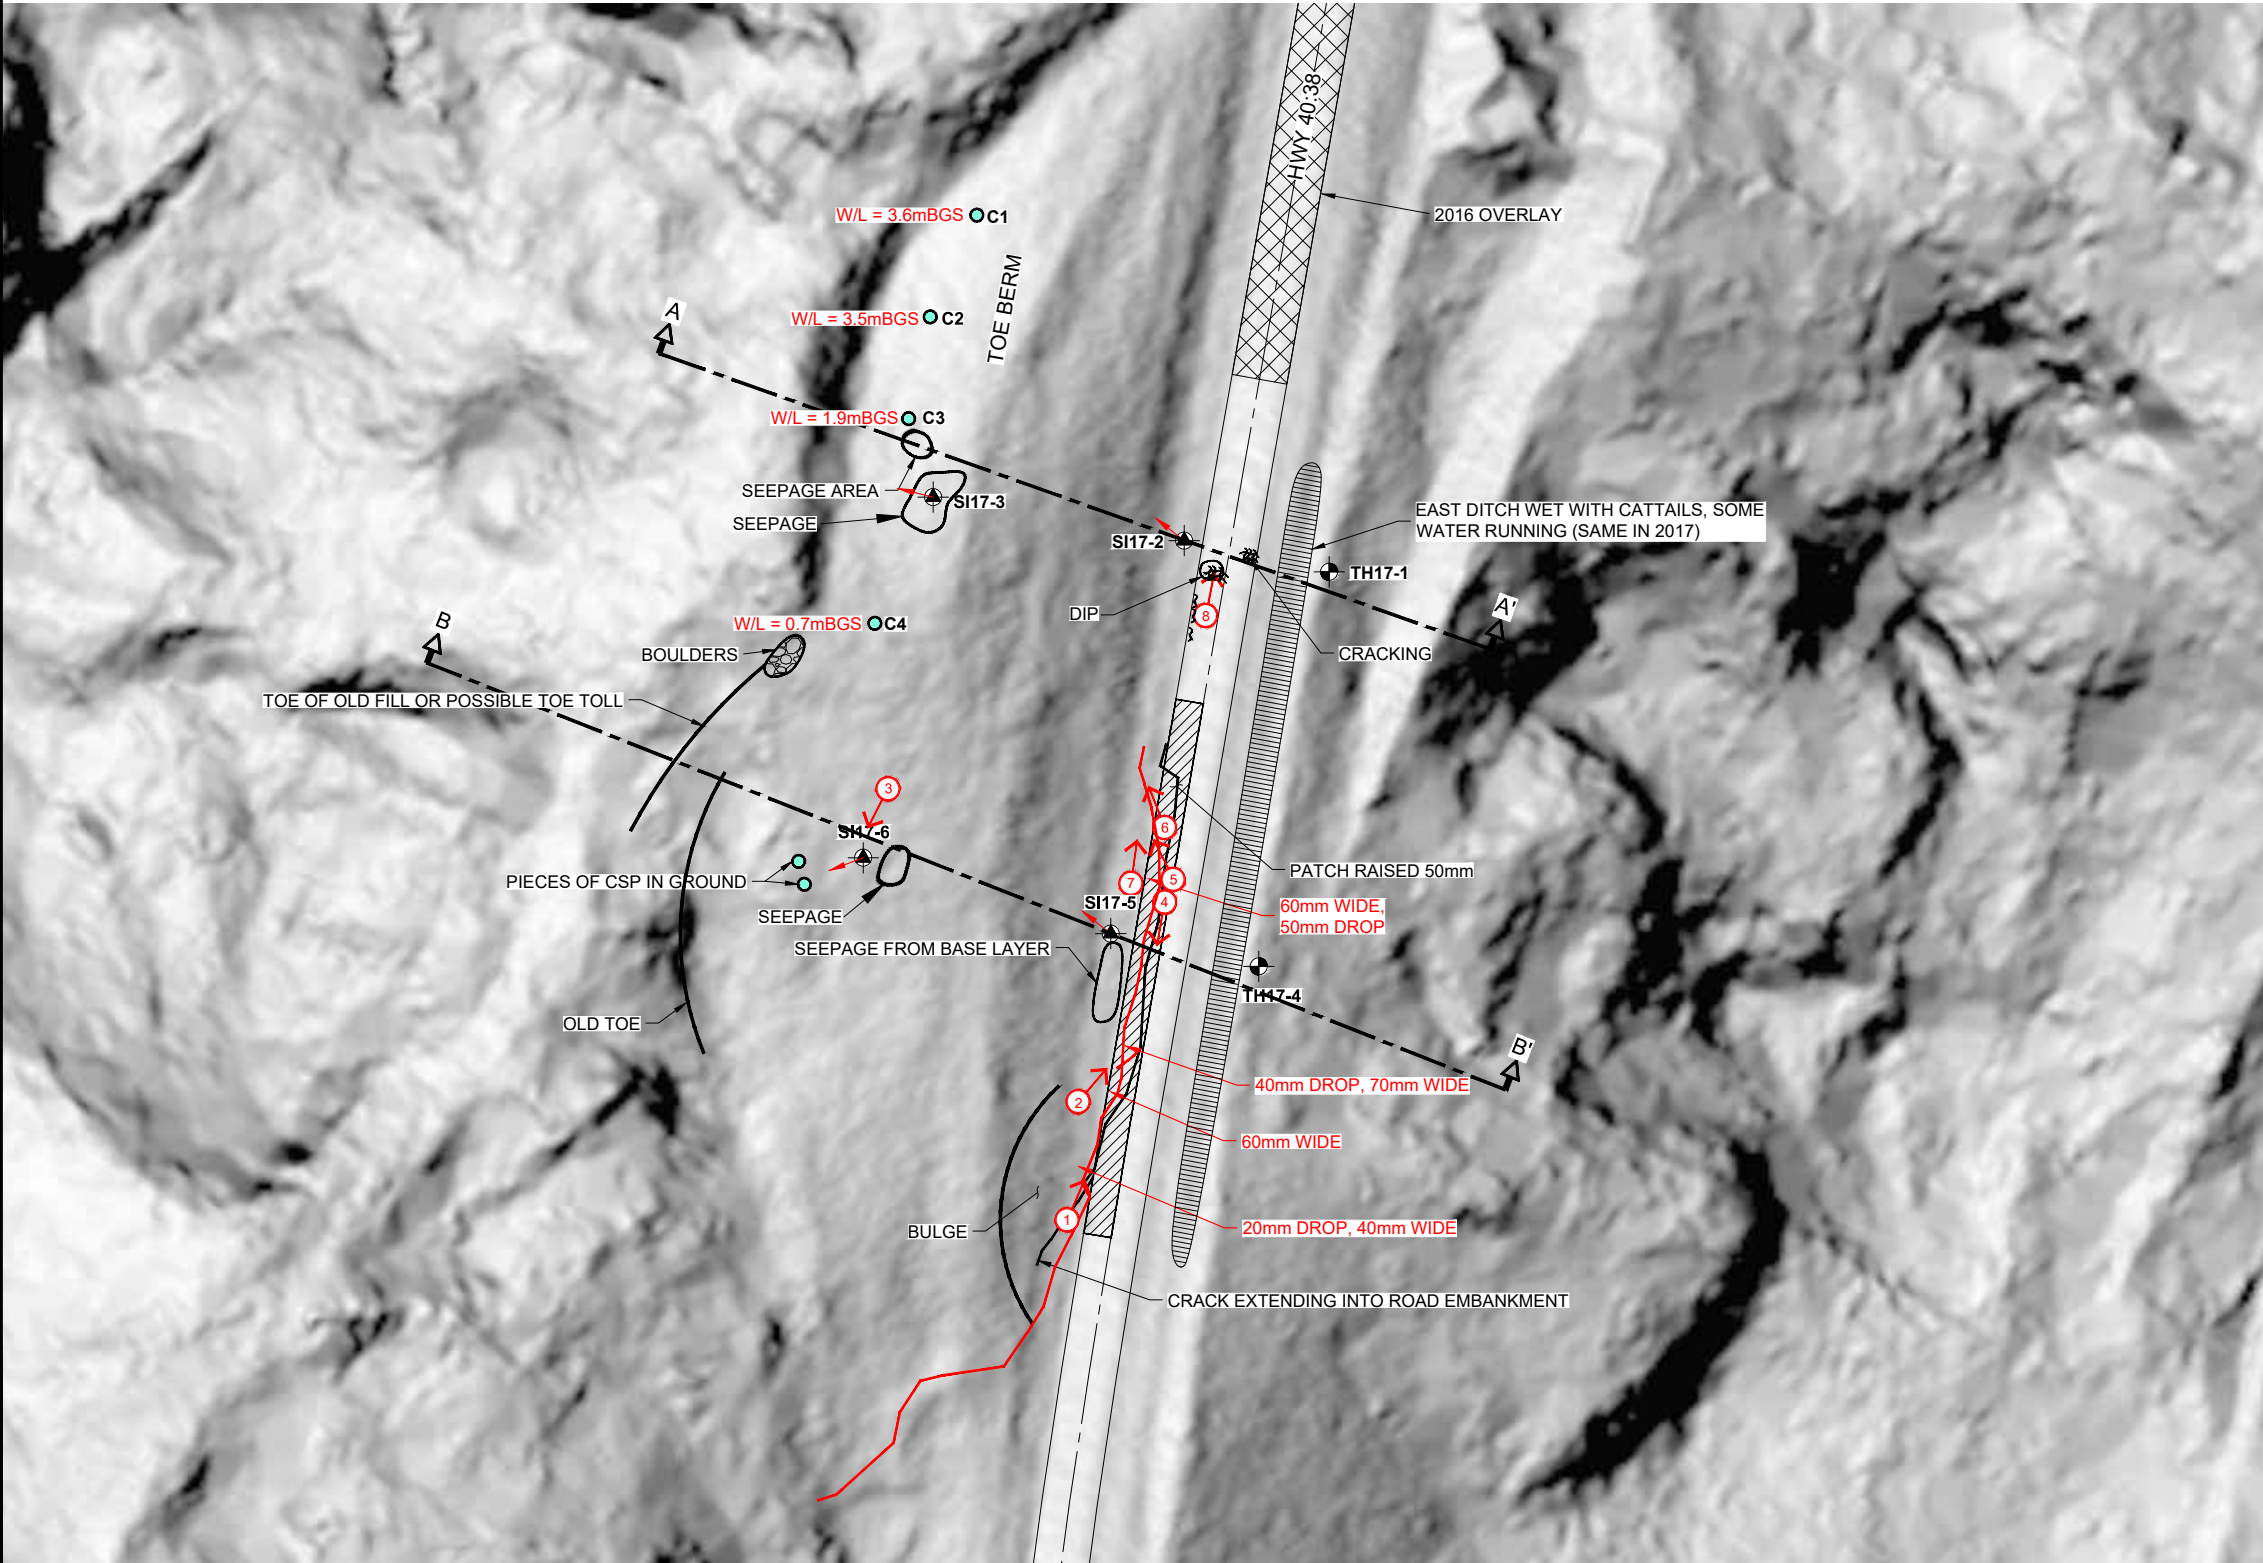
DWG No. 13353-GP34-1-1

Primary Site Issue:	Landslide in a ~25 m high sidehill highway embankment fill	
Dimensions:	About 100 m long by ~200 m wide	
Date of any remediation:	Within a couple years after construction initiation (early 1980's), dewatering measures consisting of vertical wells (and possibly horizontal drains) were installed, along with a 6 m high toe berm.	
Maintenance:	A full SB lane/shoulder acp patch was placed over the cracked area in June 2015. In summer 2016, 50 mm was milled out of the S.B. lane and was overlaid over the cracked area. An area north of the site was also overlaid over both lanes.	
Observations:	Description	Worse?
<input checked="" type="checkbox"/> Pavement Distress	A headscarp crack is affecting an approximate 80 m length of pavement along the southbound lane/shoulder. The crack got worst after the milling/overlay and the pavement has dropped up to 50 mm and is now up 70mm wide near the middle. The main scarp has extended further into the embankment on either side. A dip and crack extension was also observed 25 m north of this area.	<input checked="" type="checkbox"/>

<input checked="" type="checkbox"/> Slope Movement	Movement of the embankment fill has re-activated in recent years.	<input checked="" type="checkbox"/>
<input type="checkbox"/> Erosion		<input type="checkbox"/>
<input checked="" type="checkbox"/> Seepage	Seepage was observed near both of the lower SI's (SI17-3 and SI17-6), where ponding of water and softer ground was observed in these areas.	<input checked="" type="checkbox"/>
<input type="checkbox"/> Bridge/Culvert Distress		<input type="checkbox"/>
<input type="checkbox"/> Other		<input type="checkbox"/>
Instrumentation June 21, 2018: Inclinometers SI17-2 = 2 mm/yr @ 9-11 m depth; SI17-3 = 1 mm/yr @ 10-11 m depth; SI17-5 sheared off at 7.3 m depth; SI17-6 = 36 mm/yr @ 5-7 m depth. Piezometers (All BGS): PN17-1A = 1.2 m; PN17-1B = 5.2 m; PN17-2A = 7.5 m; PN17-2B = 7.7 m; PN17-3A = 3.7 m; PN17-3B = 9.1 m; PN17-4A = 2.8 m; PN17-4B = 2.6 m, (4A/4B = 0.6 & 0.3 m decrease in W/L since fall 2017); PN17-5A = 10.1 m; PN17-5B = 12.1 m; PN17-6A = 1.6 m; PN17-6B = 9.8 m.

The water levels in four of the vertical wells (300 mm diameter CSP pipes sticking up above ground) near the central to north end of the site were measured on May 23, 2018 and were found to be between 0.7 m to 3.6 m below the ground surface. There were two other's CSP pipes near the south end that were found to be crushed during a previous inspection.

The last set of inclinometer monitoring (from June 2018) showed that SI 17-5 had sheared off at 7.3 m and SI 17-6 showed movement of 36 mm/yr (showed on attached section B-B'), while much slower rates of 1 to 2 mm/yr were measured in SI's 17-2 and 17-3 (shown on attached section A-A'). These are similar rates indicated for SI17-2/17-3 prior to June 2018. The high rates of movement in SI17-5 and SI17-6 coincide with the large crack observed in the pavement during the 2018 inspection date and indicate movements have re-activated in the former slide area.

It is anticipated that gradual clogging of the dewatering system, and/or elevated groundwater levels, may be one of the causes of the renewed movements. Depending on details of the dewatering system installed, on-going slope movements may also be affecting the functionality of the system.

The diagonal crack (see Photo 6), and the movement rates suggest the start of movements further to the north.

Continue to patch and possibly mill the highway that is affected by the slide scarp area. The dip and crack further north may also require similar maintenance in the future.

Consideration could be given to installing a subdrain to further lower the water table in the east ditch and through the slide area. on the latest results of the instrument readings, it might be appropriate to also increase the size of the toe berm. However, since the slide movements could extend below the berm and further downslope, shear piles might also be required at the toe berm location.

Alternatively, a tied-back pile wall could be considered along the shoulder of the highway, the highway could be shifted into the hillside, using a retaining wall to support the toe of the south steeper portion of the backslope, or the slide could be offloaded by reconstructing the highway with light weight fill, supporting the downslope edge with a retaining wall and cutting to flatten the slope between the wall and the existing toe berm. These options will be further discussed in a preliminary engineering report that is being prepared by Thurber.
