November 30, 2022

**CON0022166 Peace Region (Grande Prairie District – South) GRMP Instrumentation Monitoring Site GP034; H40:38, km 21.016 Slide 2.9 km South of Kakwa River Bridge Section C – 2022 Fall Readings**

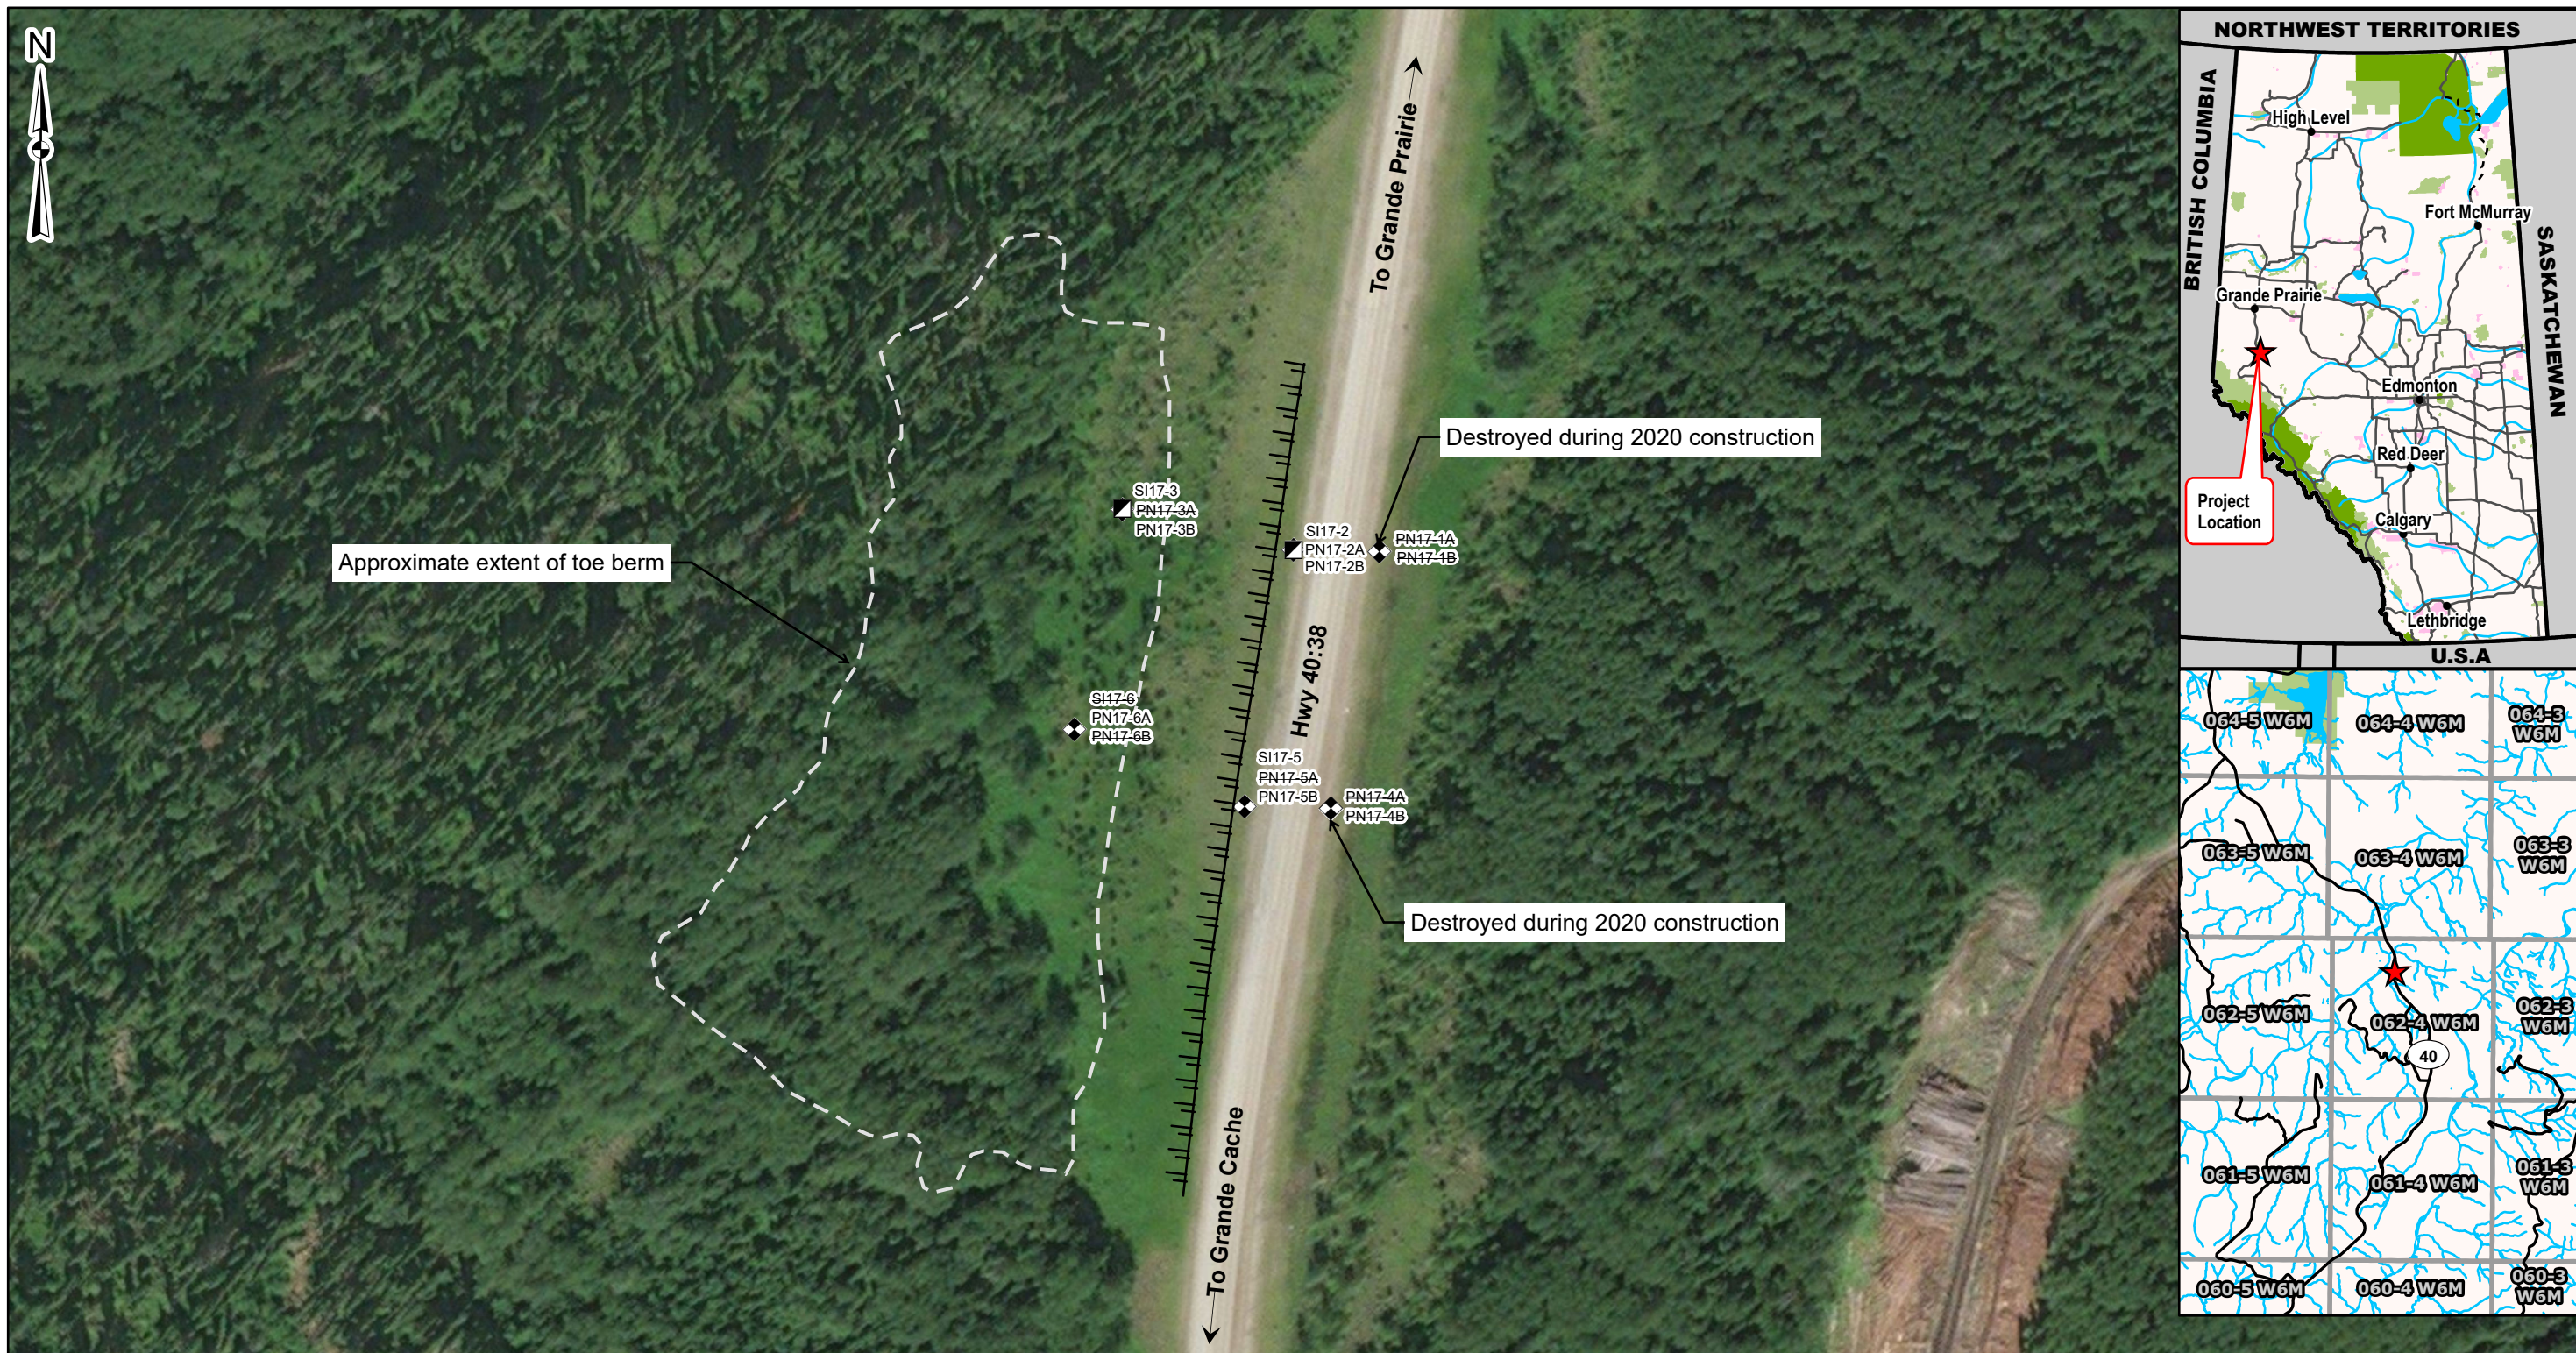
Two slope inclinometers (SIs) (SI17-2 and SI17-3) and six pneumatic piezometers (PNs) (PN17-2A/B, PN17-3B, PN17-5B, and PN17-6A/B,) were read at the GP034 site in the Peace Region (Grande Prairie District – South, GP South Region) on September 27, 2022 by Messrs. Gabriel Bonot, E.I.T. and Guerin White, E.I.T. of Klohn Crippen Berger Ltd. (KCB). These instruments were read as part of the GP South Region Geohazard Risk Management Program (GRMP). The site is located on Hwy 40:38, km 21.016. The approximate site coordinates are 6028755 N, 399896 E (UTM Zone 11, NAD 83). A site plan is presented in Figure 1.

The geohazard at the GP034 site consists of a landslide in a 25 m high sidehill highway embankment fill, approximately 500 m upslope (east) from the edge of the Kakwa River.

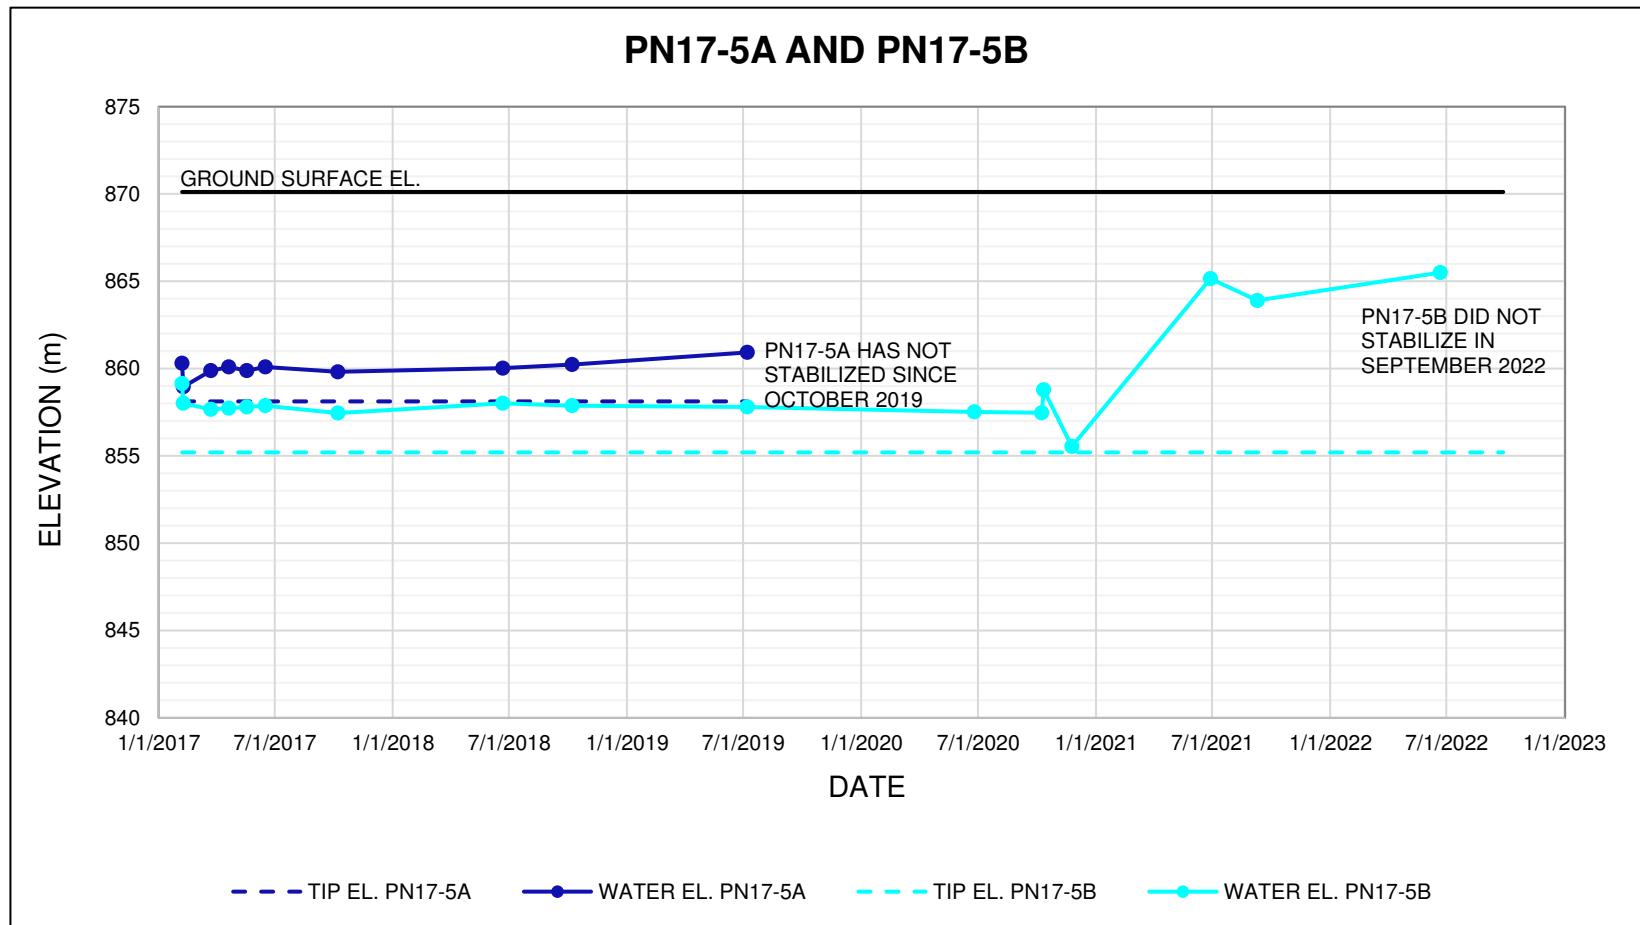
TITLE	
		Piezometer Data GP034 - Slide 2.9 km S of Kakwa River Bridge Hwy 40:38, km 21.016	
SCALE	PROJECT No.	A05116A01	FIG No.

The elevated porewater pressures recorded in PN17-5B (did not stabilize in September 2022) and PN17-6B, installed depth near approximate elevations of 855 m and 845 m, respectively, are potentially attributing to the increased rate of movement recorded in SI17-2 at an approximate depth of 10 m below ground surface. The time required for excess porewater pressures to decrease could take several months, with accompanied continued movement in the foundation.
