**CON0022166 Peace Region (Grande Prairie District – South) GRMP Instrumentation Monitoring Site GP034; H40:38, km 21.016 Slide South of Kakwa River  
Section C – 2025 Spring Readings**

TITLE  
Site Plan  
GP034 - Slide South of Kakwa River  
Hwy 40:38, km 21.016

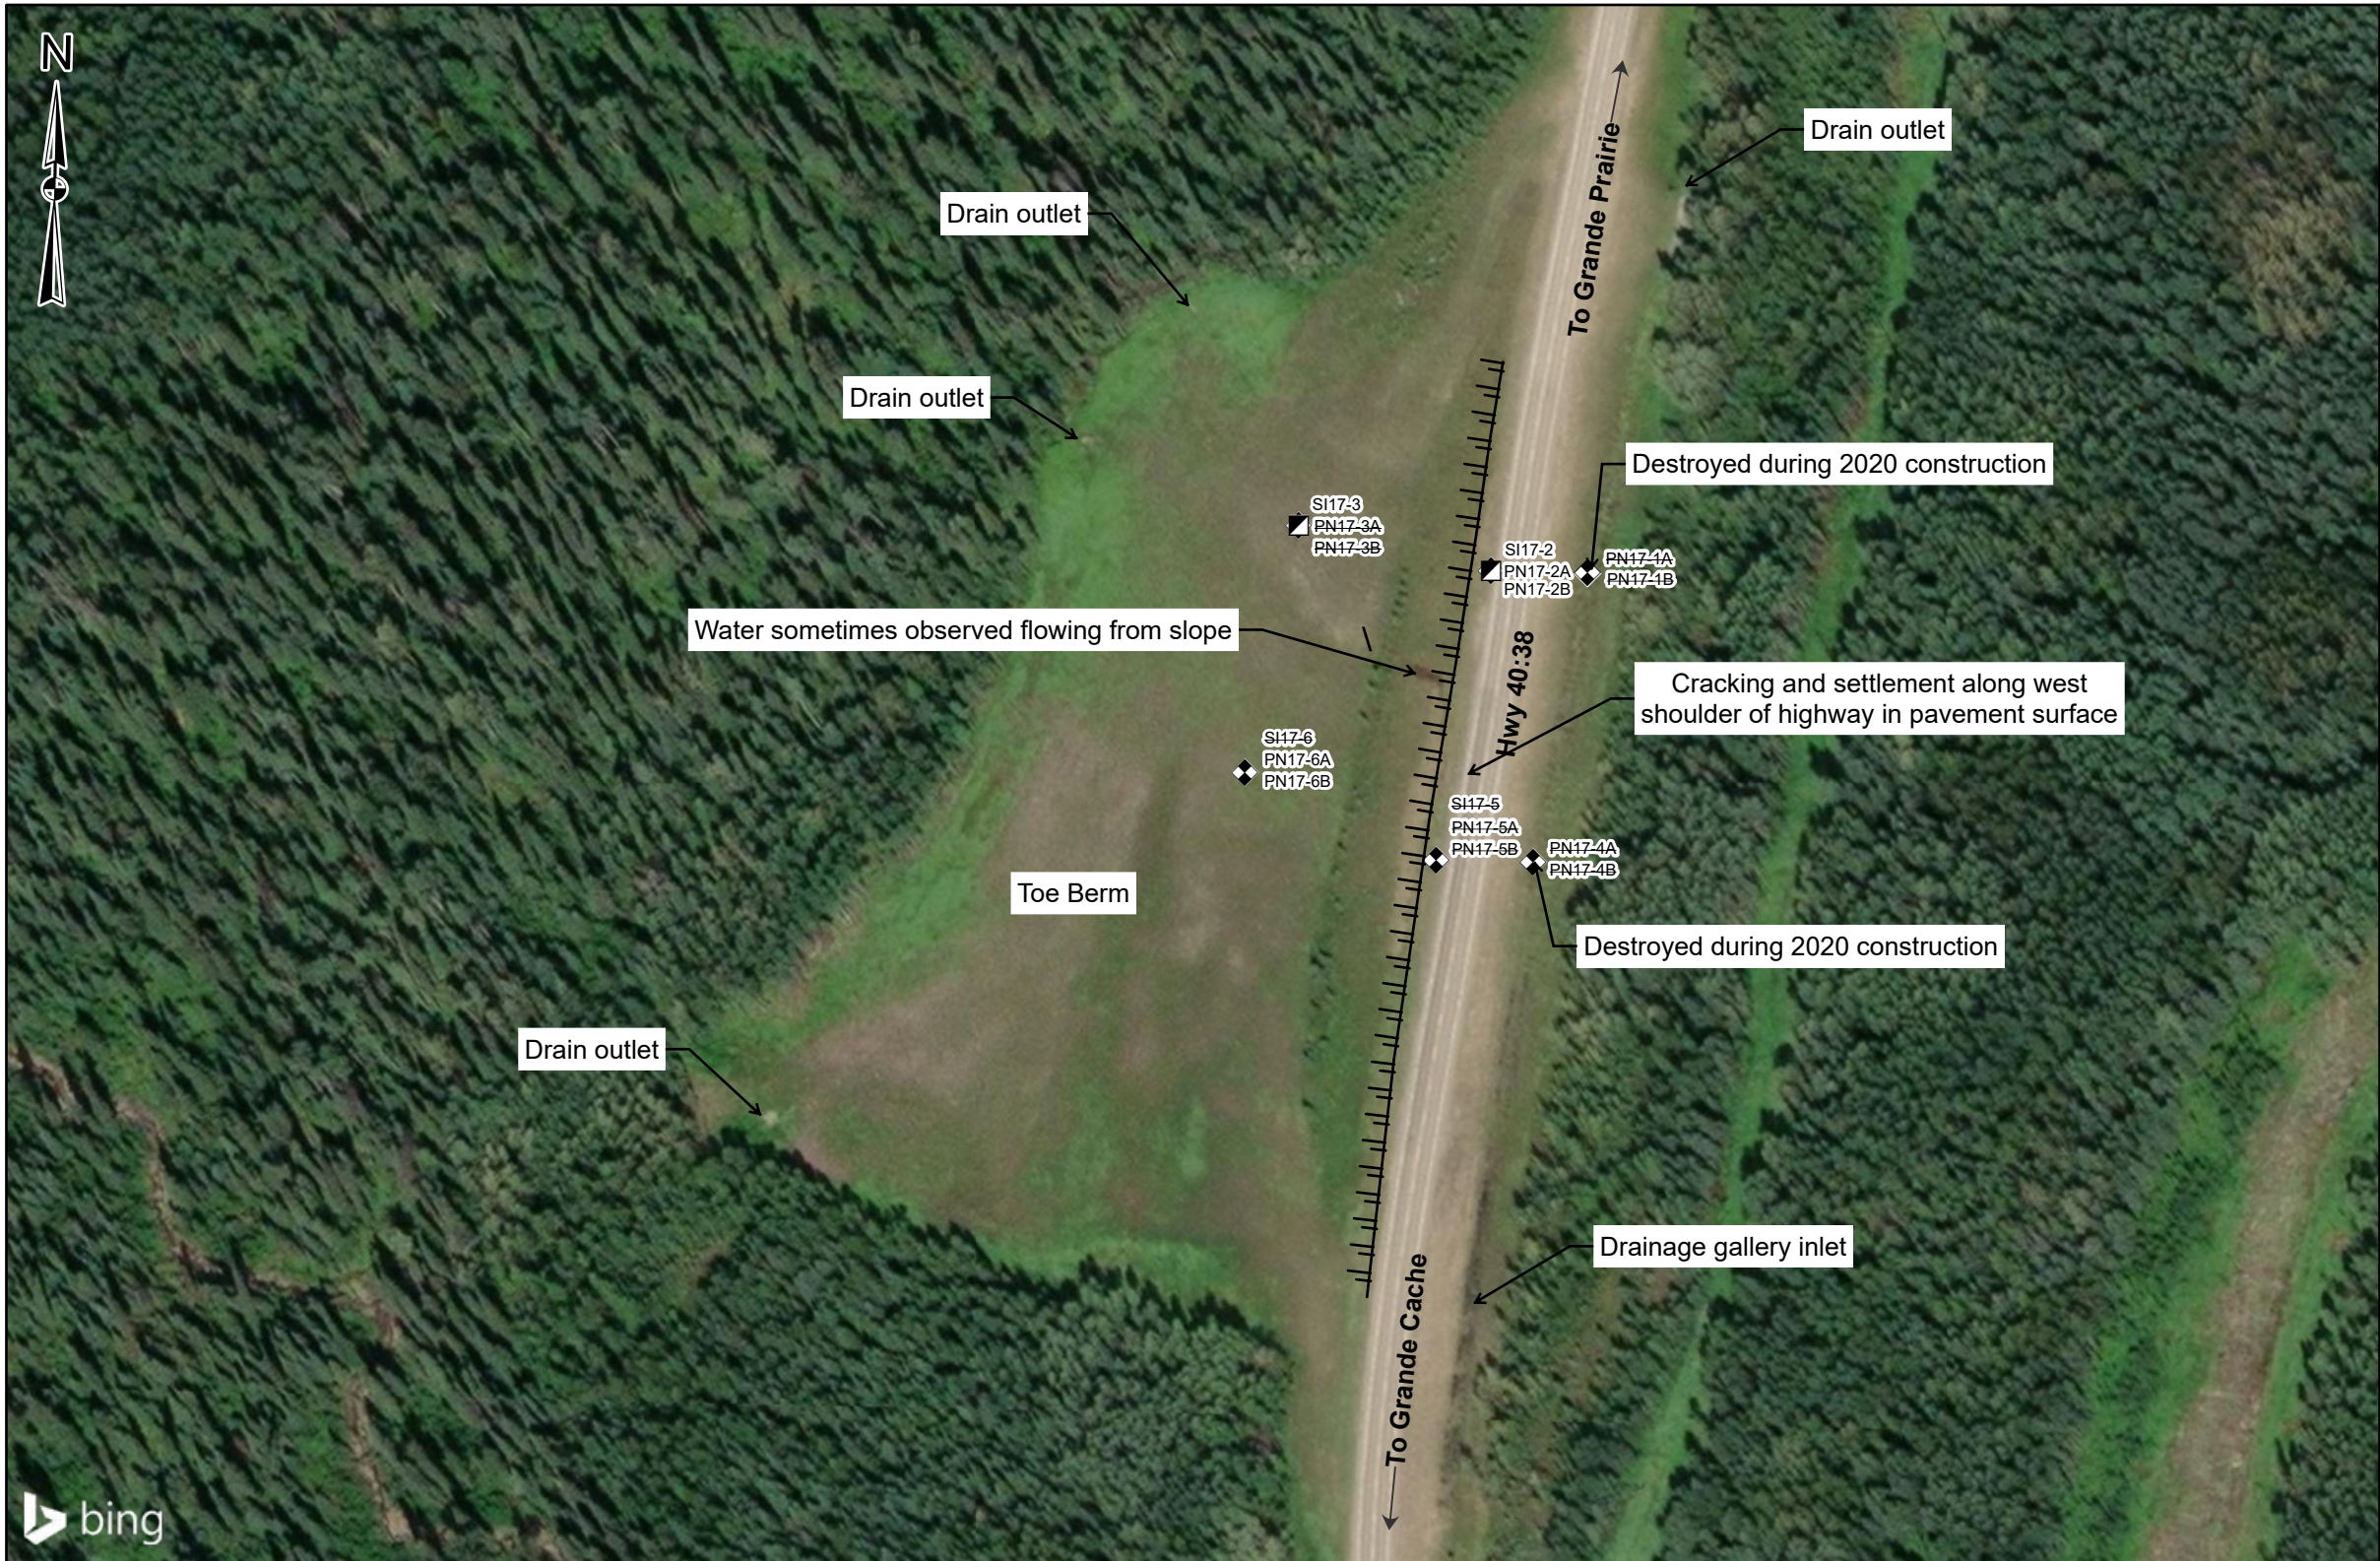
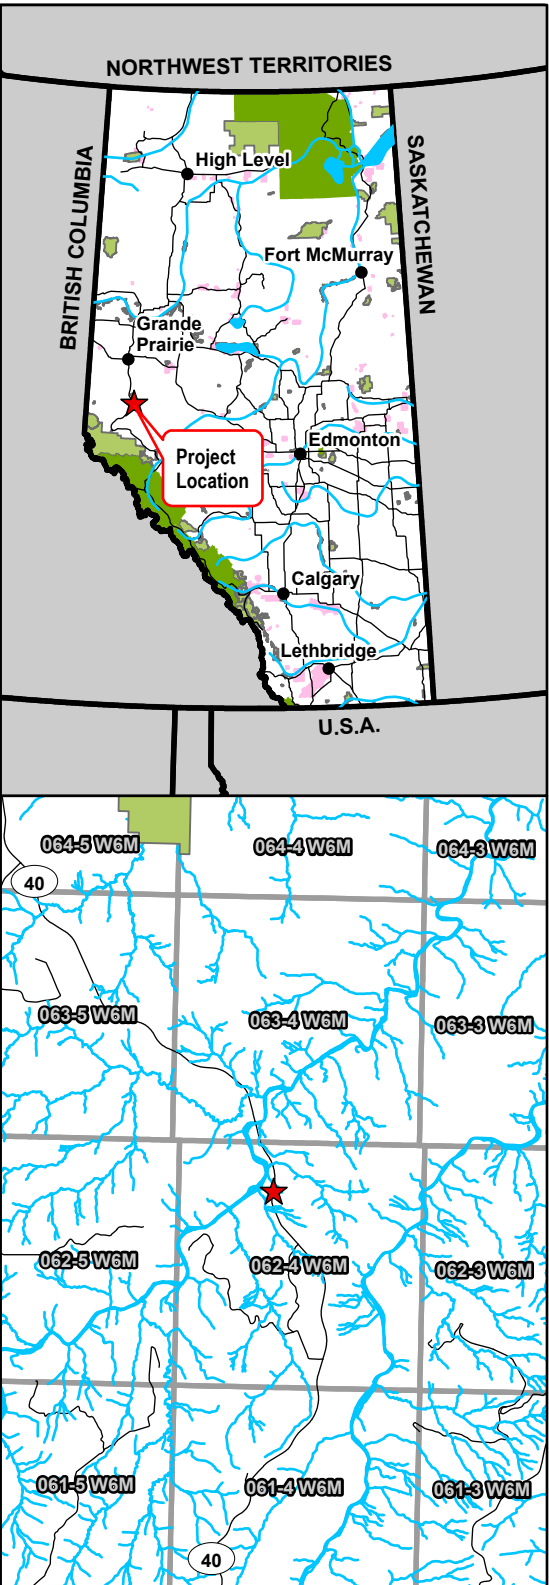
The geohazard at the GP034 site consists of a landslide in the fill and foundation of an approximate 25-m high side-hill highway embankment, approximately 500 m upslope (east) from the Kakwa River.

In 2017, 4 SIs and 12 piezometers were installed at the site by a previous consultant to monitor movement and groundwater conditions, respectively. Some of these instruments are now inoperable (e.g., sheared or damaged), as detailed in Table 1.1 (see table notes). Recommendations for replacement are made in Section 3.

PN17-1A/B and PN-4A/B were destroyed in 2020 during construction, and PN-3A/B and PN-5A/B have also become inoperable (i.e., readings do not stabilize). Replacement of these instruments or installation of new instruments near the location of observed groundwater discharge should be considered if site conditions deteriorate and/or repair work were to be resumed.

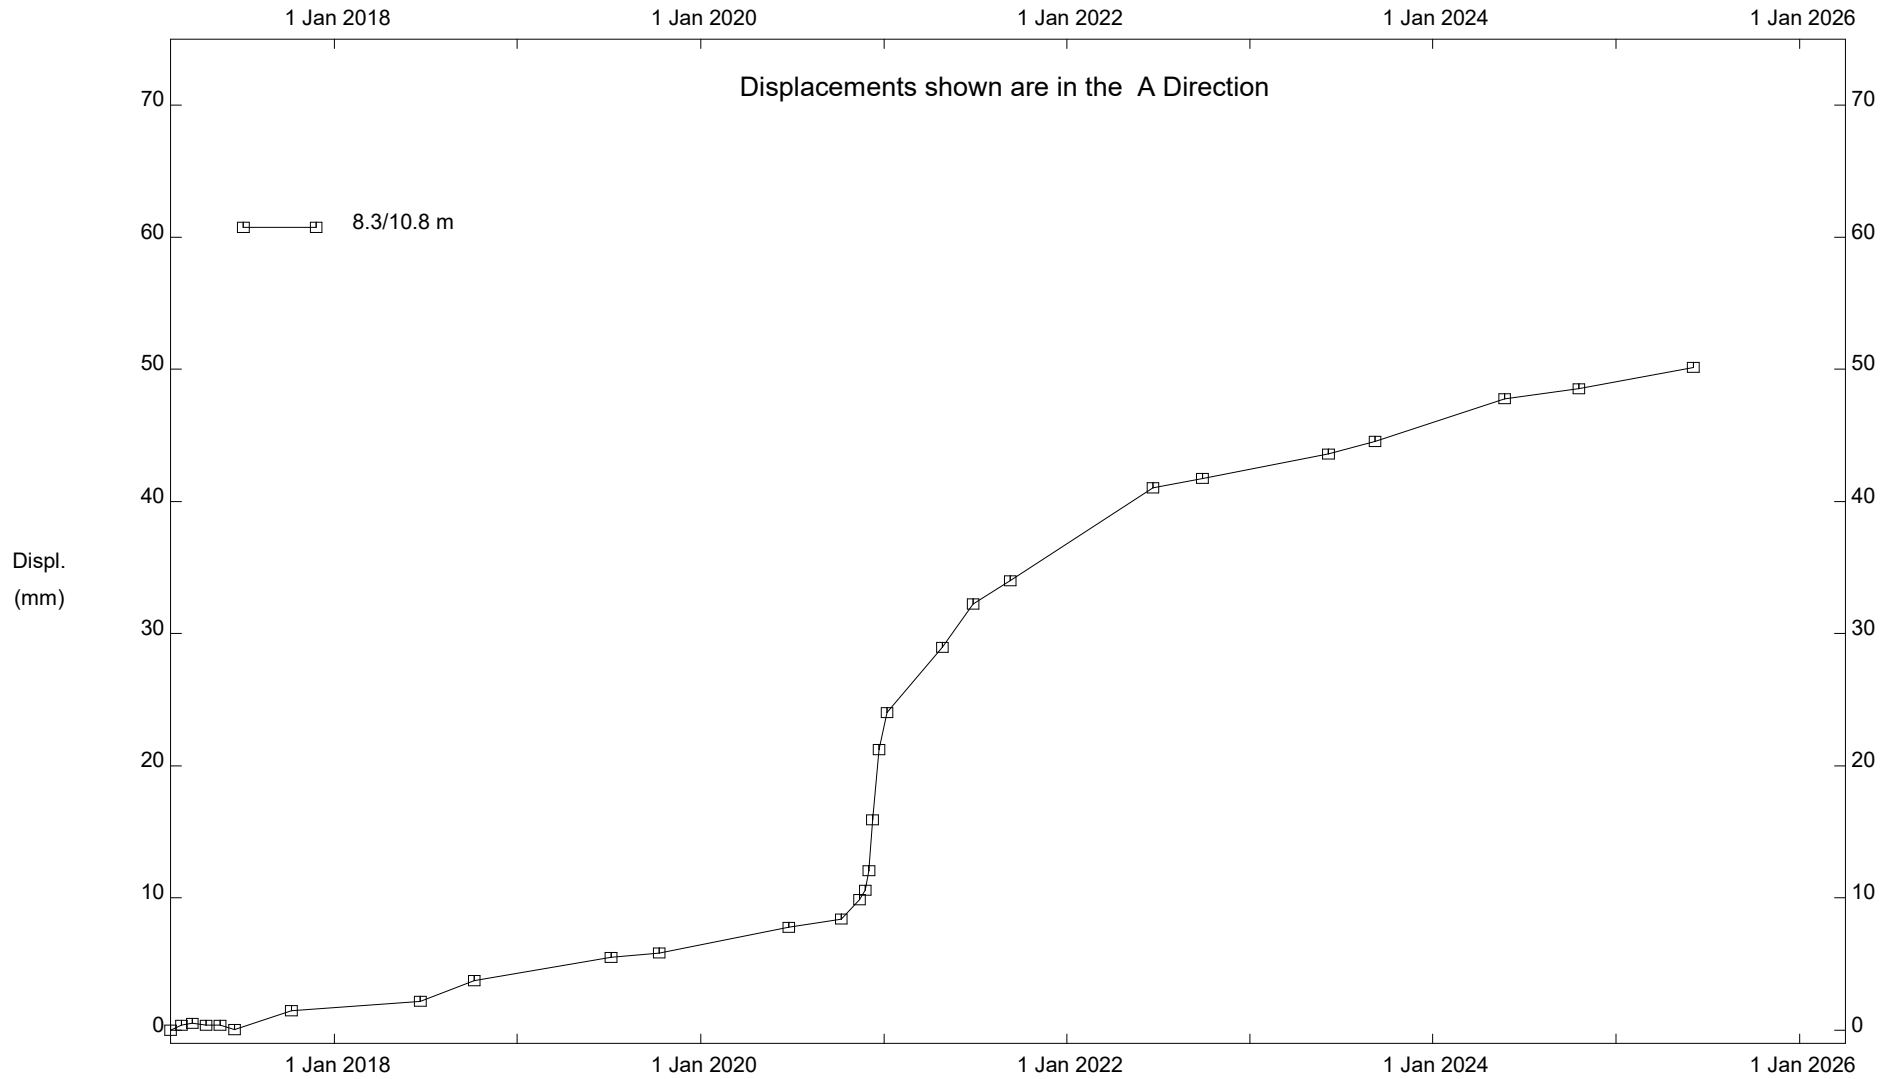
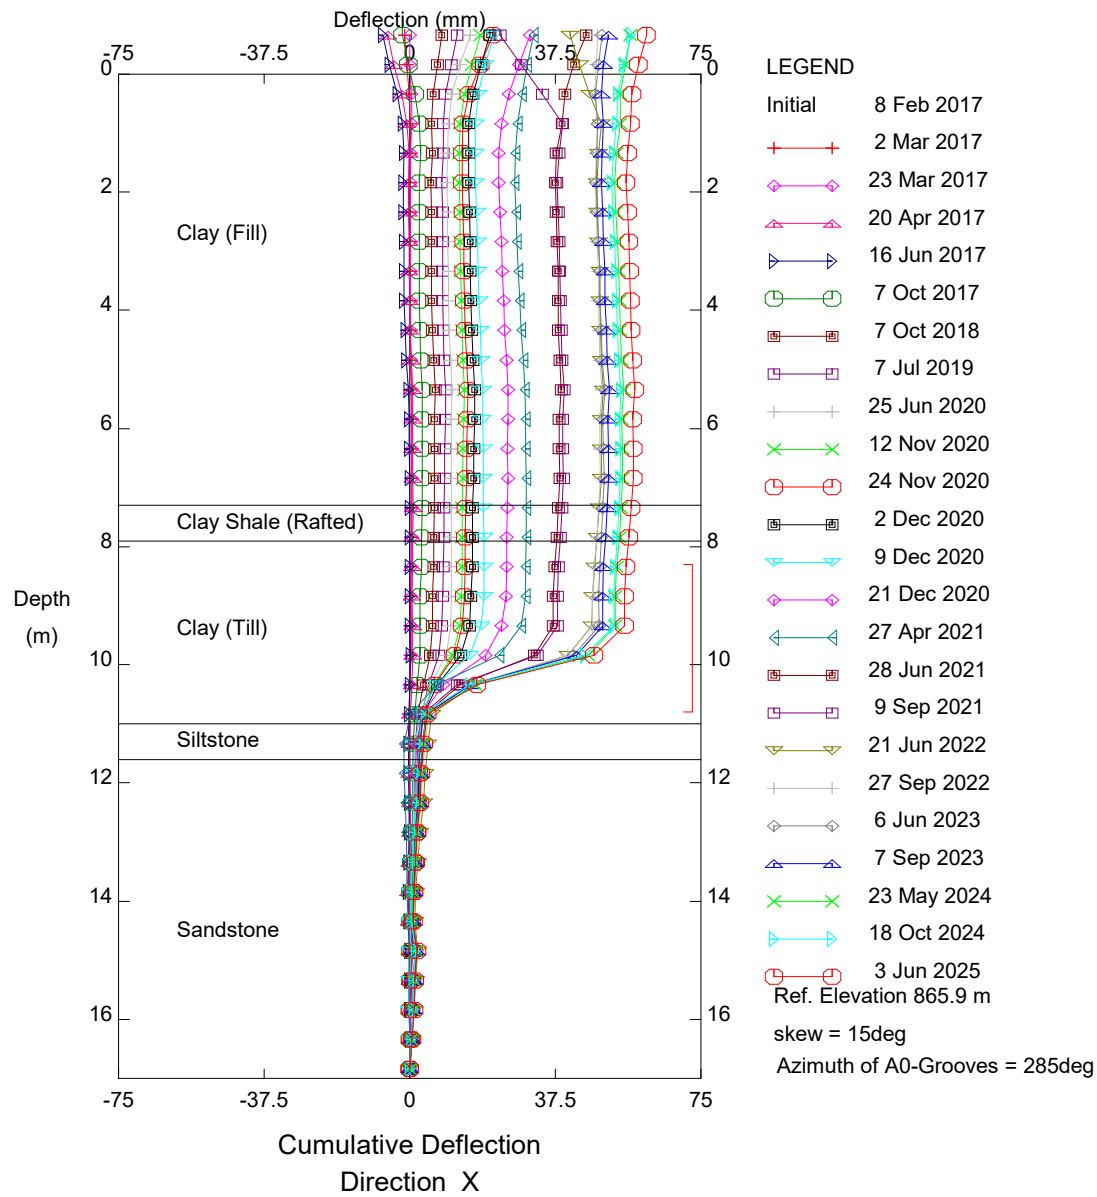
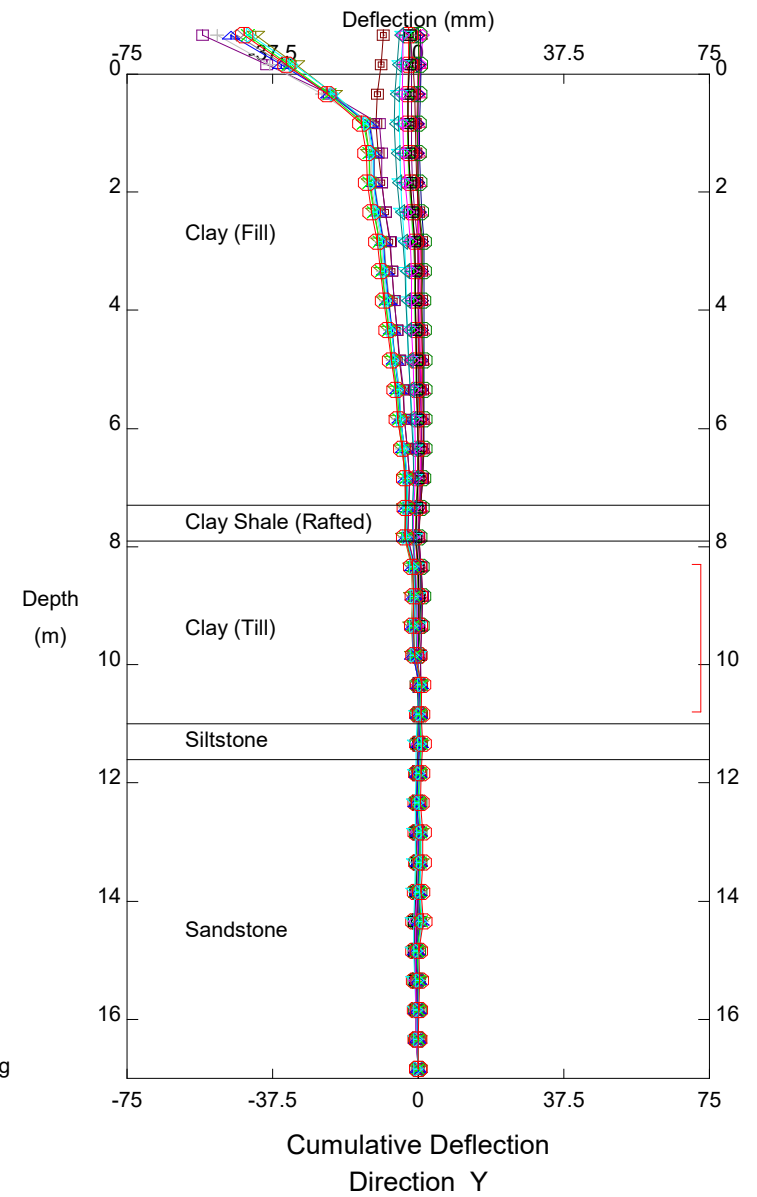
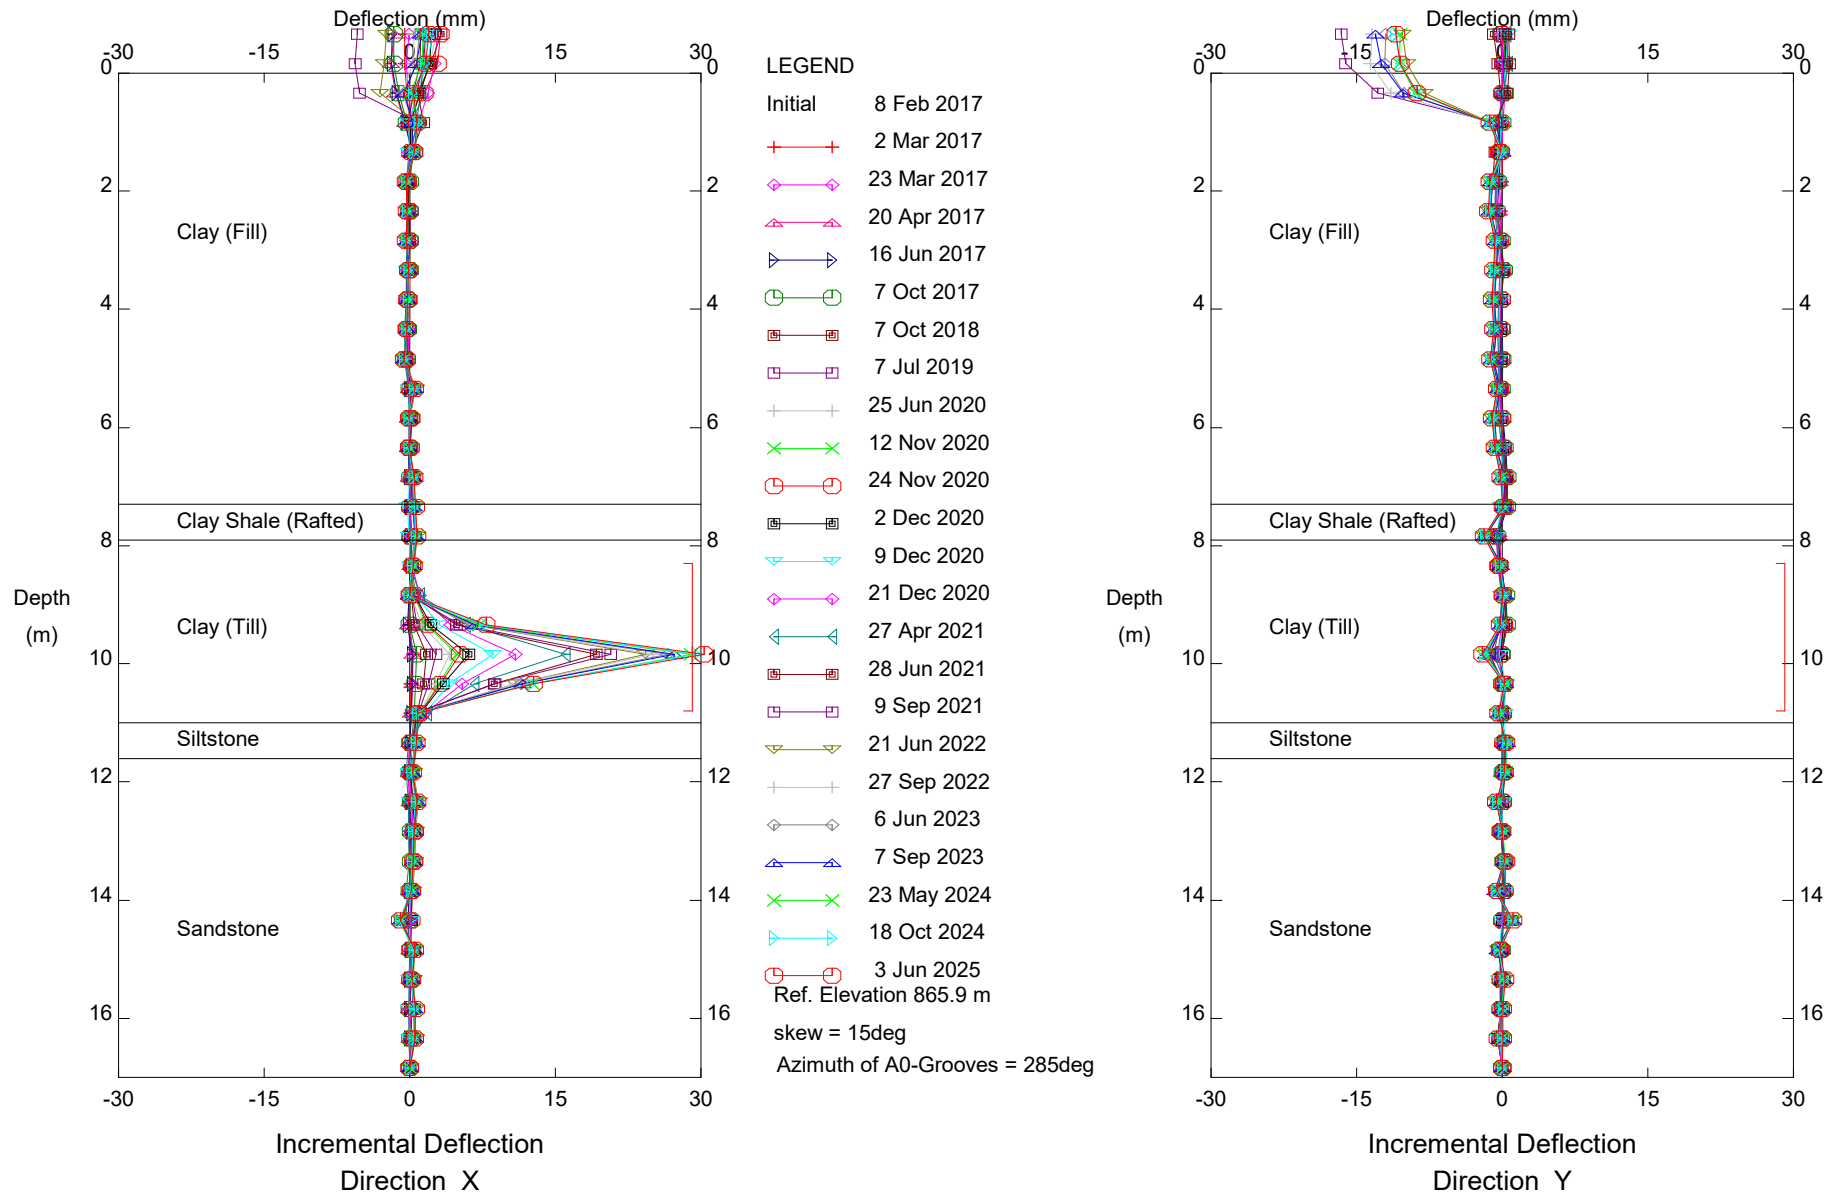
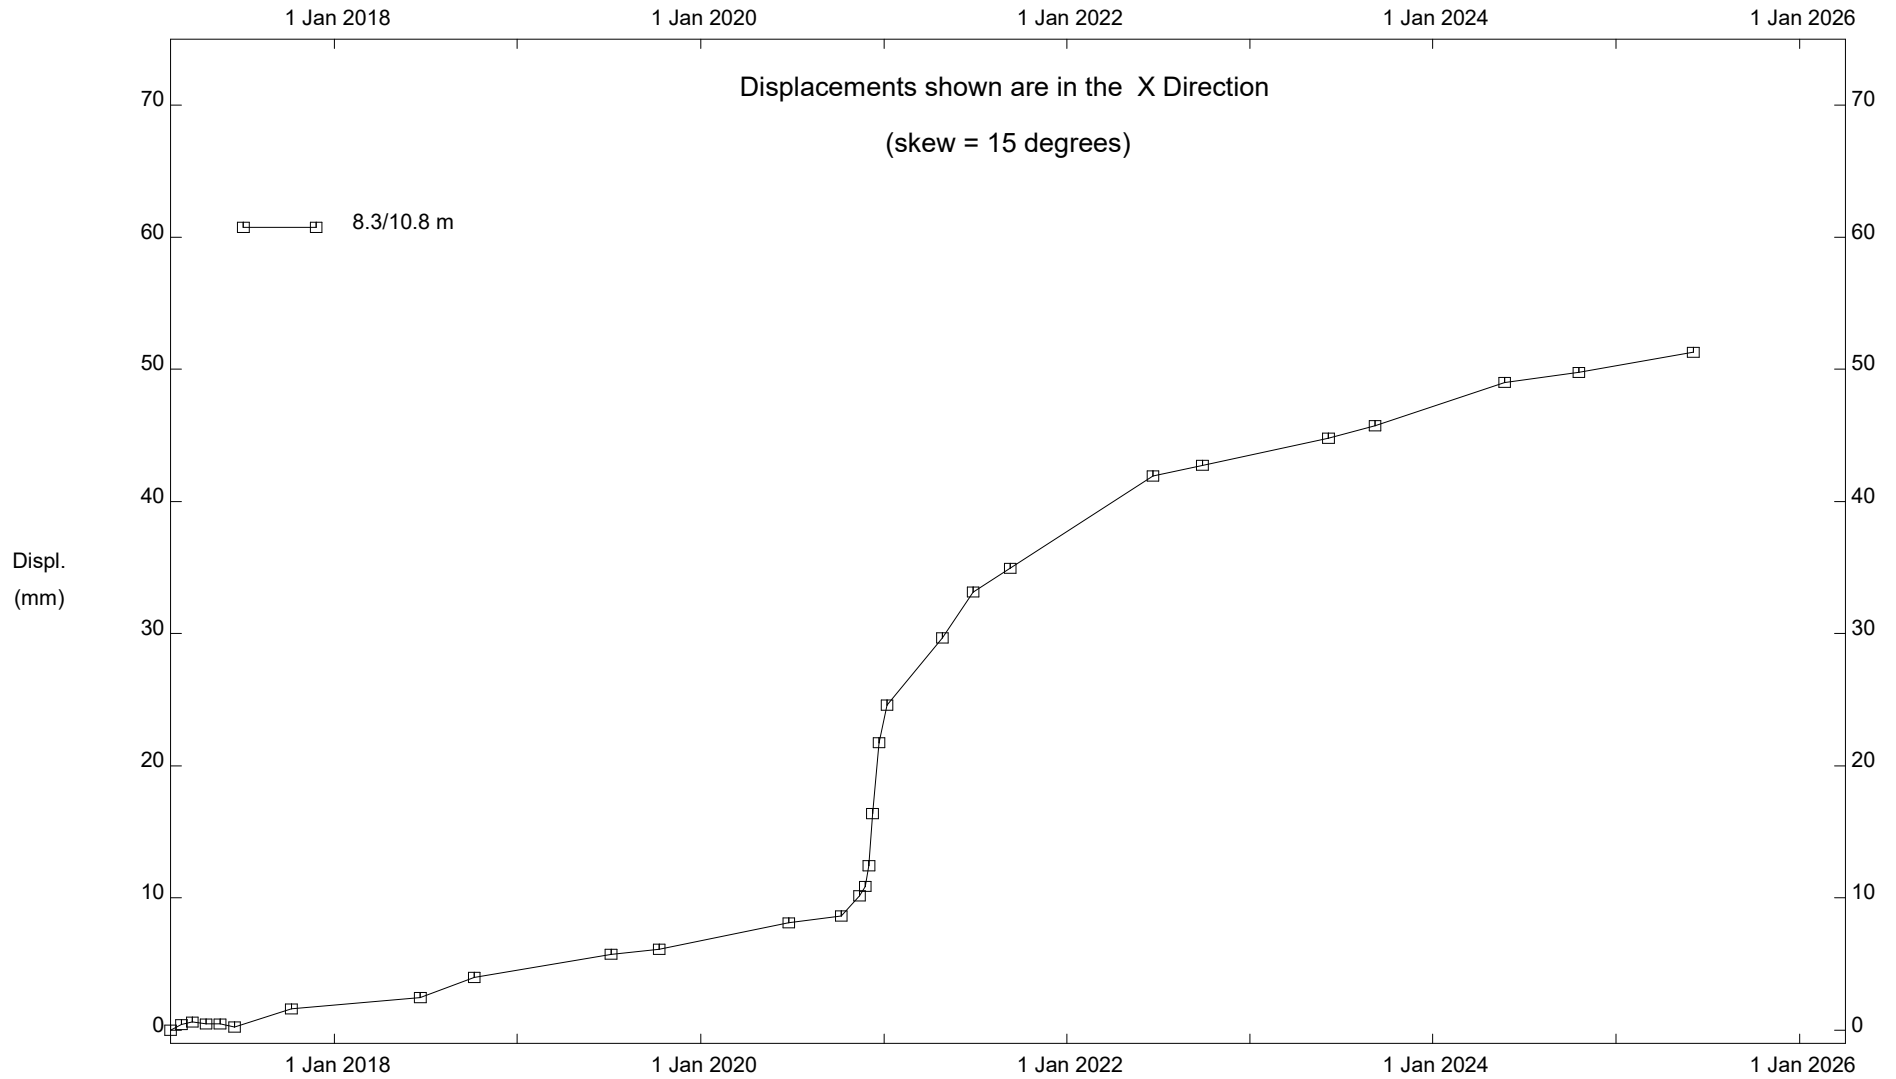
GP034; H40:38, Slide S. of Kakwa River, Inclinometer SI17-2

- SI17-2 between an approximate depth of 9.3 m and 10.8 m below ground surface (approximately elevation 856.6 m to 855.1 m) at the bottom of a clay till foundation unit overlying bedrock (siltstone); and
- SI17-3 between an approximate depth of 13.0 m and 14.5 m below ground surface (approximately elevation 841.6 m to 840.1 m) in a clay foundation unit overlying bedrock (clay shale).

The rate of foundation movement being recorded in SI17-2 and SI17-3 was relatively slow and steady (less than 5 mm/year) between February 2017 (installation/initialization) and October 2020 but increased up to approximately 212 mm/year and 867 mm/year, respectively, when toe berm construction began in late 2020. Since January 2021, the rate of foundation movement recorded in SI17-2 and SI17-3 has been decreasing and is currently less than 3 mm/year. It is noted that the rate of movement recorded in SI17-2 and SI17-3 does not appear to have increased in response to a 5.2 magnitude earthquake that occurred near the site in February 2025.

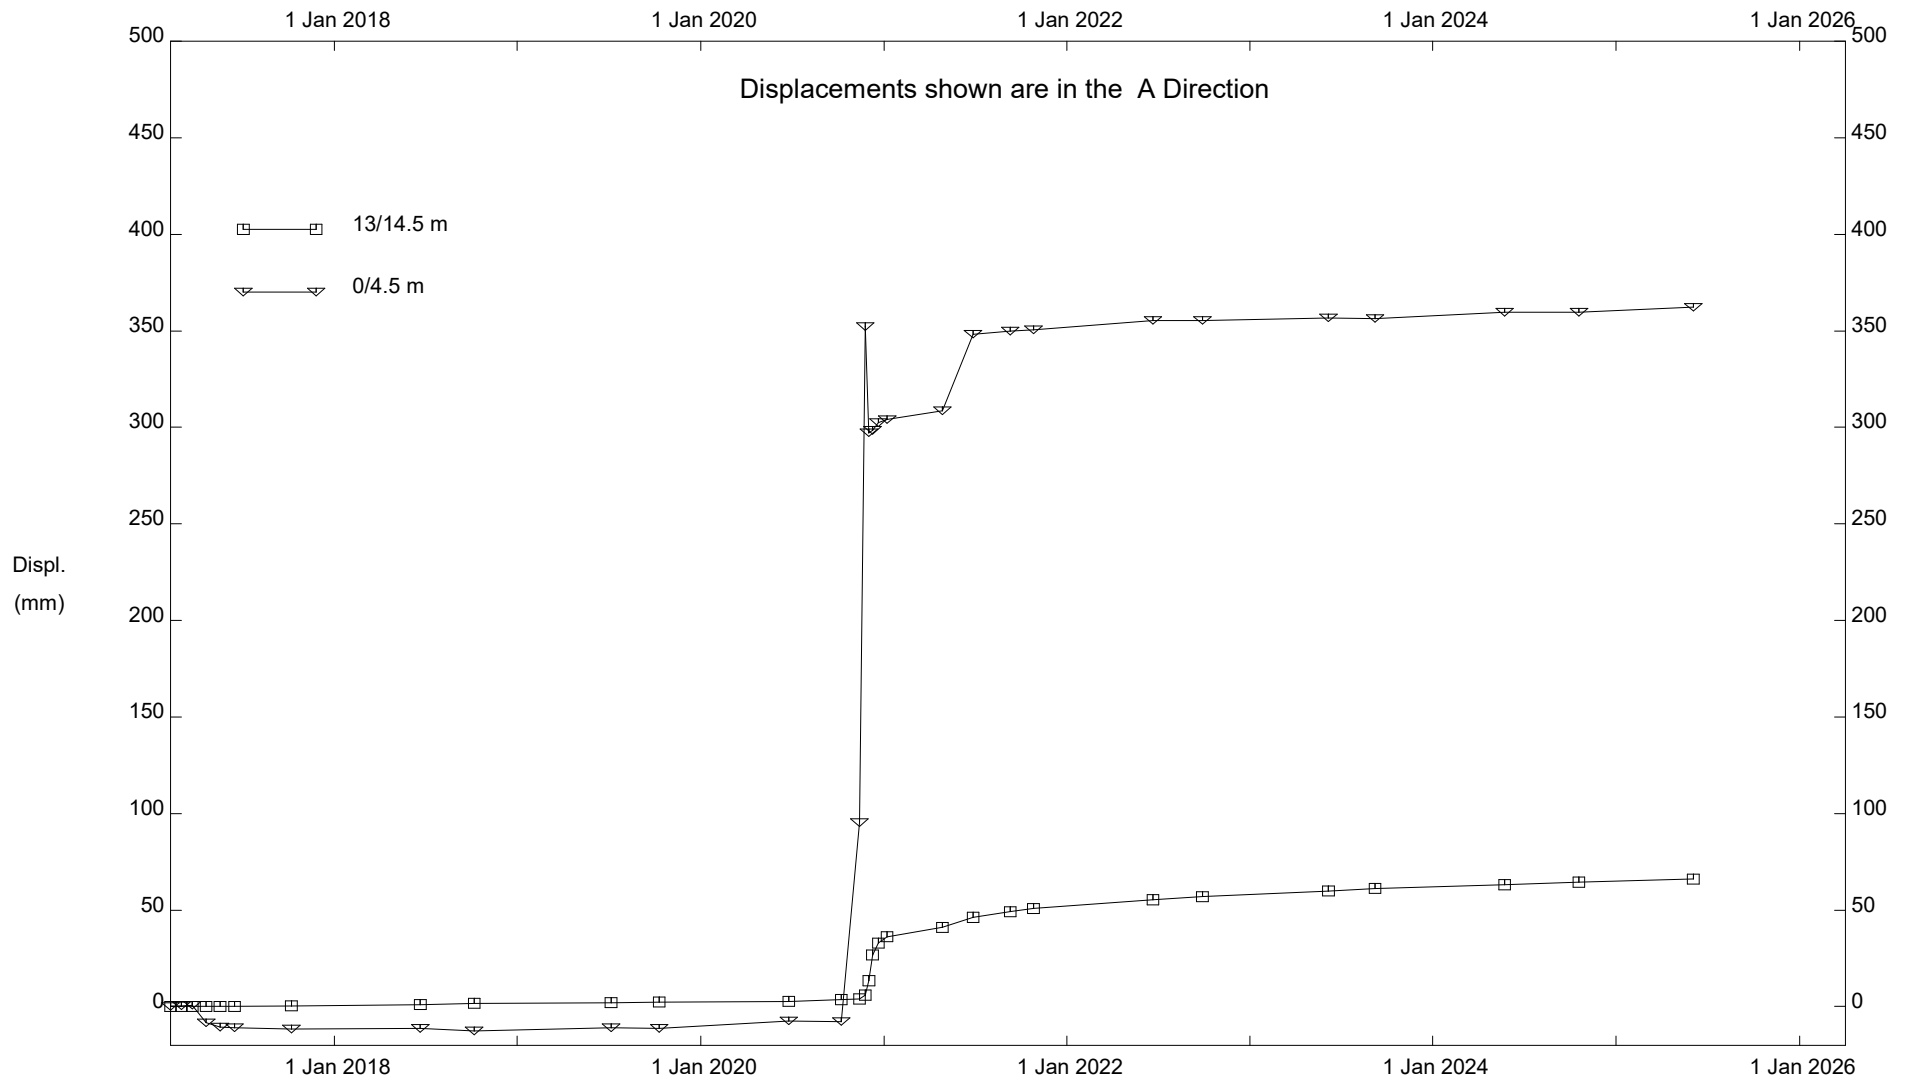
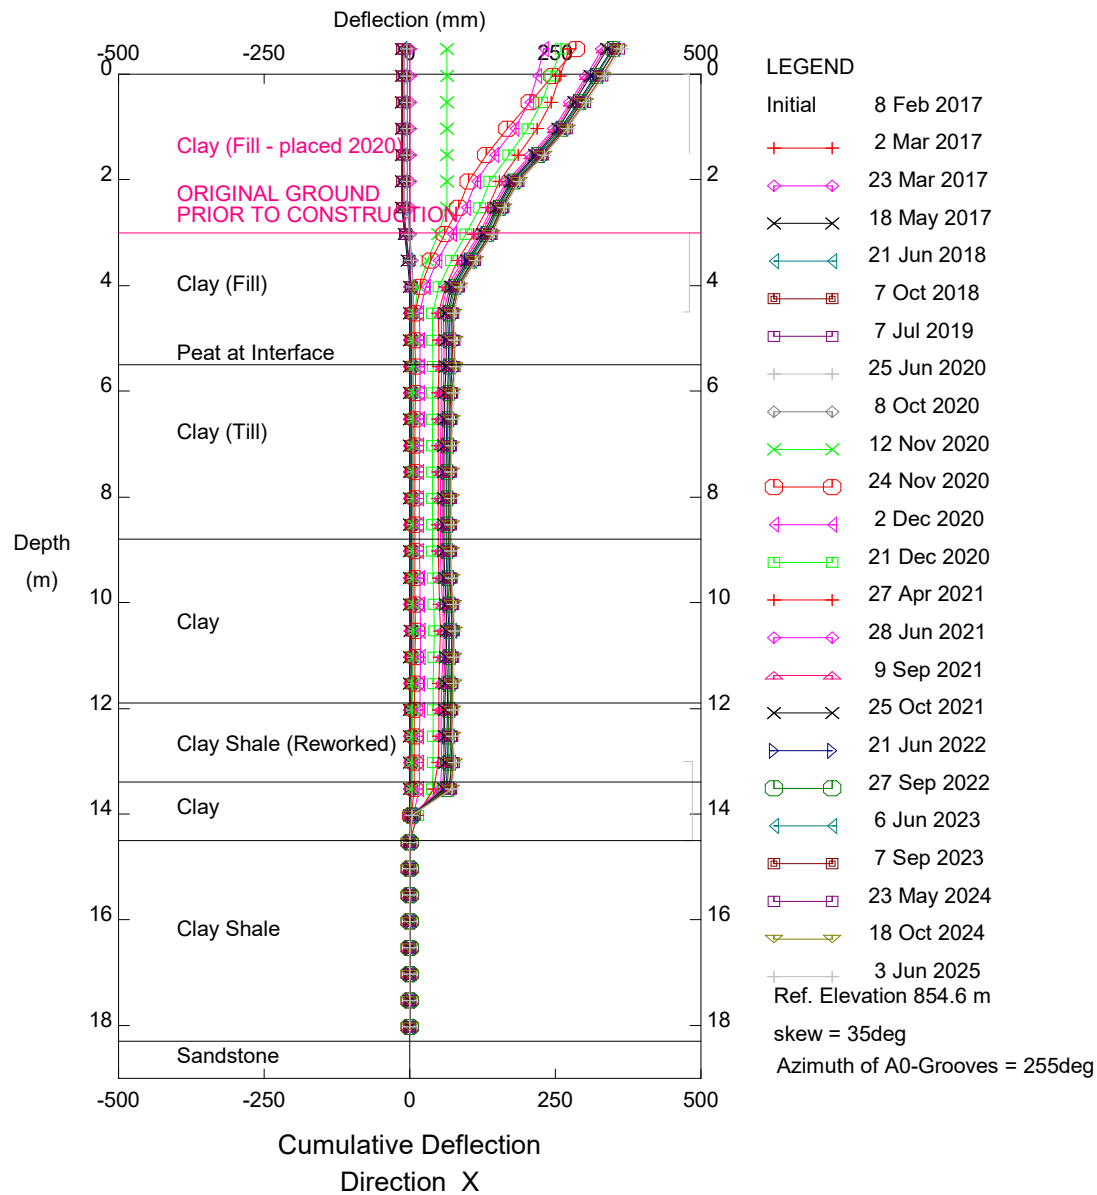
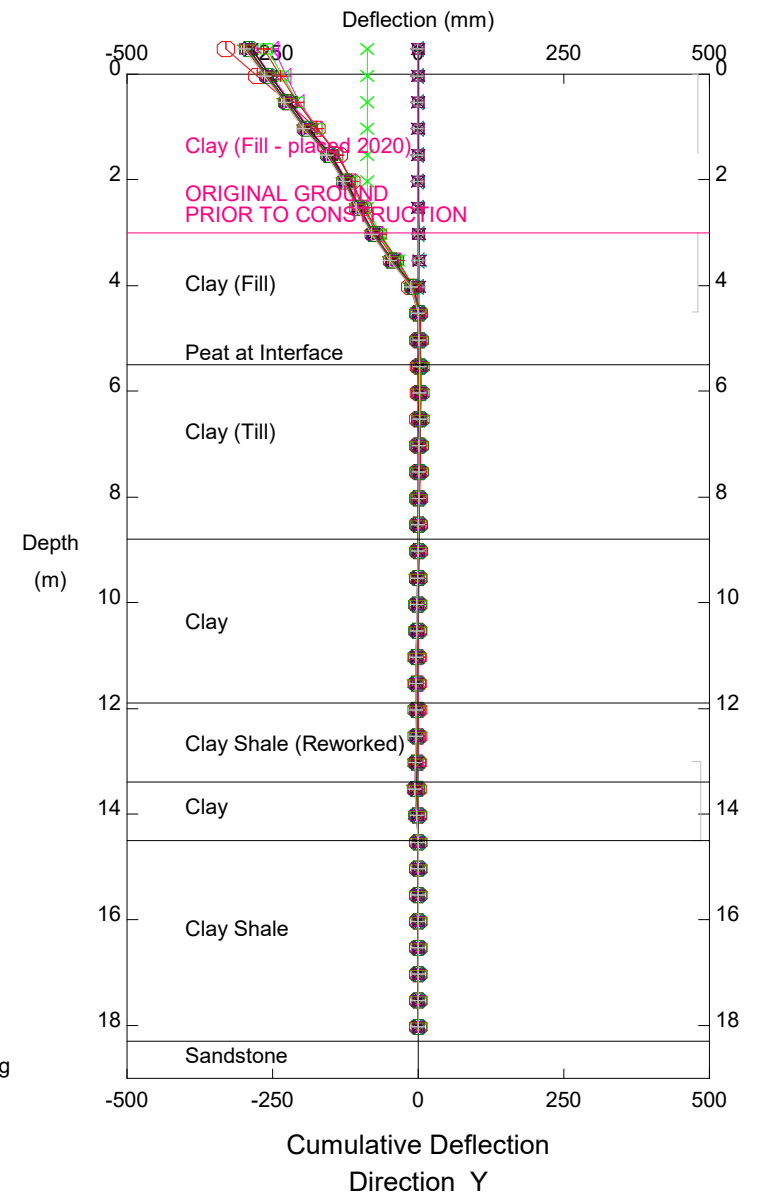
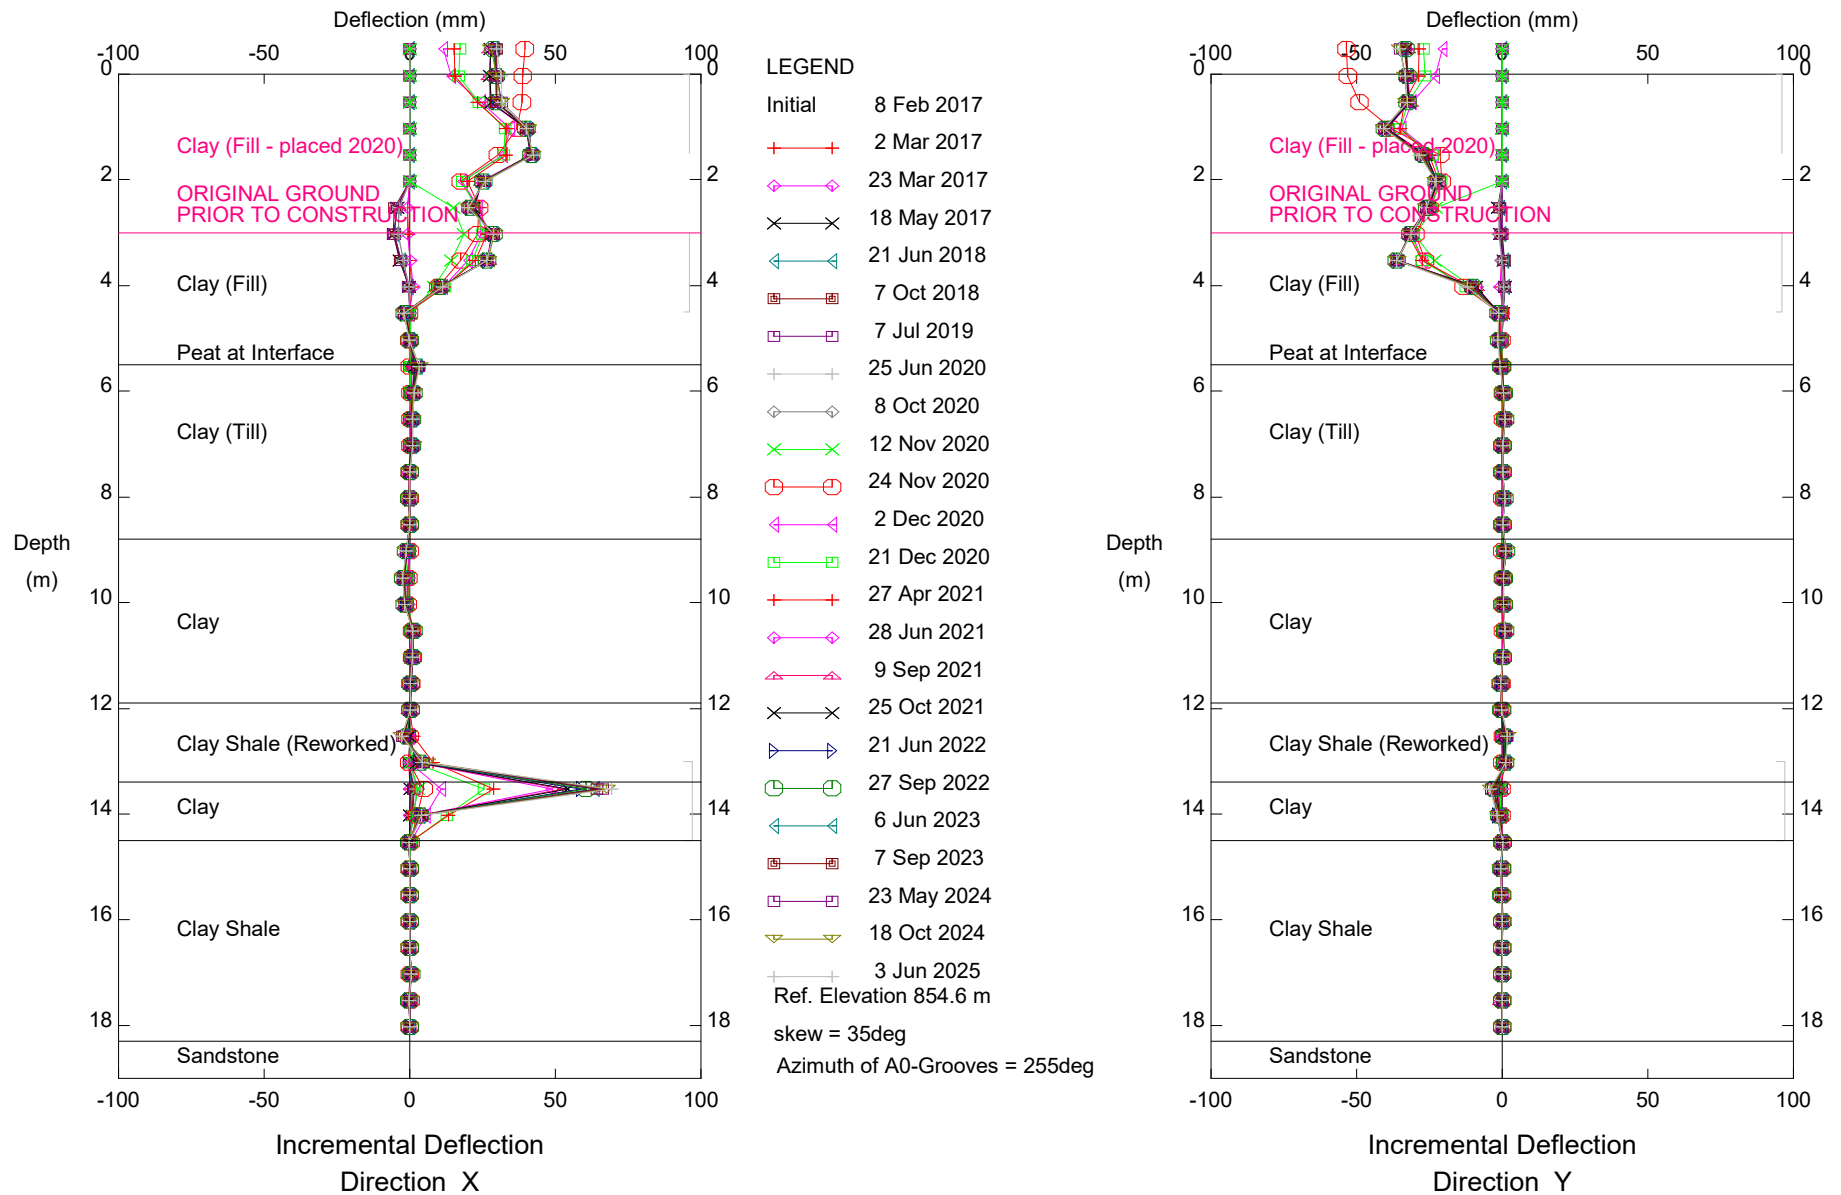
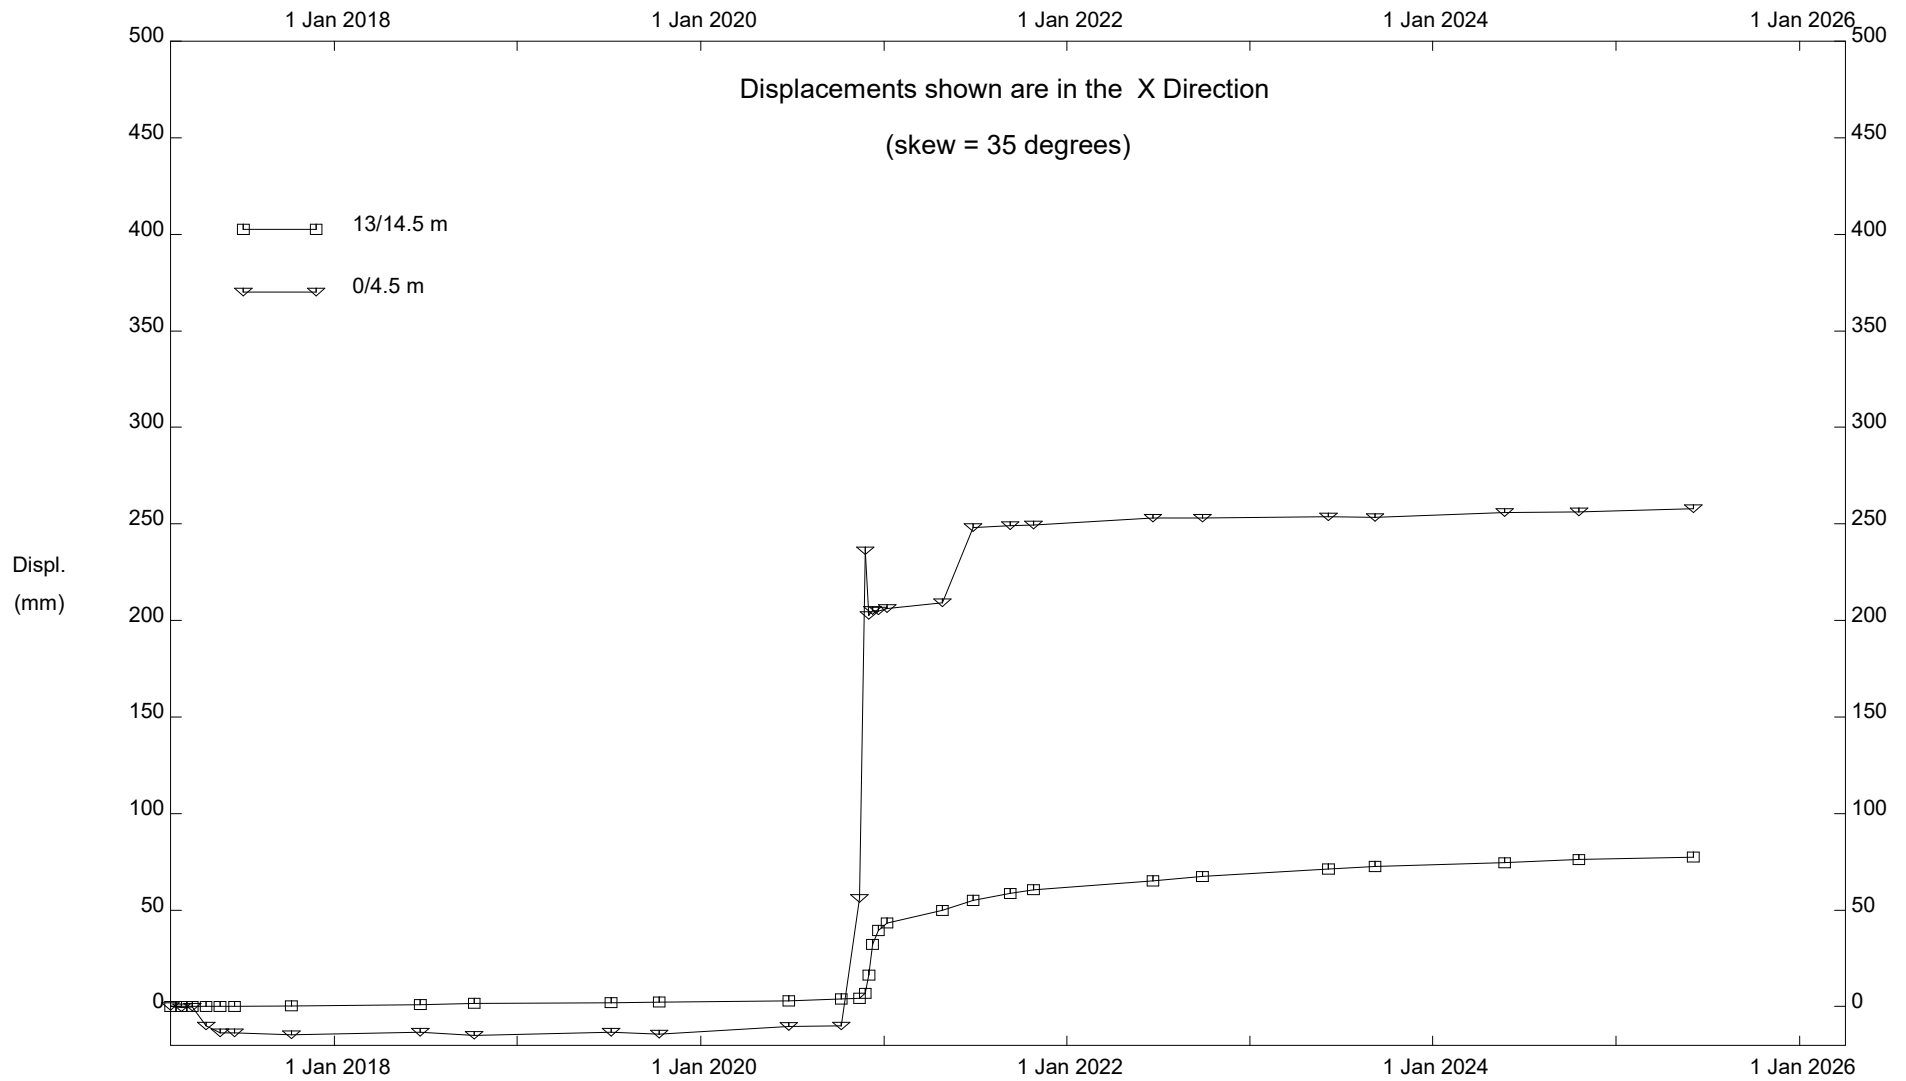
GP034; H40:38, Slide S. of Kakwa River, Inclinometer SI17-3

The shallow fill movement being recorded in SI17-3, since toe berm construction in late 2020, is believed to be causing the cracks observed in the pavement surface and along the highway embankment and may be an extension upwards along the backscarp, associated with deeper movement. The rate of shallow movement recorded between late 2020 and September 2021 is difficult to assess due to the SI casing being extended in November 2020 and the SI reading equipment being changed four times between November 2020 and June 2021. The maximum rate of movement recorded during toe berm construction was approximately 5,519 mm/year. Since September 2021, the rate of shallow fill movement recorded in SI17-3 has been decreasing and is currently less than 3 mm/year.
