SITE INSPECTION FORM

SITE NUMBER AND NAME: GP044 Cutbank River Slide (North)		HIGHWAY & KM: 40:40, 1.002	PREVIOUS INSPECTION DATE: May 23, 2018	INSPECTION DATE: June 15, 2022
LEGAL DESCRIPTION: NE-21-65-05-W6M	NAD 83 COORDINATES: UTM Northing Easting 11 6056410 391477		RISK ASSESSMENT: PF: 9 CF: 2 TOTAL: 18	
AVERAGE ANNUAL DAILY TRAFFIC (AADT): 2290 (north) & 2170 (south) (Reference No. 70000761, 2021)			CONTRACT MAINTENANCE AREA (CMA): 504

PROJECT
 PEACE REGION (GRANDE PRAIRIE DISTRICT-SOUTH)
 GEOHAZARD RISK MANAGEMENT PROGRAM

TITLE
 Site Plan
 GP044 - Cutbank River Slide (North)
 Hwy 40:40, km 1.002

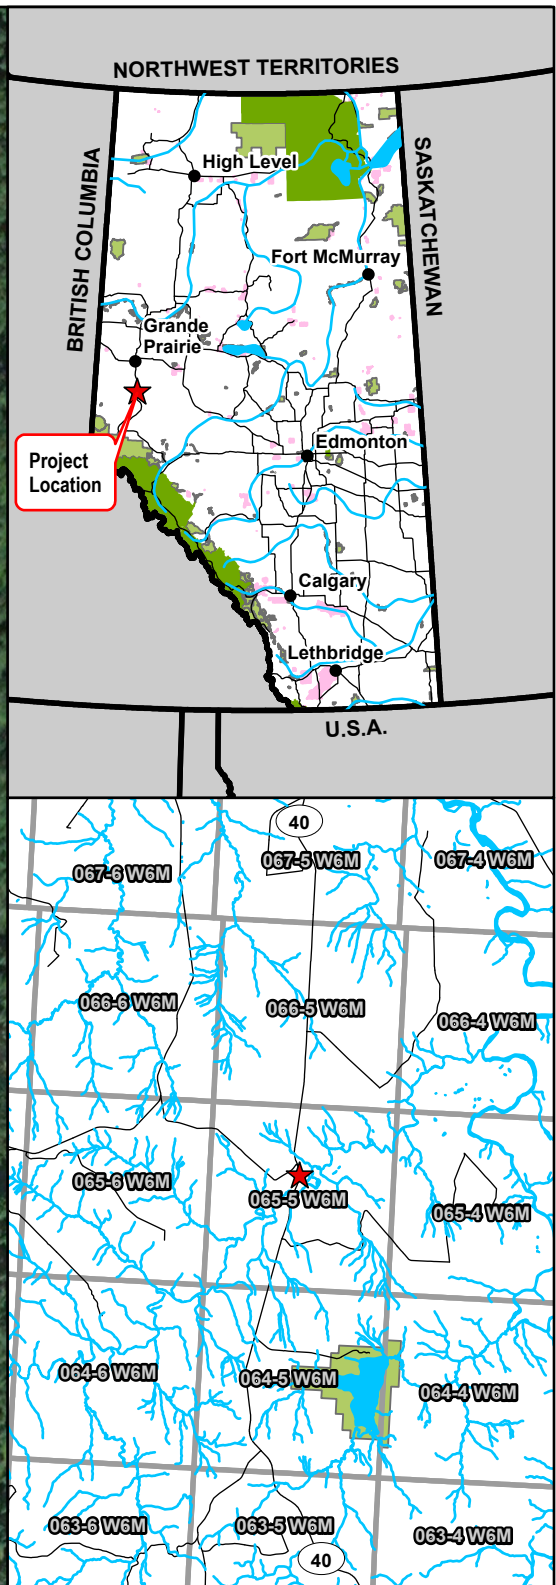
Available imagery does not show backslope repair completed in 2020, which included backslope flattening, construction of a diversion ditch at crest of backslope, reconstruction of two drainage swales along backslope, and placement of riprap check dams in upslope/west highway ditch
