<b>SITE NUMBER AND NAME:</b> GP045 Smoky River East Valley Slope Slide and Sinkhole		<b>HIGHWAY &amp; KM:</b> 43:04, 35.005	<b>PREVIOUS INSPECTION DATE:</b> May 30, 2020	<b>INSPECTION DATE:</b> July 19, 2021
<b>LEGAL DESCRIPTION:</b> SW 16-72-02 W6M	<b>NAD 83 COORDINATES:</b> UTM Northing Easting 11 6121684 420116		<b>RISK ASSESSMENT:</b> Slide: PF: 10 CF: 3 TOTAL: 30 Sinkhole: PF: 11 CF: 6 TOTAL: 66	
<b>AVERAGE ANNUAL DAILY TRAFFIC (AADT):</b> 5930 (west) & 6470 (east) (Reference No. 30720 & 70000114)			<b>CONTRACT MAINTENANCE AREA (CMA):</b> 504

PROJECT	GRANDE PRAIRIE SOUTH REGION GEOHAZARD RISK MANAGEMENT PROGRAM	
TITLE	Site Plan GP045 Smoky River East Valley Hwy 43:04, km 35.005	
SCALE	PROJECT No.	FIG No.
1:1,500	A05116A01	1

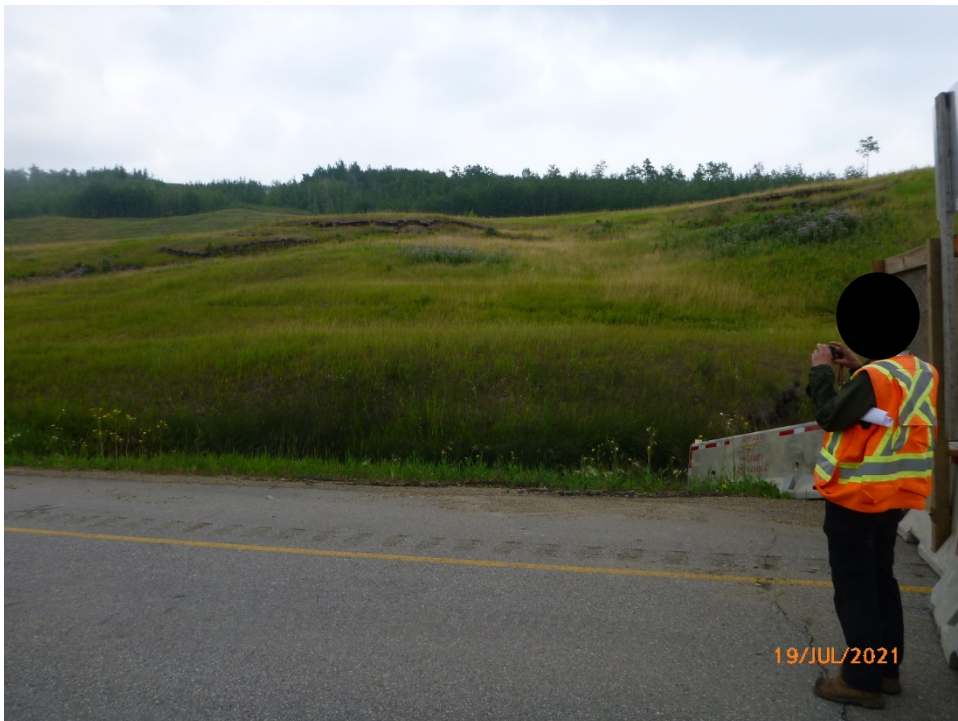
**Photo 4** Toe bulge in the north (eastbound) ditch of Hwy 43. Photo taken July 19, 2021 facing east.

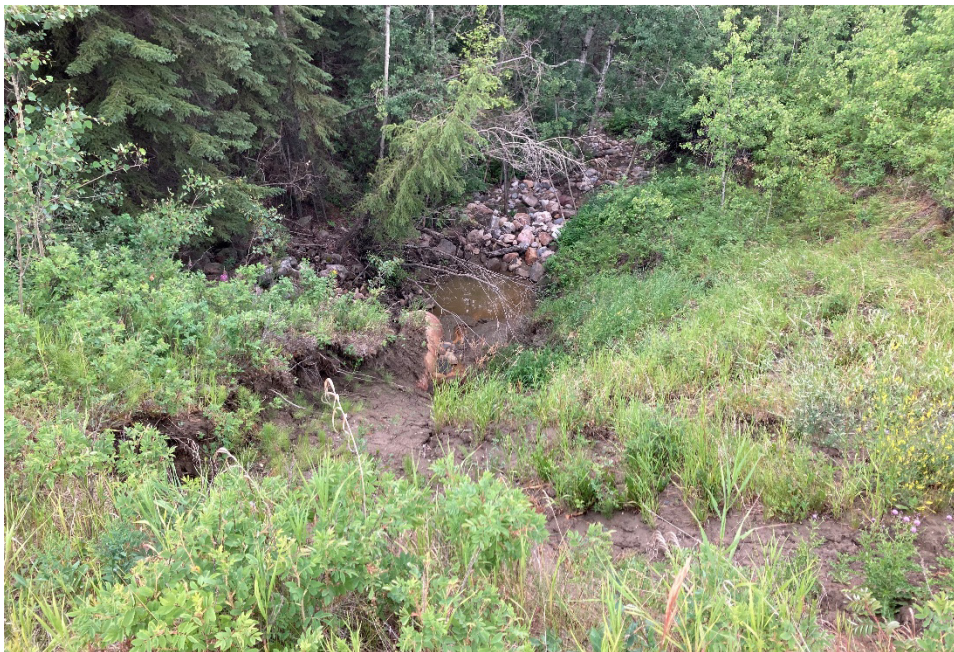
- Went to inlet of 1200 mm CSP culvert (WP080). Inlet has no trash rack and woody debris was found on top of the crown of the culvert. Water flow is rising above the inlet to the culvert and could indicate that the culvert is blocked with woody debris (this could explain the “surging” behaviour observed at the outlet of the 0.9-m-diameter steel pipe culvert)

**Photo 6** Inlet of 1200 mm diameter CSP culvert. Photo taken July 19, 2021 facing southeast.
