November 28, 2025

**CON0022166 Peace Region (Grande Prairie District – South) GRMP Instrumentation Monitoring
Site GP028; H43:12, km 34.473 Two Creeks
Section C – 2025 Fall Readings**

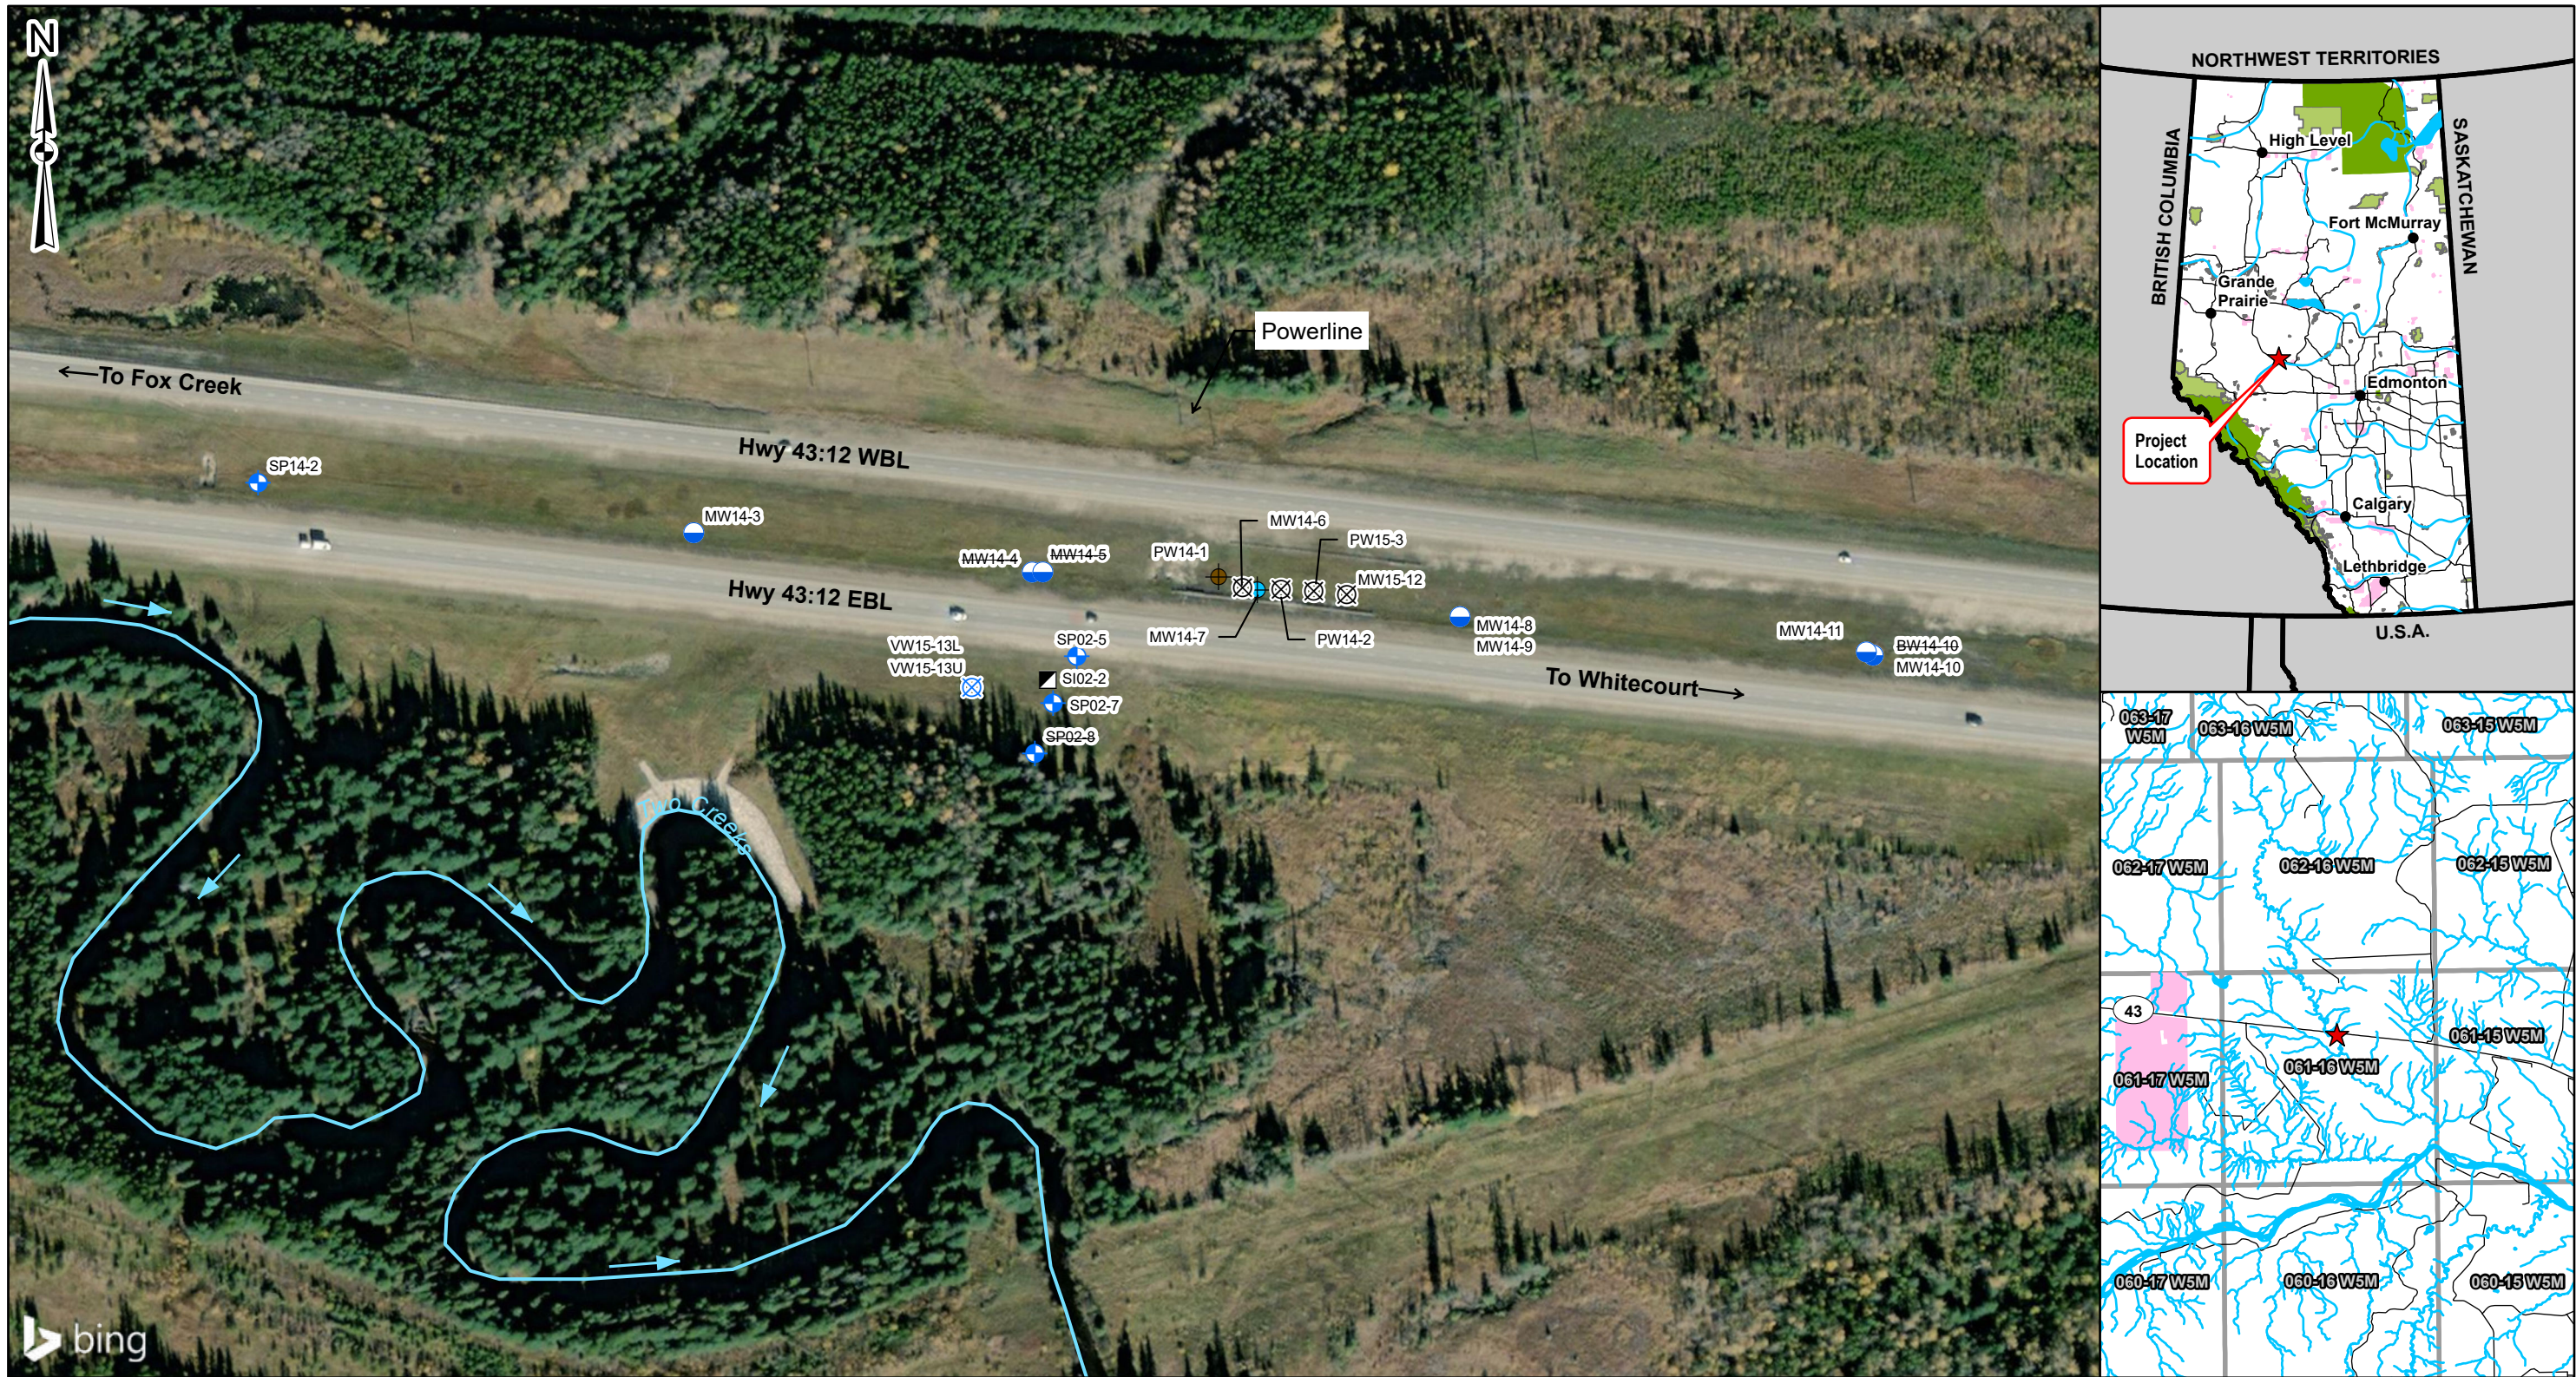
Six vibrating wire piezometers (VWPs) (VWP15-13U/L, MW14-6, MW15-12, PW14-2, and PW15-3), seven standpipe piezometers (SPs) (SP02-05, SP02-07, SP14-2, MW14-3, MW14-8, MW14-10, and MW14-11), two monitoring wells (MW14-7 and MW14-9), one pumping well (PW14-1) were read at the GP028 site in the Peace Region (Grande Prairie District – South) (GP South Region) on September 3, 2025 by Evan Hergott, E.I.T. and Katrina Cereno, E.I.T. of KCB. Four VWPs (MW14-6, PW14-2, PW15-3 and MW15-12) were reread by Evan Hergott on September 24, 2025. These instruments were read as part of the GP South Region Geohazard Risk Management Program (GRMP). The site is located on Hwy 43:12, km 34.473. The approximate site coordinates are 6017213 N, 544193 E (UTM Zone 11, NAD 83). A site plan is presented on Figure 1.

The geohazard at the GP028 site consists of a landslide with a backscarp that extends through the south (eastbound) lanes of Hwy 43:12 and toes out in Two Creeks. High groundwater levels are also impacting the pavement subgrade/surface. The site is located north (upslope) of Two Creeks.
