**ALBERTA TRANSPORTATION
GEOHAZARD ASSESSMENT PROGRAM
PEACE REGION – GRANDE PRAIRIE DISTRICT
2020 INSPECTION**

Site Number	Location	Name	Hwy	km
GP30	East of Fox Creek	Iosegun River (0.5 km W Bridge)	43:12	16.5
Legal Description		UTM Co-ordinates (NAD 83)		
SW35-61-18-W5		11U N 6,018,815	E 526,395

Date	PF	CF	Total
Previous Inspection:	May 13, 2019	11	2	22
Current Inspection:	June 18, 2020	12	2	24
Road AADT:	7,560	Year:	2019	
Inspected By:	Barry Meays (Thurber) Roger Skirrow, Ed Szmata (AT)			
Report Attachments:	<input checked="" type="checkbox"/> Photographs <input checked="" type="checkbox"/> Plans <input checked="" type="checkbox"/> Maintenance Items

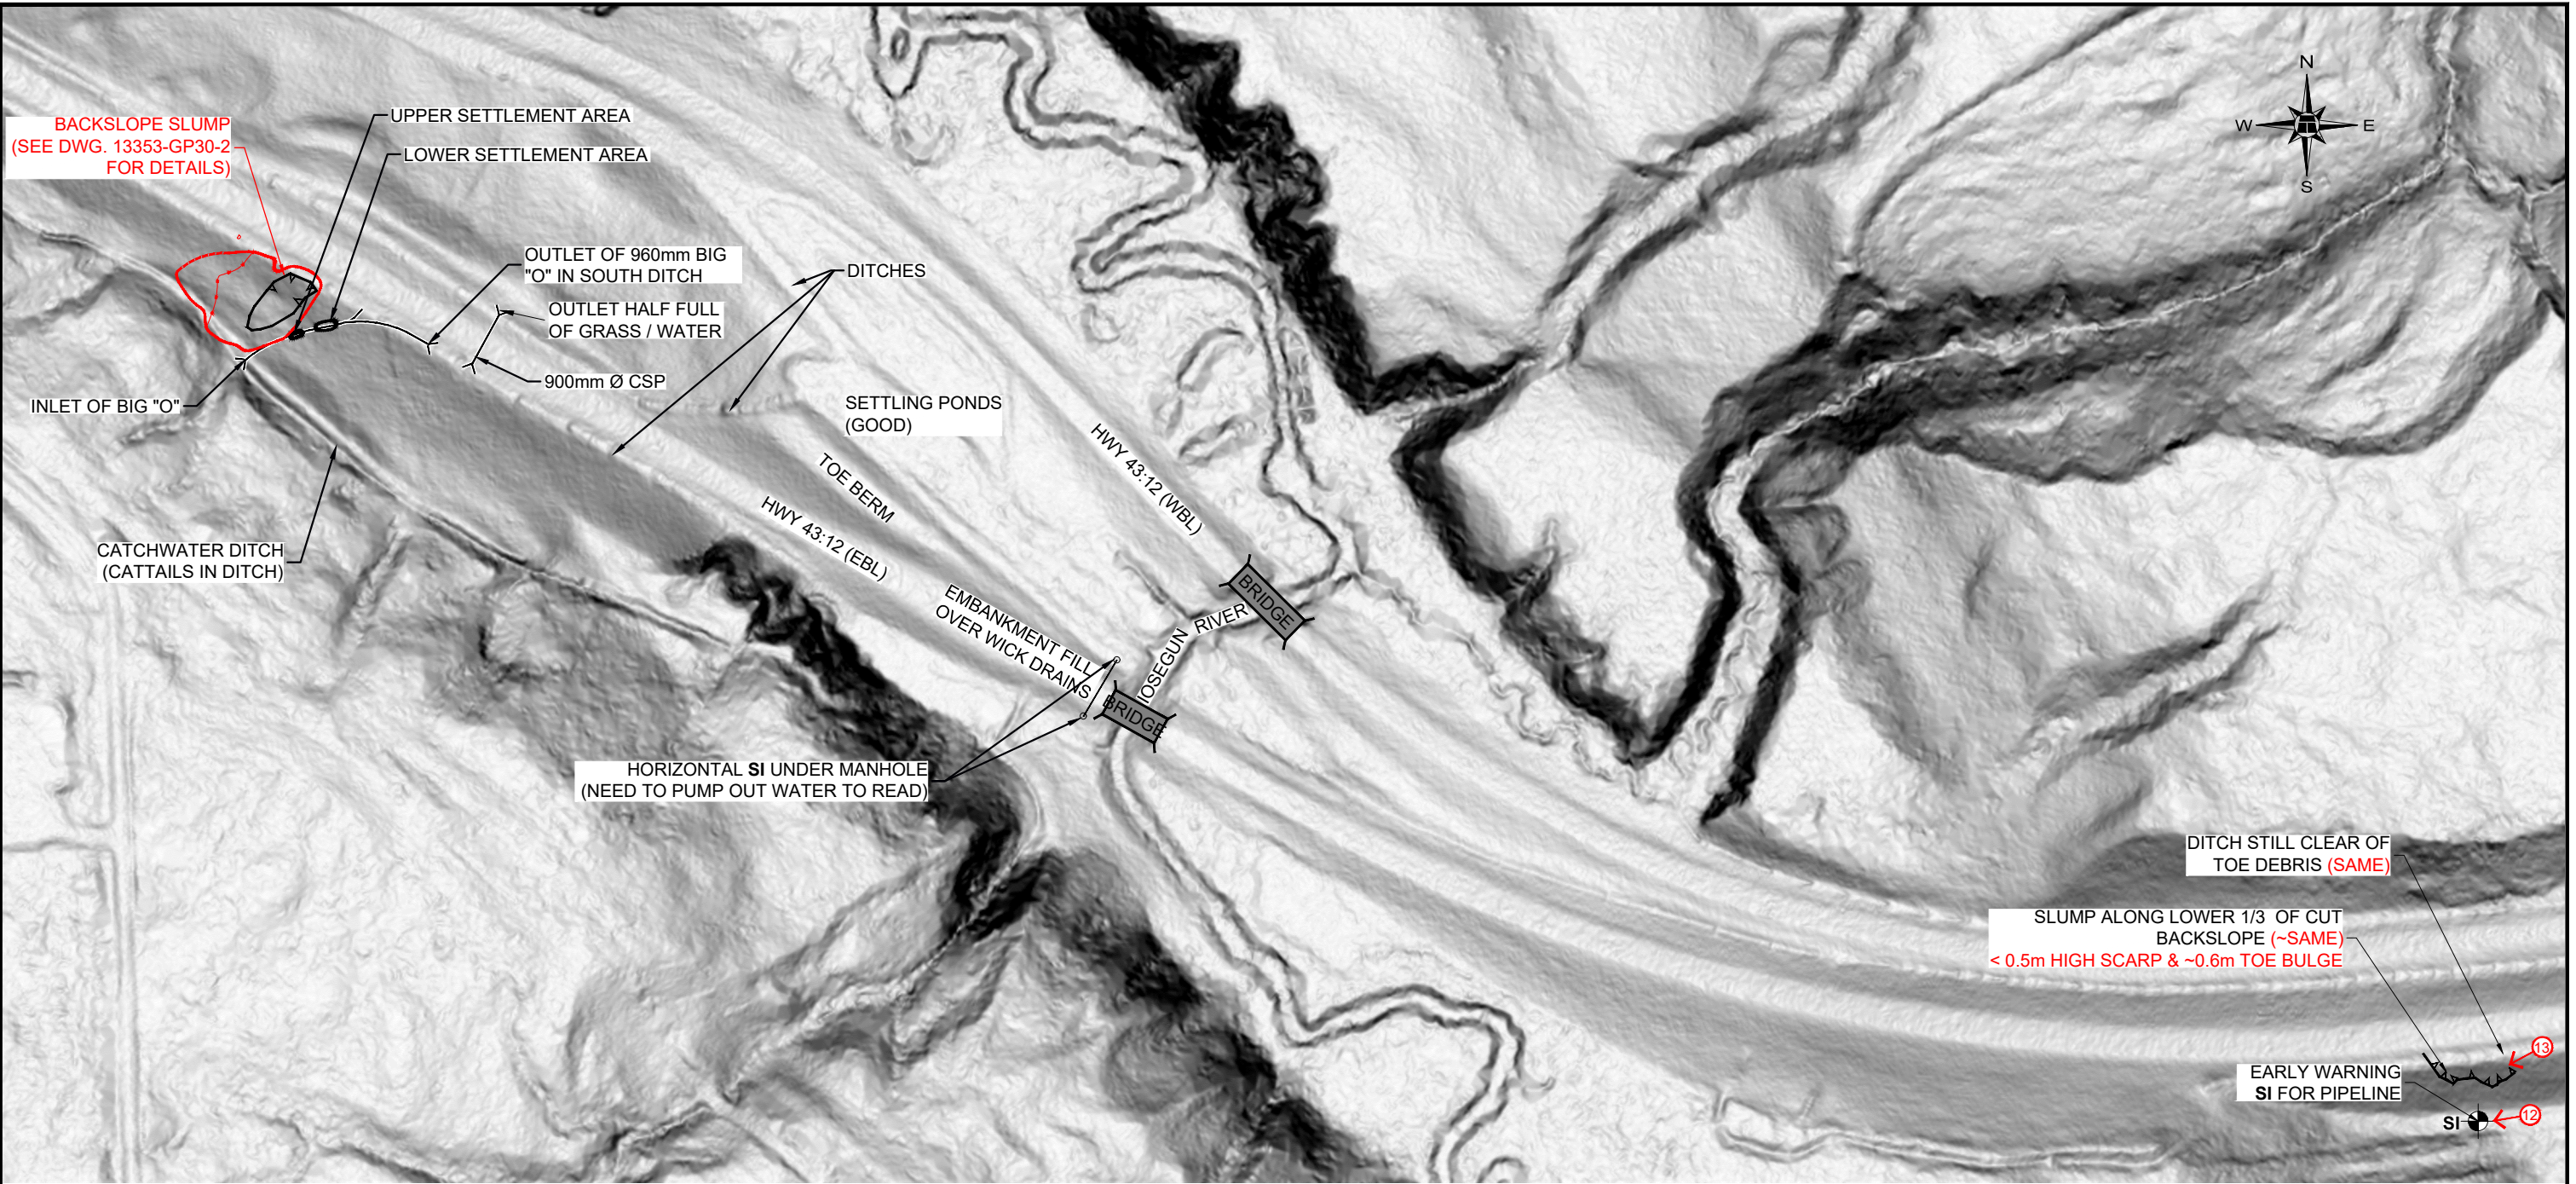
DWG No. 13353-GP30-1

Primary Site Issue:	Leakage from a buried 960 mm dia. "Big O" pipe running down the south backslope west of the river, that drains water from a catchwater ditch along the top of the backslope down to the south highway ditch. The pipe is separated (and possibly crushed), and a slump has formed alongside the pipe (which became much larger in 2020 when the berm downslope of the catchwater ditch breached above the slump). Also east of the river, a slump on the south backslope has formed.		
Dimensions:	W River: ~60 m length x <5m wide x <1.2m deep of settlement/erosion along the Big O pipe alignment. ~70 m wide x 70 m long slump in the backslope. E River ~40 m wide backslope slump x 50 m long.		
Date of any remediation:	In 2010 W of the River, ~110 m length of Big O pipe was installed down the south backslope, with some deepening/regrading of ~300 m of the catchwater ditch at the top of the backslope to drain into the pipe inlet from both directions, and construction of a 1.2 m high berm on the downslope side of the catchwater ditch, to funnel surface runoff into the pipe. The pipe was to be anchored, have 1 m of cover, have riprap protection at the inlet, and a gabion wall splash pad at the outlet. Some slope regrading of the previous slump, and some finger drains to tap existing seepage was also performed at this time.

Maintenance:			
Observations:	Description	Worse?	
<input type="checkbox"/> Pavement Distress		<input type="checkbox"/>	
<input checked="" type="checkbox"/> Slope Movement	W River: A slump ~70 m wide x 70 m long x <0.2m backscarp has formed (initially caused by backslope erosion and/or piping from the upper part of the pipe, and enlarged by the catchwater ditch berm breach), and extends west of the pipe. E River: ~40 m wide x 50 m long slump has its scarp about 1/3 of the way up the cut backslope, and appears to be toeing out in the south hwy ditch.	<input checked="" type="checkbox"/>	
<input checked="" type="checkbox"/> Erosion	Along the base and the surface of the Big O pipe in the highway backslope W of the River. Also at the point where the catchwater ditch berm breached into the slump.	<input type="checkbox"/>	
<input checked="" type="checkbox"/> Seepage	From joints of the 960 mm dia. Big O pipe. A bit from the sides of the catchwater ditch. Also, some intermittent	<input type="checkbox"/>

<p>Assessment: W River A catchwater ditch existed all along the top of the south backslope to capture and prevent surface water from running along the backslope (was supposed to drain towards the west). At a relatively low spot in the ditch, surface water began seeping through and/or spilling overtop the backslope (the channel capacity of this ditch may have been undersized and the gradient too flat). Erosion began to form along this surface runoff path. This caused a backslope slump failure to form, about 50 m long x 30 m wide on the lower half of this 30 m high, 3H:1V backslope, that transitions between the top catchwater ditch and the south highway ditch.</p> <p>In 2010, the remedial measures described above were implemented. This flow from the Big O then runs along the south highway ditch over one of the pre-existing gabion check weirs, before entering a 900 mm CSP that crosses beneath the highway eastbound lanes and into settling ponds in the median.</p> <p>The following spring (of 2011), failure of the Big O pipe was assessed via equipment entering the pipe internally, and joint separation was confirmed. This resulted in flow leakage, causing soil erosion along the slope face. It was also speculated equipment travelling overtop of the pipe with insufficient cover may have also crushed the top of the pipe, further worsening the situation.</p> <p>The current observations suggest that below grade separation or disconnection of the pipe is well founded, or possibly the pipe is squashed almost shut further downslope from the inlet. The inlet area to the Big O pipe is quite well defined to intercept flow and funnel it into the pipe, and surface water should be entering the pipe with unabated resistance. Subsurface water leakage appears to be causing piping erosion below grade along the pipe alignment, which in turn caused settlement depressions to reflect at surface. A slump formed in the backslope west of the pipe (originally about the same size as the one noted prior to 2010), which originated near the upper part of the pipe alignment. In 2020 this slump has enlarged considerably (~70 m wide x 70 m long) due to surface runoff/infiltration coming from a breach in the catchwater ditch berm, which meanders over the disordered slump terrain and is saturating the slump and backslope surfaces. The west slide toe debris is starting to squeeze into the ditch, but so far ditch runoff is going around the toe bulge and not affecting the highway embankment yet.</p> <p>The 900 mm CSP cross-culvert outlet in the median was noted to be about half full of grass and water. This could be due to a flatter than desired gradient in order to match the median ditch elevation, and/or vegetation growth in/around the outlet.</p> <p>EB Lane Bridge Abutment As part of the new hwy EB lane twinning in ~2002, a horizontal and vertical inclinometer were installed along the west side of the new EB lanes bridge to monitor movements of the west embankment fill over wick drains. Apparently the horizontal inclinometer SI-1 can be accessed through a manhole which must be first pumped out, and provided good previous data.</p>

Although OK now, the east bound (south) highway ditch at either slide location may need periodic cleaning of toe debris that accumulates if the slide(s) continue to move.

The erosion and slumps should be regularly monitored for deterioration and enlargement. Install subdrains to control the intermittent seepage that is occurring adjacent to the pavement westbound lanes. Repair the breached catchwater ditch berm by constructing an ~10m long x 2 m high berm in place to redirect catchwater ditch drainage into the Big O pipe inlet further downslope (east).

AND 2) The west slump will need to be repaired for either option above, by excavating out the material to below the slide plane, installing a subdrain(s) along the base that outlets into the ditch, and re-compacting the salvaged clay material in place (assume 3m deep average).

The backslope slump east of the river will also need to be repaired. Due to the higher consequence of failure resulting from a pipeline behind the backslope, it is recommended that the slide be excavated and backfilled in stages with granular fill, topped with topsoil, soil covering and seed. The SI should be read to guide construction and ensure that excessive ground movements are not occurring near the pipeline.
