**ALBERTA TRANSPORTATION
GEOHAZARD ASSESSMENT PROGRAM
PEACE REGION–GRANDE PRAIRIE
2020 INSPECTION**

Site Number	Location	Name	Hwy	km
GP16	Hwy 666:02 S. of Grande Prairie (Wapiti River Valley Slides)	Mid-Valley/Old Major (Site 1)	666:02	34+773
		Lower Valley (Site 2)		34+837
		Valley Top (Site 3)		34+250
Legal Description (Site 1)		UTM Co-ordinates (Site 1)		
NE¼ 15-070-06 W6M		11U E 383370		N 6103058

Date	PF	CF	Total
Previous Inspection:	30-Aug-2019	13	6	78 (Site 1)
		14	6	84 (Site 2)
		14	5	70 (Site 3)
Current Inspection:	27-May-2020	14	6	84 (Site 1)
		15	7	105 (Site 2)
		14	5	70 (Site 3)
Road AADT:	2680	Year:	2019	
Inspected by:	Ed Szmata, TRANS Dwayne Loewen, TRANS Rishi Adhikari, TRANS		Nicole Wilder, Thurber Don Proudfoot, Thurber	
Report Attachments:	<input checked="" type="checkbox"/> Photographs <input checked="" type="checkbox"/> Plans <input checked="" type="checkbox"/> Maintenance Items

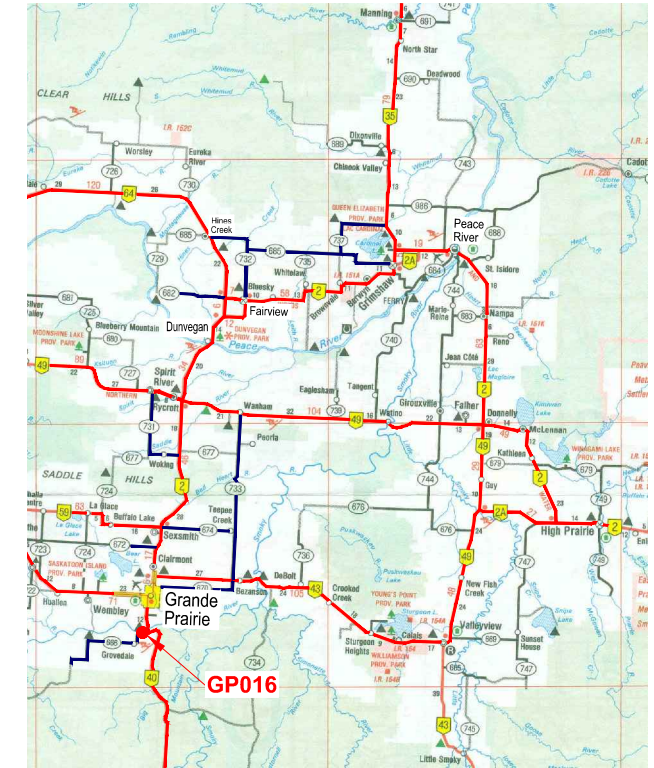
SITE MAP
NOT TO SCALE

- NOTES:**
1. FEATURE LOCATIONS ARE APPROXIMATE.
 2. PREVIOUS OBSERVATIONS SHOWN IN BLACK.
 3. MAY 27, 2020 FEATURES SHOWN IN RED.
