July 15, 2025

CON0022166 Peace Region (Grande Prairie District – South) GRMP Instrumentation Monitoring Site GP016; H666:02, km 34.837 Slide 2 km West of Hwy 40 and Hwy 666 Junction Section C – 2025 Spring Readings

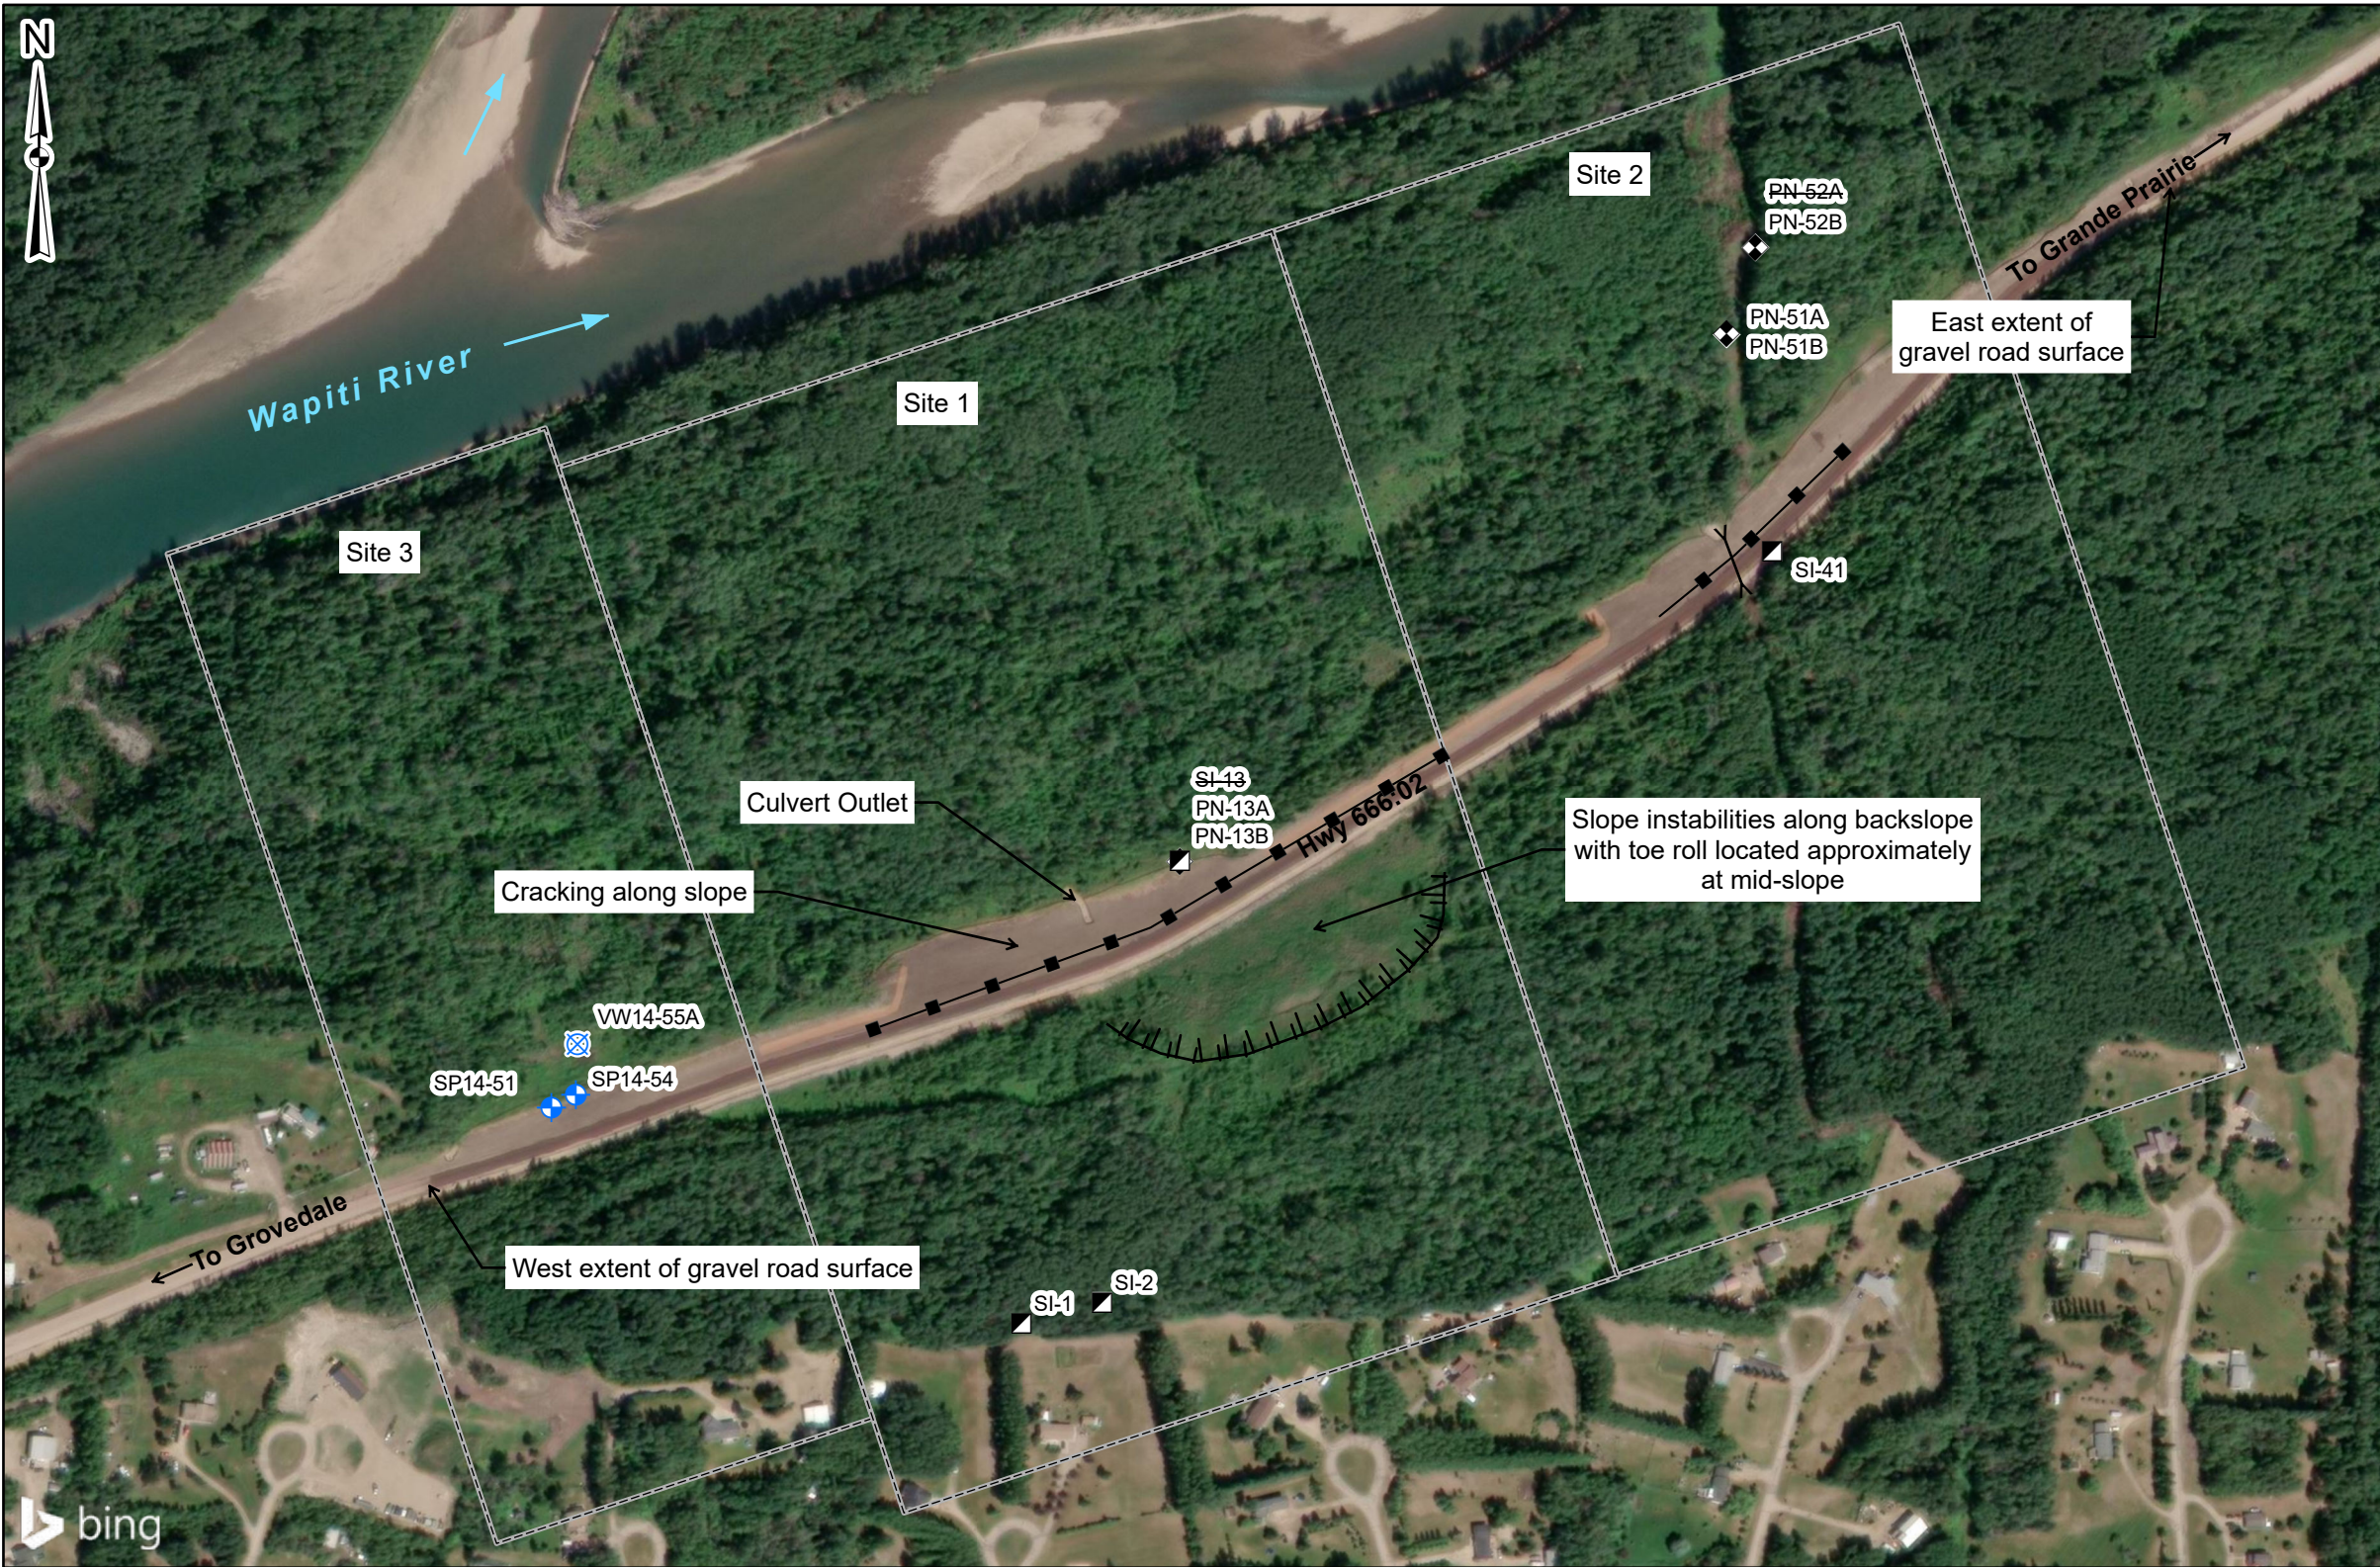
PROJECT PEACE REGION (GRANDE PRAIRIE DISTRICT-SOUTH) GEOHAZARD RISK MANAGEMENT PROGRAM		
TITLE Site Plan GP016 - Slide 2km W. of Hwy 40 and Hwy 666 Junction Hwy 666:02, km 34.837		
SCALE 1:5,000	PROJECT No. A05116A01	FIG No. 1

The geohazard at the GP016 site consists of three landslides (Sites 1 through 3) along the south slope of the Wapiti River Valley. Site 1 is the middle landslide, while Sites 2 and 3 are on the east and west sides of the site, respectively. It is noted that the entire south slope of the Wapiti River Valley is a sliding zone.

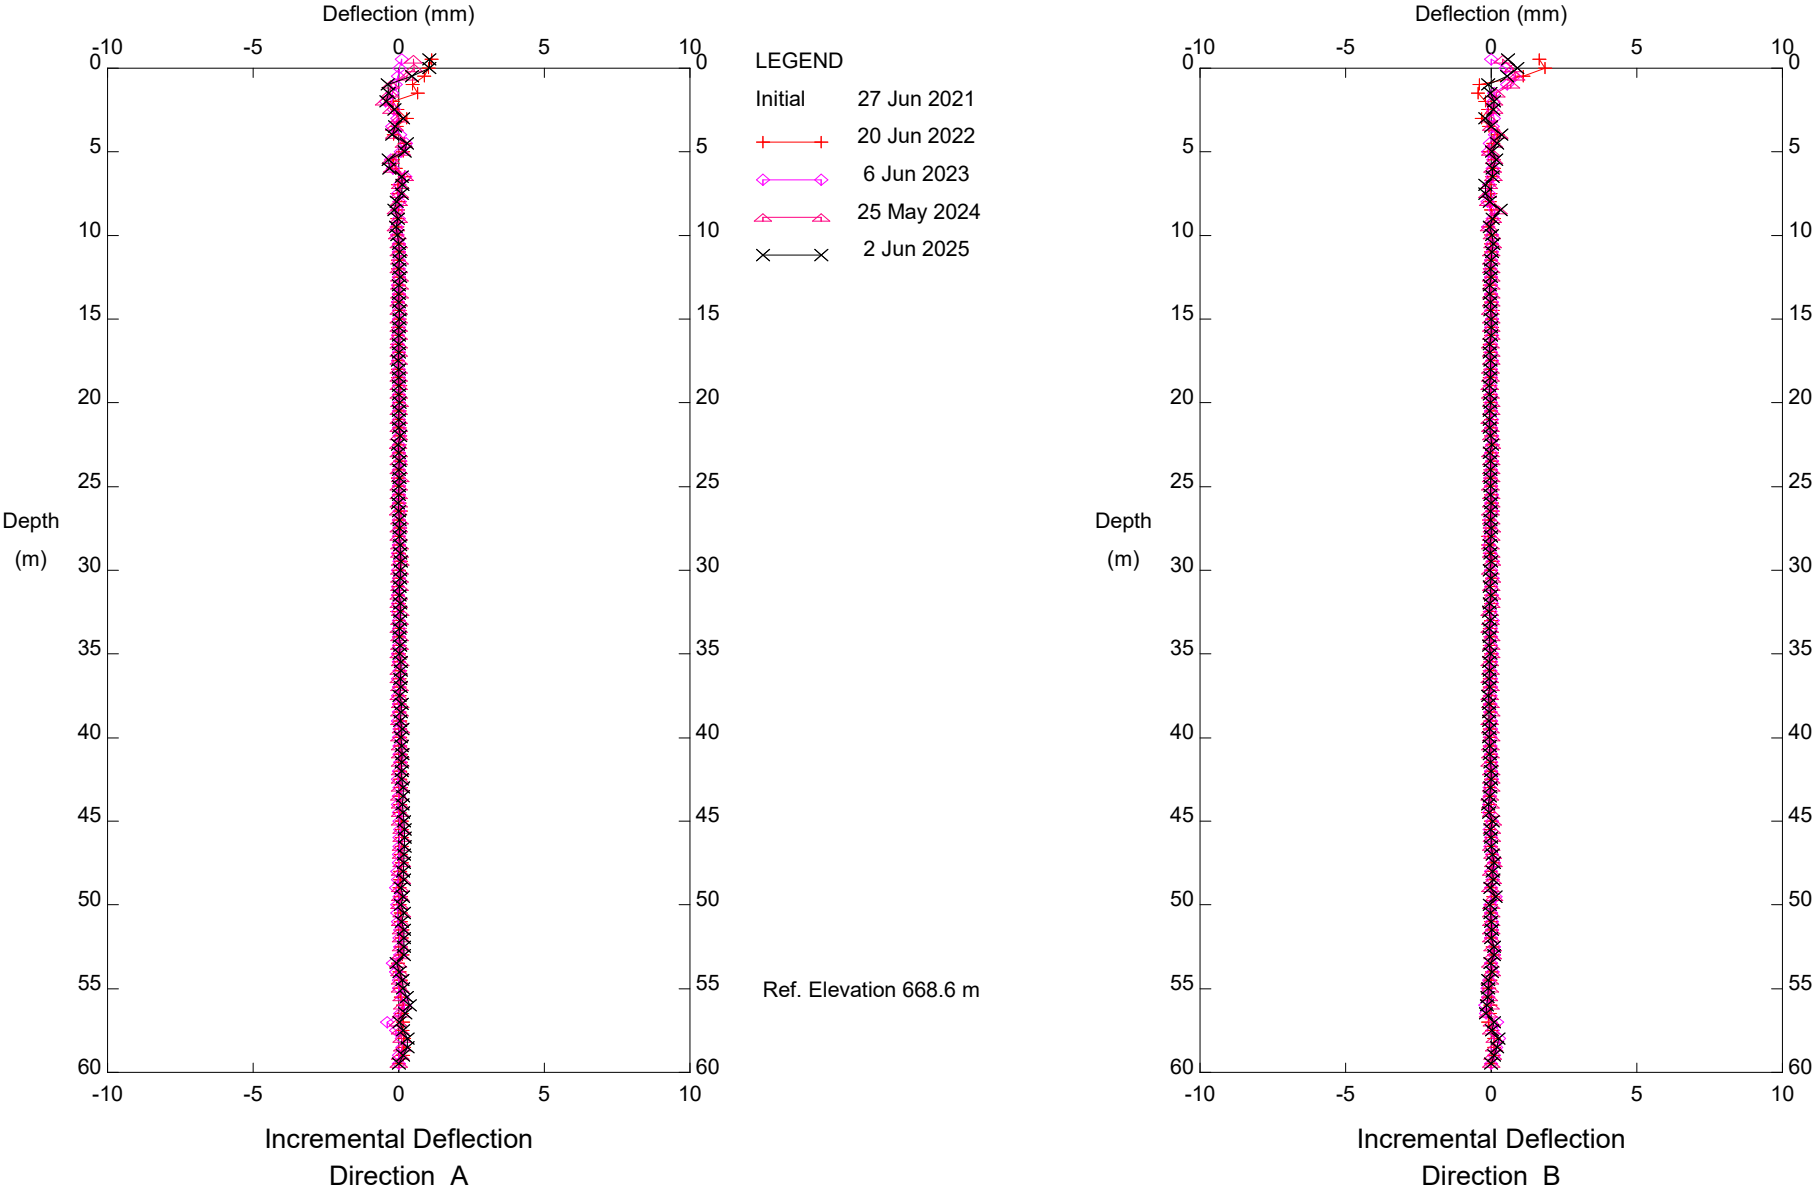
GP016; H666:02 Slide 2 km West of Hwy 40, Inclinator SI-1
Alberta Transportation

- For SI-1, the data is relatively noisy and the readings after 2021 do not line up well with the previous consultants' readings. To improve our ability to interpret the data, we have re-initialized this instrument to the June 2021 readings. Only the re-initialized plots are included in Appendix I.
- For SI-2, the previous consultant was copying the bottom eight readings (4 m) for each subsequent reading instead of using the data obtained in the field. Without this correction, there is a "kick-out" at the base of the instrument when compared to the previous readings. With the replacement readings, KCB's readings are relatively consistent with the previous readings. However, to improve our ability to interpret the data, we have re-initialized this instrument to the June 2021 readings. Only the re-initialized plots are included in Appendix I.

Depending on long-term plans for the site, TEC could consider replacing SI-13, since it was the last active SI at highway surface, and either removing or replacing SI-01 and SI-02, since the data recorded in these instruments is noisy and difficult to interpret. Alternatively, TEC could adopt change-detection or remote-sensing type monitoring, including Light Detection and Ranging (LiDAR), Interferometric Synthetic Aperture Radar (InSAR), or low-cost differential Global Positioning System (GPS) if the risk of equipment loss or damage is acceptable. Such an assessment would help provide a wider perspective assessment on where movements are occurring across the whole slope and may offer some opportunities to assess the influence of toe-of-slope movements and associated time-lag effects to when the slope movements affect the highway surface.
