September 8, 2009

File: 15-16-229

**PEACE REGION (PEACE RIVER/HIGH LEVEL) GEOHAZARD ASSESSMENT
HWY 2:60 EMBANKMENT SLIDE AREA (PH 13), NAMPA
2009 ANNUAL INSPECTION REPORT**

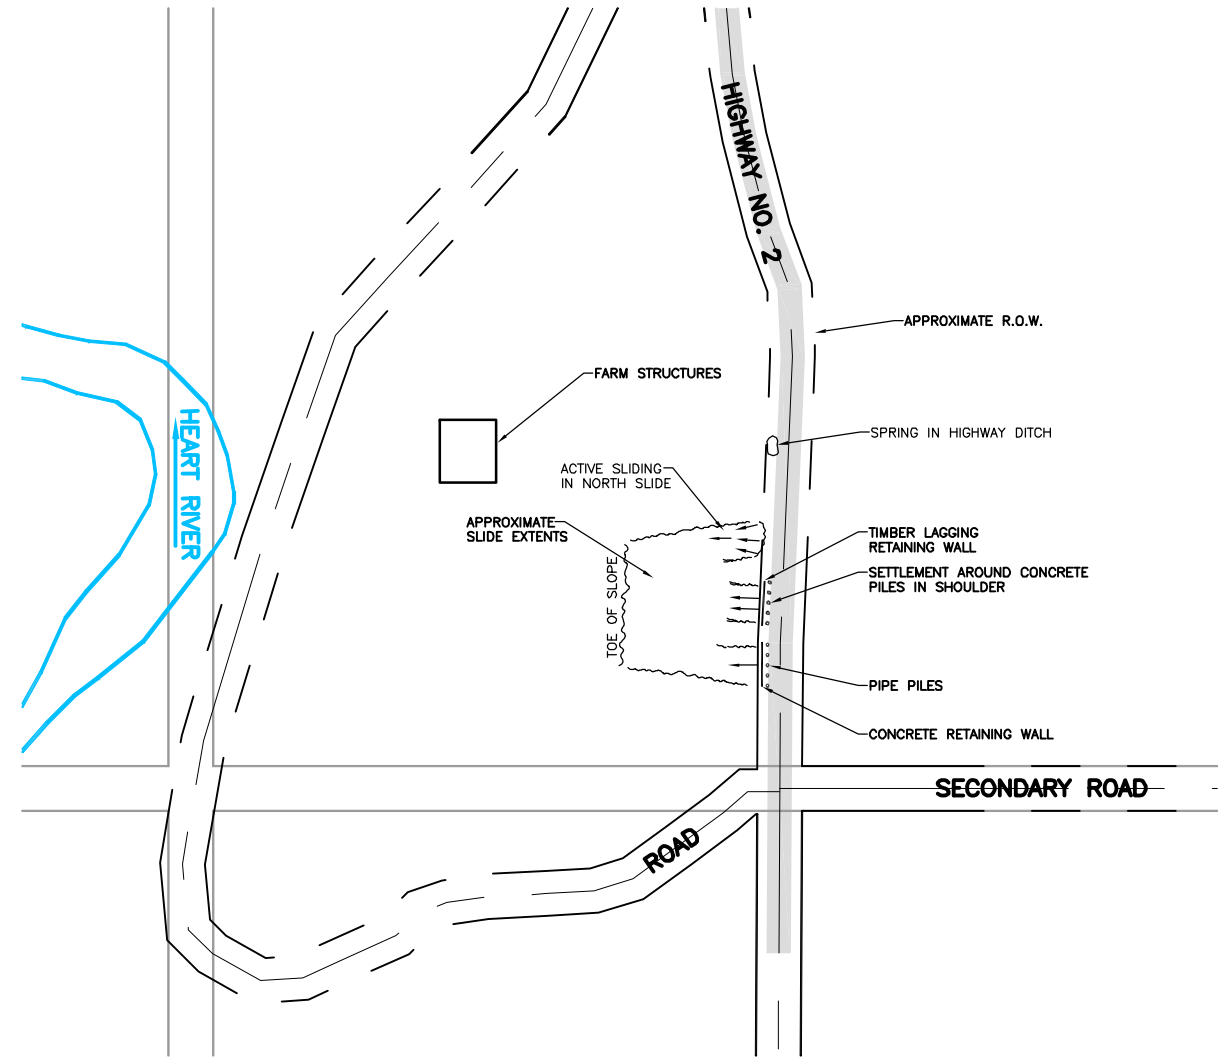
DETAIL PLAN

Conditions at the site appeared to be relatively unchanged since the 2008 inspection and are noted on the attached site sketch plan. Select photographs taken during the visit are also included.
