**PEACE REGION (SWAN HILLS AREA) GEOHAZARD ASSESSMENT
HWY 33:12 EMBANKMENT SLUMP (SH9)
2005 ANNUAL INSPECTION REPORT**

This letter documents the 2005 annual site inspection of an area of former slope instability located along Hwy 33:12 about 23 km north of Swan Hills, Alberta. Thurber Engineering Ltd. (Thurber) undertook this inspection in partial fulfillment of our Geotechnical Services for Geohazard Assessment, Instrumentation Monitoring and Related Work contract (CE047/2004) with Alberta Infrastructure and Transportation (AIT).

**HWY 33:12 EMBANKMENT SLUMP
23 km NORTH OF SWAN HILLS (SH9)
UPDATED SITE SKETCH PLAN (JUNE 7, 2005)**

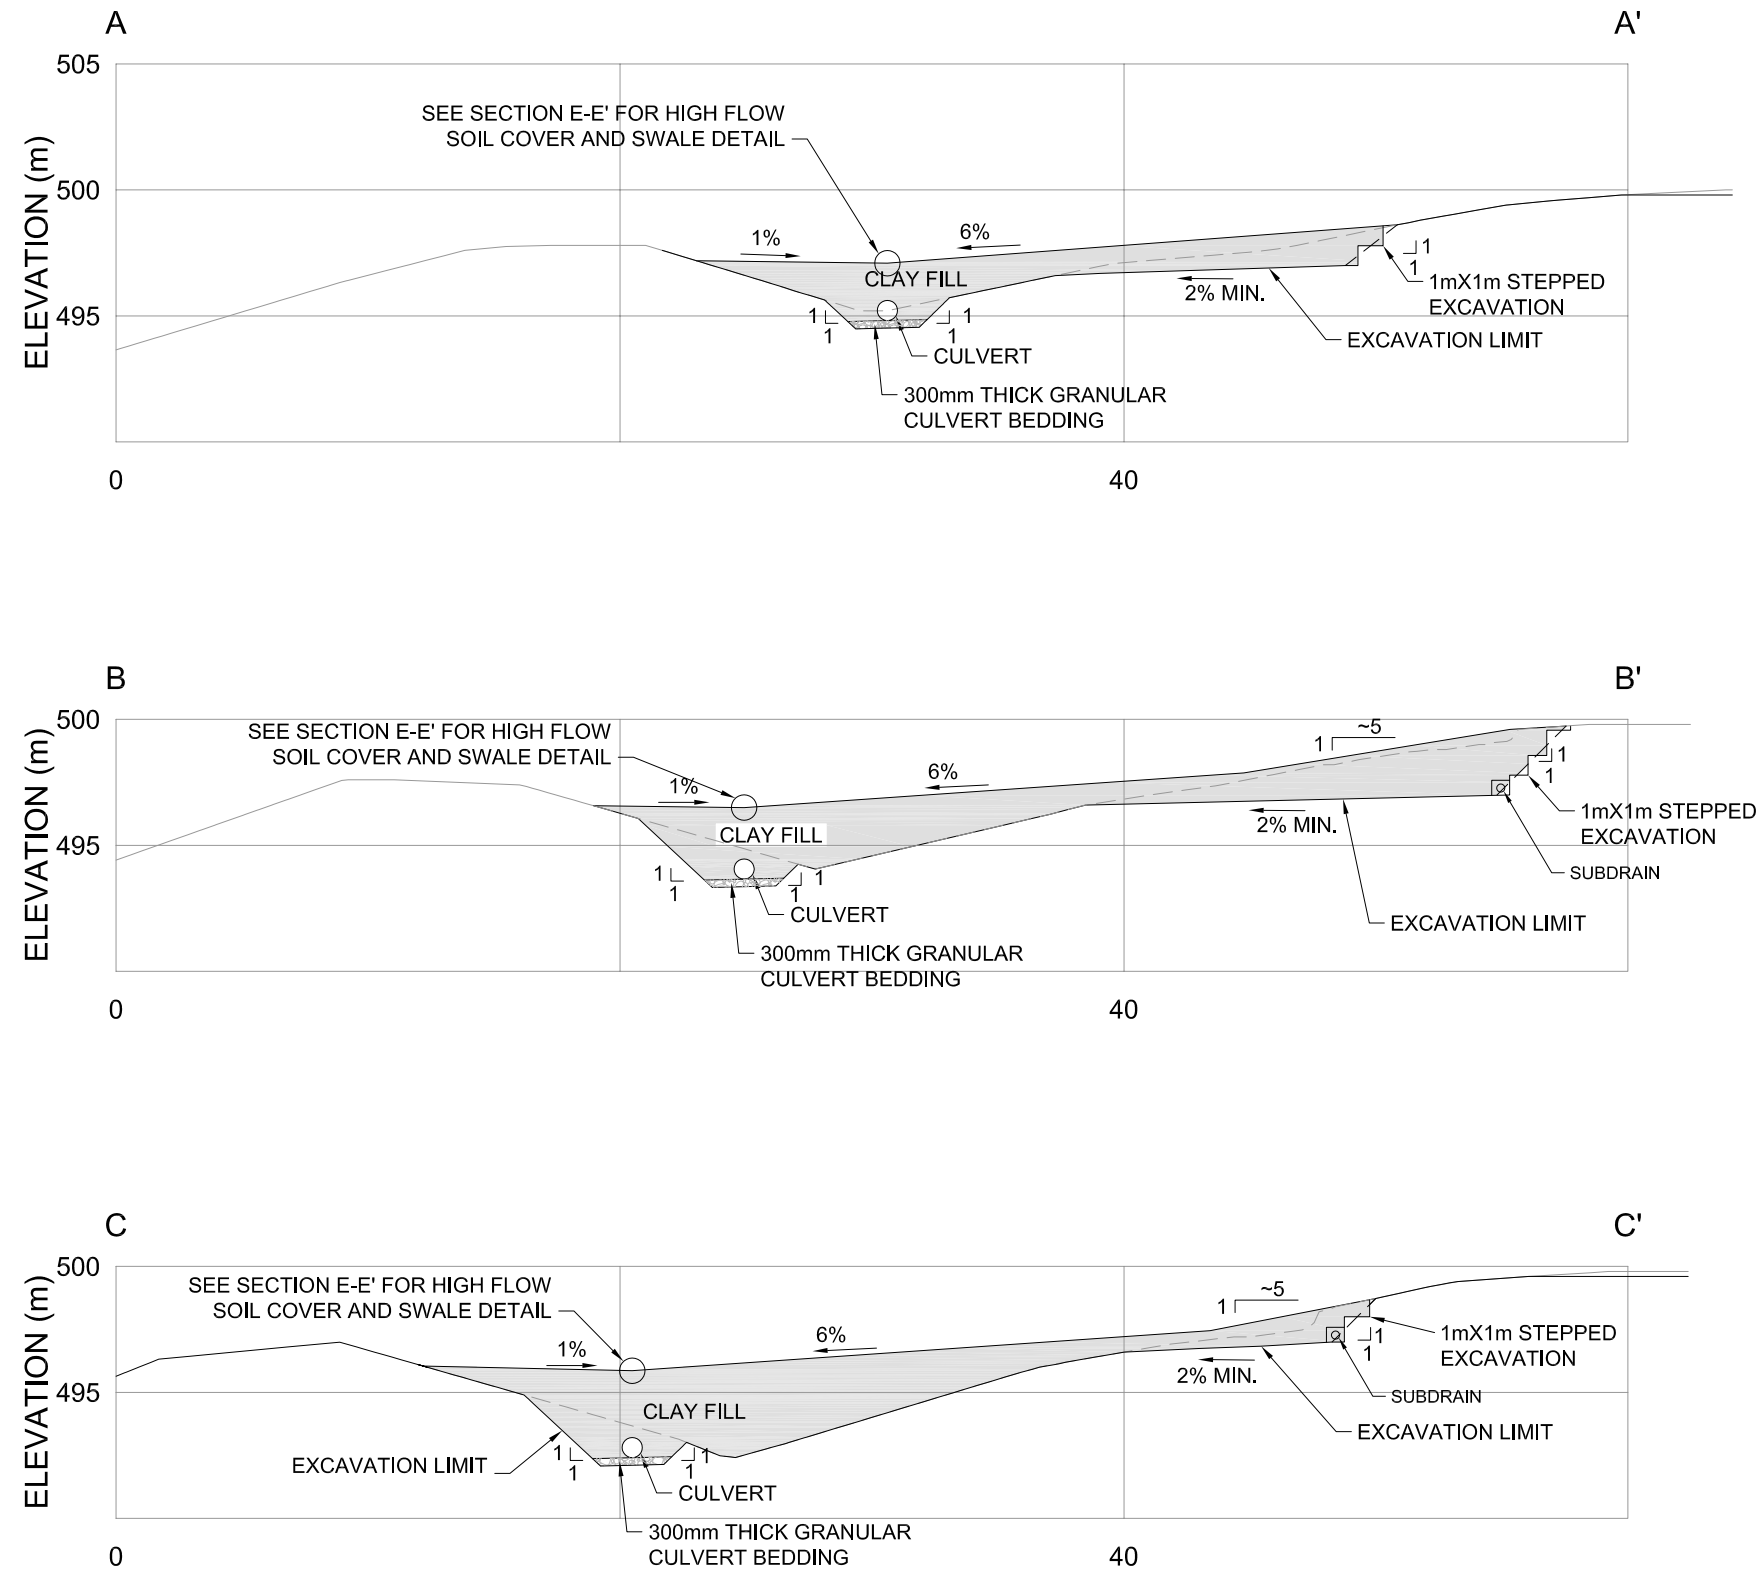
Grass was just beginning to sprout on the recently rehabilitated west sideslope. Two silt fences were installed across the slope in a north-south fashion above the culvert outlet, and were functioning well but had a couple of loose spots. An additional silt fence located lower down the slope along the south edge of the creek was loose. A 7 m long crack up to 20 mm wide was observed right at the grade change of the flatter upper slope and lower steeper slope nearer the south side of the old slump (see attached drawing).

The fresh crack observed south of the culvert at the break in the west sideslope is likely attributed to settlement of the freshly placed fill, but it could possibly be a reflection of the previous instability.

The slumping that occurred prior to repairs at the culvert inlet was likely caused by erosion, and possibly hampered by debris in the pipe. The recent repairs have remedied this situation, however ongoing erosion is possible due to the sharp bend in the channel immediately in front of the culvert inlet.

The 2004 remedial measures have improved the overall condition of the existing slump on both sides of the highway. However, the crack observed south of the culvert at the boundary of the slope segments should be regularly monitored, to see if it is a reflection of a portion of the previous slump or simply recent settlement of the fill, and to warn of a potential worsening of the condition.

Yearly monitoring is also still recommended for the remainder of the site to assess the performance of the recent repairs, and to see if erosion will re-emerge in the future at either the inlet or outlet of the culvert. The condition and functionality of the subdrains installed as part of the repairs on the west slope should be monitored. The progress of revegetation on the backslope should also be checked.

It is recommended that the lower silt fence along the south side of the creek, and the few loose spots on the silt fences further up the slope west of the highway be repaired by tightening and rebasing it into the soil. Similarly, the silt fence east of the highway above the culvert inlet should be reinstated until the grass has fully caught.
