ALBERTA TRANSPORTATION AND  
ECONOMIC CORRIDORS GRMP  
PEACE REGION – (PEACE RIVER DISTRICT)  
INSTRUMENTATION MONITORING - FALL 2025

Site Number	Location	Name	Hwy	km
PH009-3	Hwy 684:02 km 30.99, Town of Peace River	Shaftesbury Trail - Shop Slide	684:02	30.9-31.1
			Old 2:02	0.0-0.4
Legal Description:		UTM Co-ordinates		
4-31-83-21 W5		11V    E    480321	N    6232126

<b>Current Monitoring:</b>	26-Sep-2025	<b>Previous Monitoring</b>	8-June-2025
<b>Instruments Read By:</b>	Mr. Niraj Regmi, G.I.T. and Mr. Angelo Castillo, of Thurber

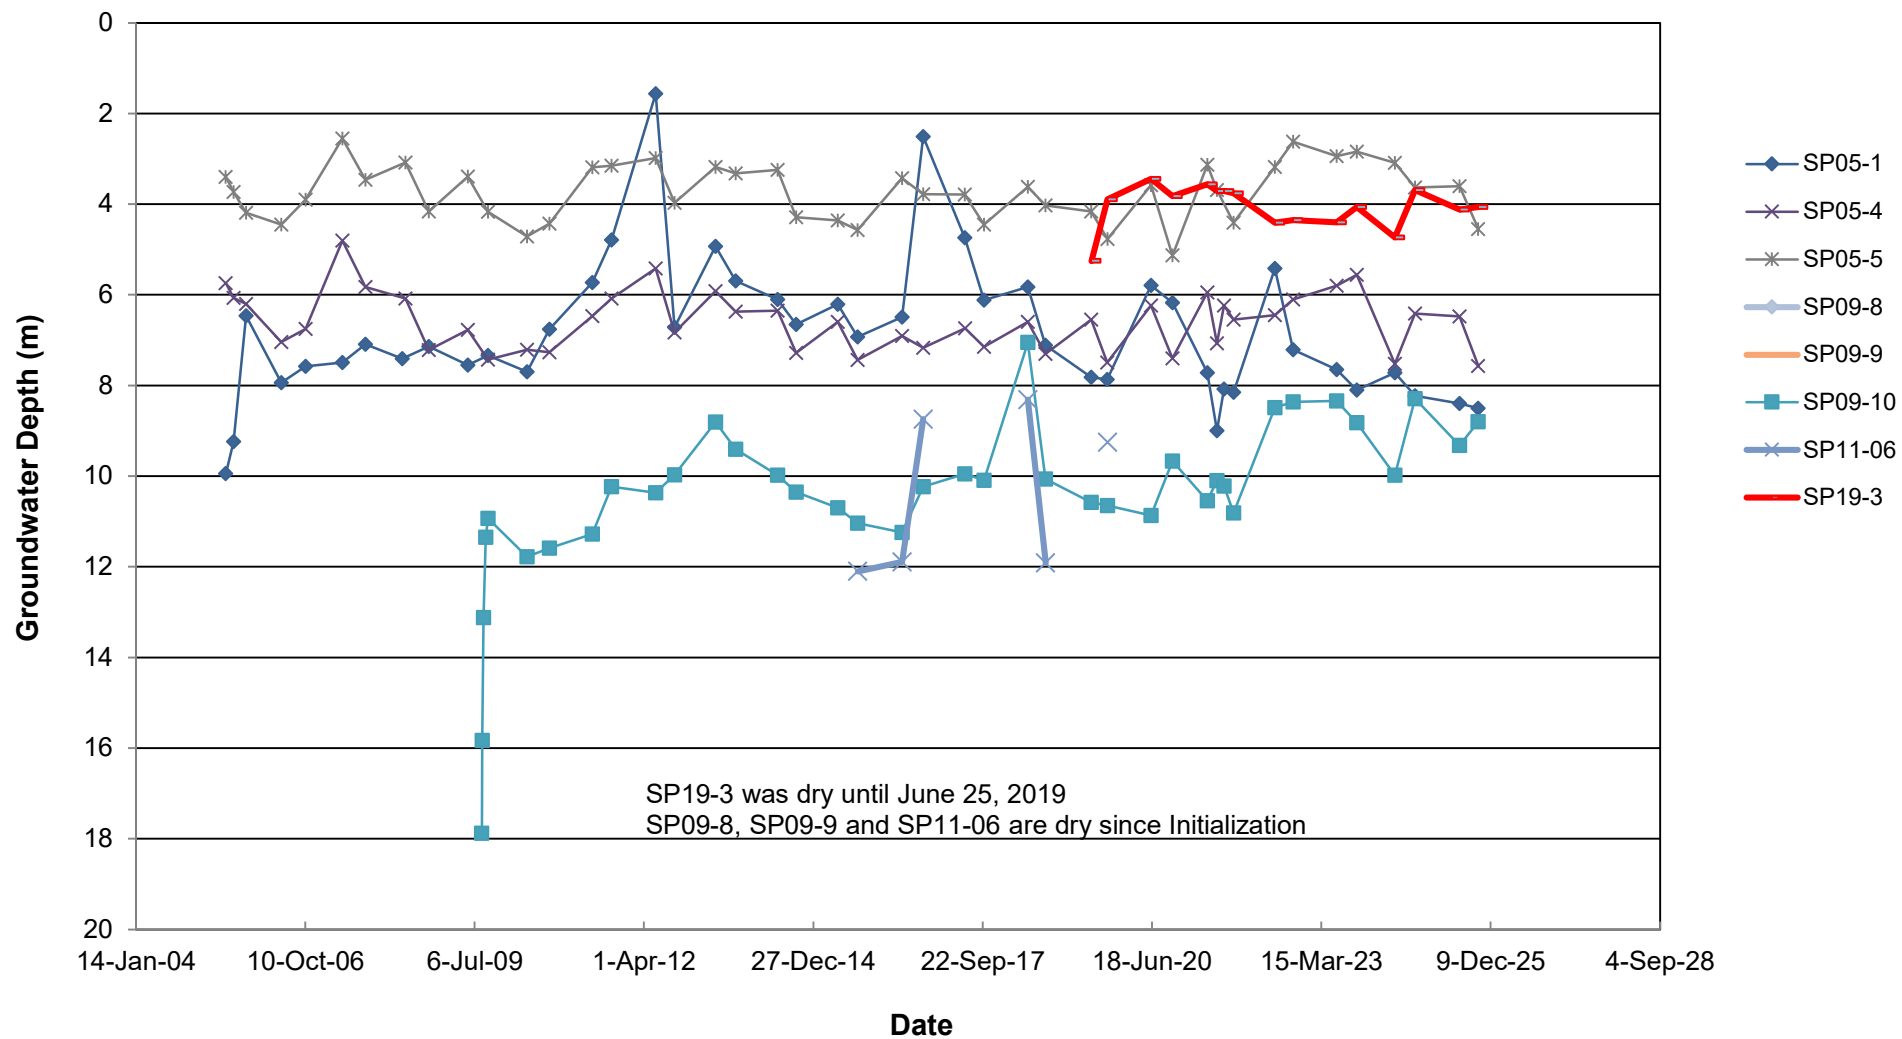
**FIGURE PH009-12  
HISTORICAL STANDPIPE PIEZOMETER READINGS:  
SHOP SLIDE**

SP19-3 was dry until June 25, 2019  
SP09-8, SP09-9 and SP11-06 are dry since Initialization
