ALBERTA TRANSPORTATION AND  
ECONOMIC CORRIDORS GRMP  
PEACE REGION – (PEACE RIVER DISTRICT)  
INSTRUMENTATION MONITORING - SPRING 2025

Site Number	Location	Name	Hwy	km
SH001	HWY 33:12 C1 9.432	Swan Hills Retaining Wall	33:12	Km 9.4
SH001A	HWY 33:12 C1 10.00			Km 10.0
<b>Legal Description:</b>		<b>UTM Co-ordinates</b>		
7-5-67-9 W5		11U E 607430	N	6070455

<b>Current Monitoring:</b>	20-June-2025	<b>Previous Monitoring</b>	16-May-2024
<b>Instruments Read By:</b>	Mr. Niraj Regmi, G.I.T., and Mr. Godfred Etiendem, Thurber

**SITE SH001/SH001A: HWY 33:12 (SWAN HILLS RETAINING WALL)**

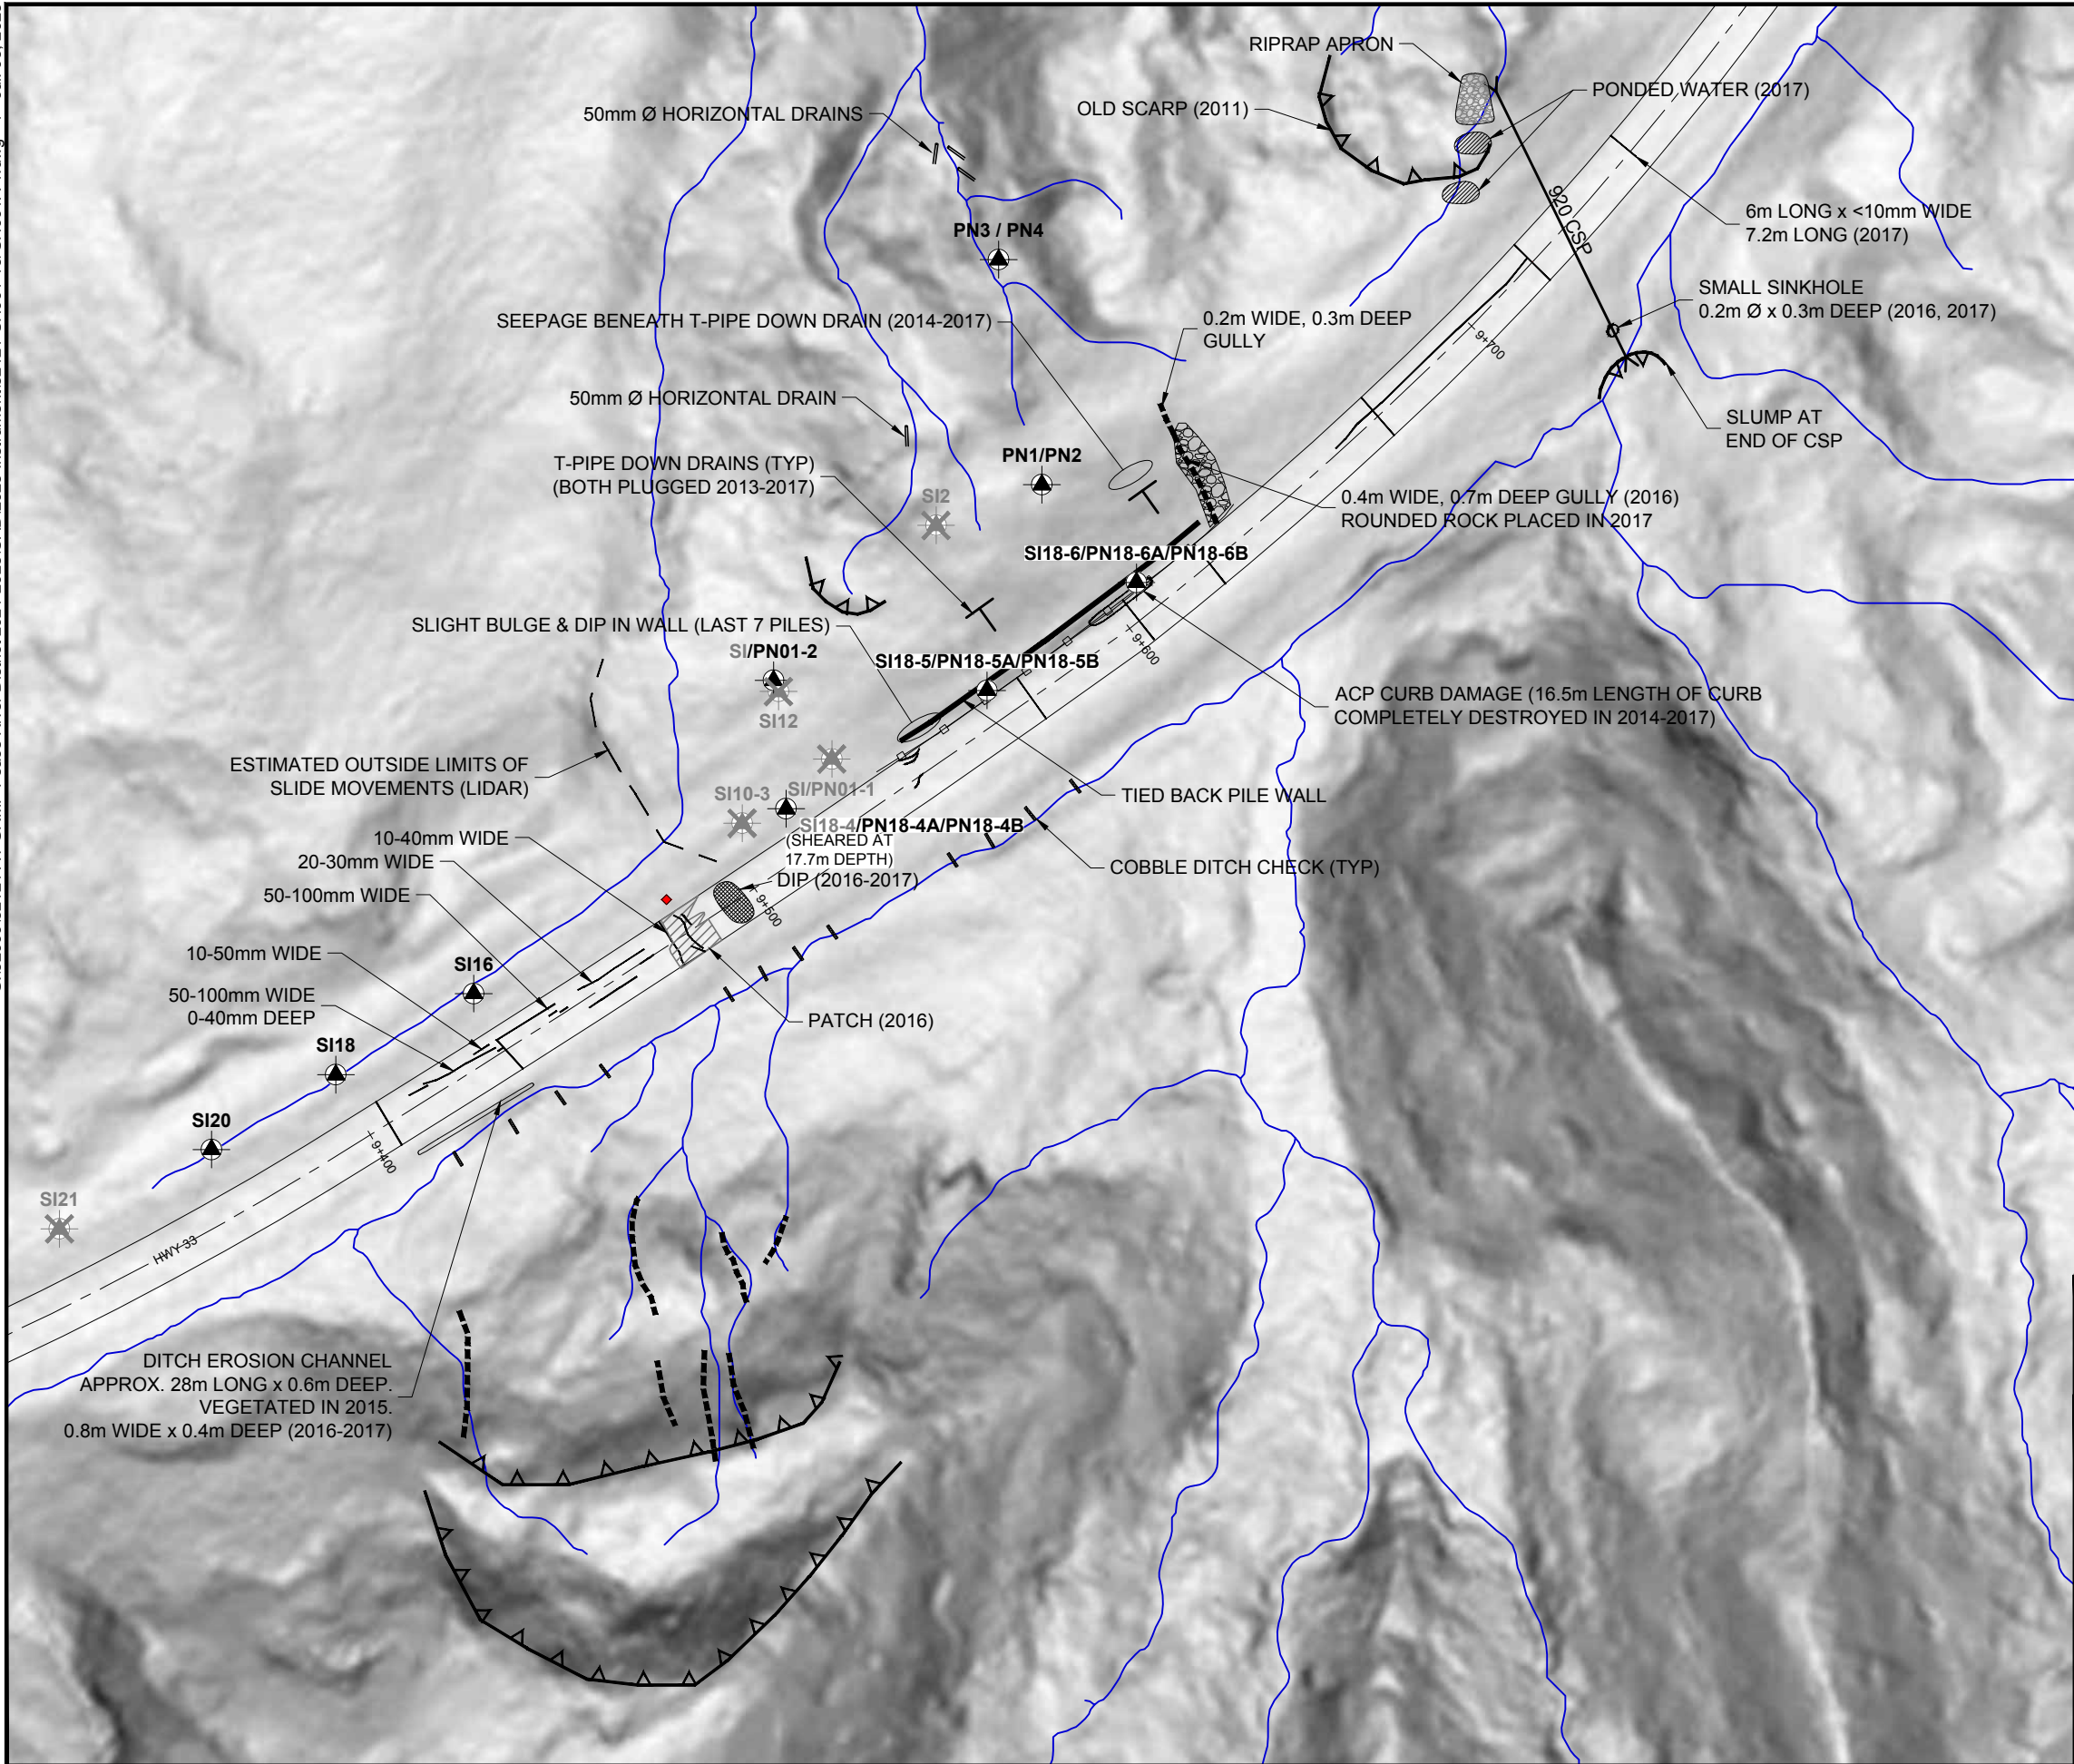
**SI-18 Run down by lawn mower, can be repaired without mechanical excavation
** Presuure keeps climbing , 300kpa and up doesn't stabilize.
*** Possibly damaged
**** Took reading twice

<b>Future Work:</b>	The instruments should be read again in the spring of 2026.
<b>Instrumentation Repairs:</b>	We recommend that repairs to slope indicator SI-18 be undertaken during the spring 2026 readings.
<b>Additional Comments:</b>	The groundwater levels at SH001A are very high. The site should be inspected for signs of seepage and increased slope deformation and pavement cracking.
