**ALBERTA TRANSPORTATION  
GEOHAZARD ASSESSMENT  
PEACE REGION (PEACE RIVER DISTRICT)  
2022 INSPECTION**

Site Number	Location	Name	Hwy	km
PH044-1 (A) PH044-2 (B)	North of Manning, AB	Meikle River Slides A and B	35:08	26.14 25.82
Legal Description		UTM Co-ordinates		
Slide A: SW7-94-22-W5M		11U E 467,665	N	6,333,024

<b>Primary Site Issue:</b>	Sideslope slumping of high embankment into oxbow of the Meikle River.	
<b>Dimensions:</b>	Slide A: 34 m length of highway, 18 m high embankment Slide B: 65 m length of highway, 24 m high embankment	
<b>Date of Remediation:</b>	1993, Slide B: Pile wall installed	
<b>Maintenance:</b>	2008: spray-patch of cracks. 2016: Overlay and chip seal of Highway 35 including these sites. High tension steel cable barrier (HTSC) installed. 2019: HTSC replaced with W-Beam guardrail	
<b>Observations (Slide A):</b>	<b>Description</b>	<b>Worsened?</b>
<input checked="" type="checkbox"/> Pavement Distress	No distress observed since overlay in 2016.	<input type="checkbox"/>
<input checked="" type="checkbox"/> Slope Movement	Continued retrogressive movement. The backscarp is 5.8 m from the highway; the landslide mass continues to expand, move, and break up.	<input

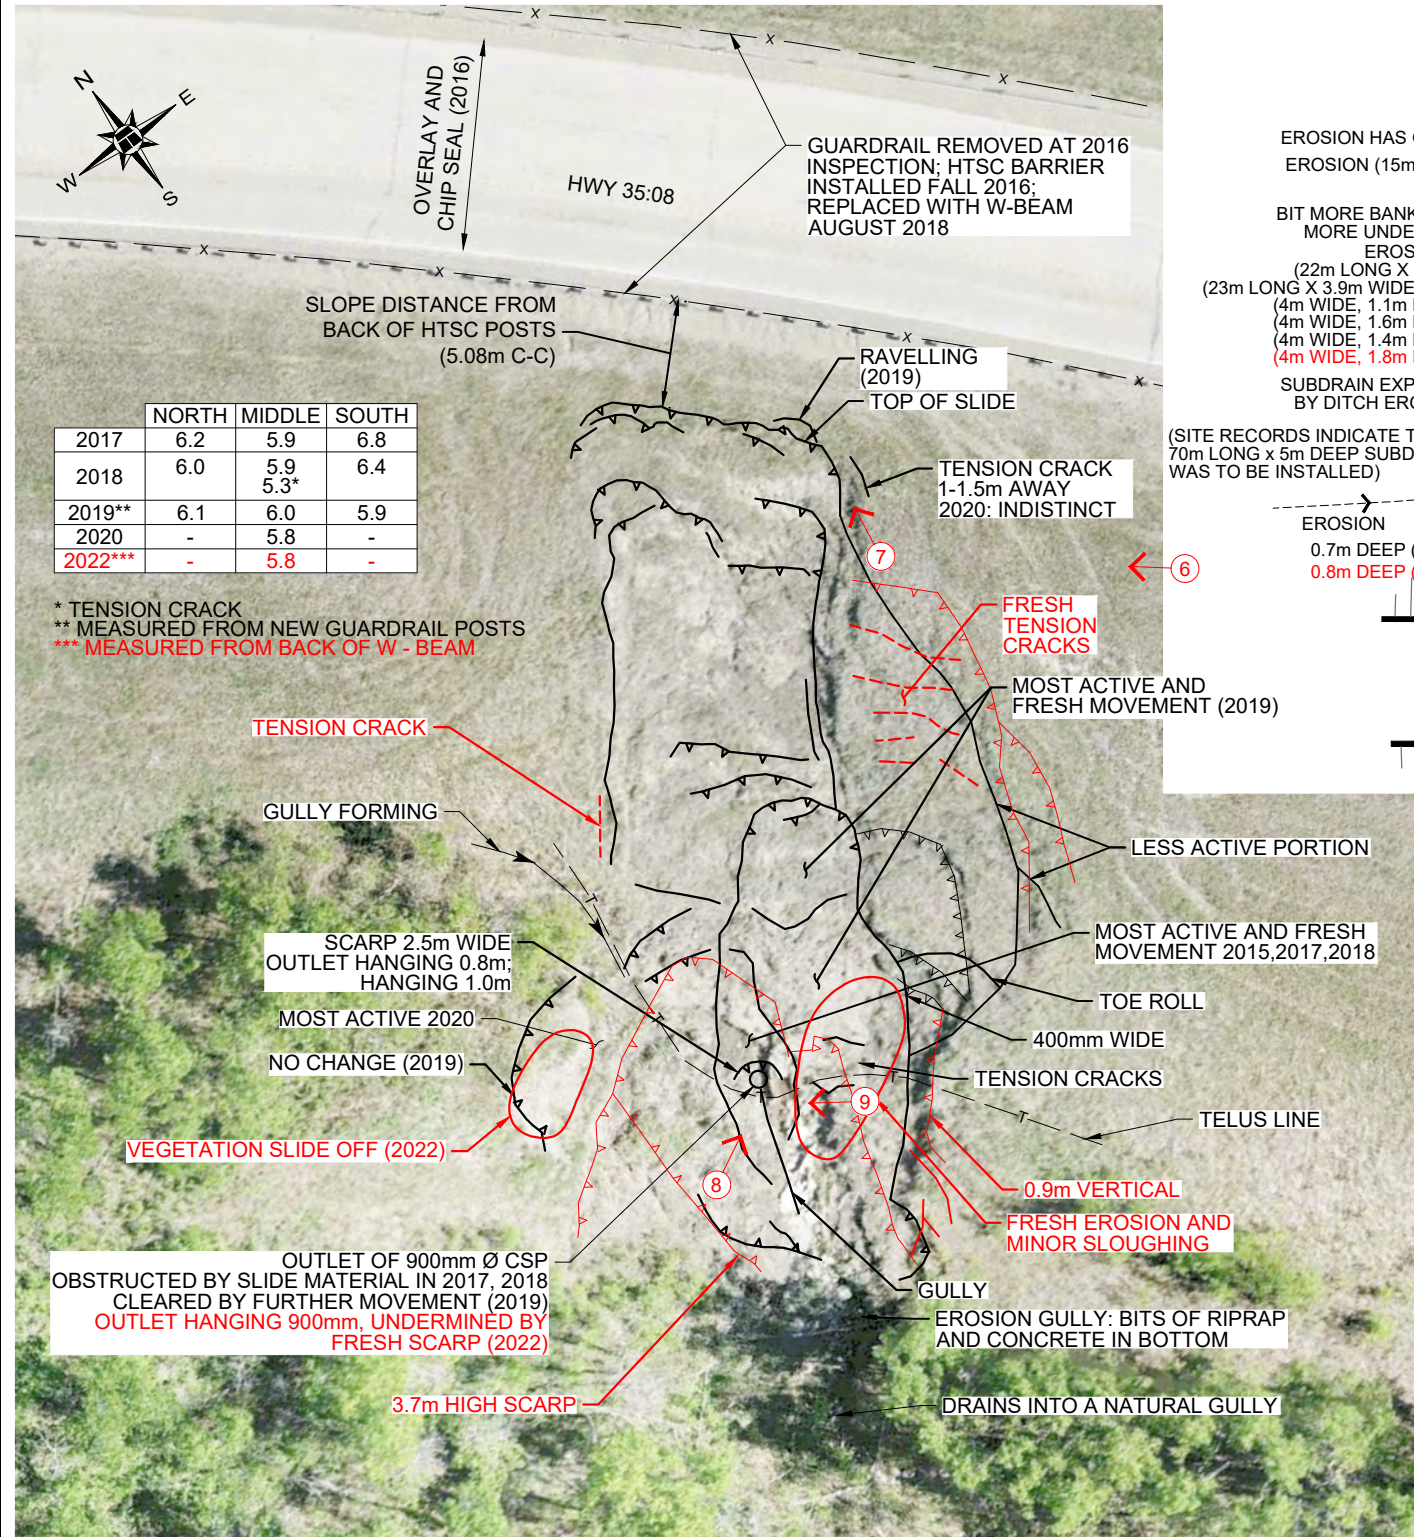
**SITE PLAN AT CULVERT OUTLET**

NORTH	MIDDLE	SOUTH
2017	6.2	5.9	6.8
2018	6.0	5.9 5.3*	6.4
2019**	6.1	6.0	5.9
2020	-	5.8	-
2022***	-	5.8	-

\* TENSION CRACK  
 \*\* MEASURED FROM NEW GUARDRAIL POSTS  
 \*\*\* MEASURED FROM BACK OF W - BEAM

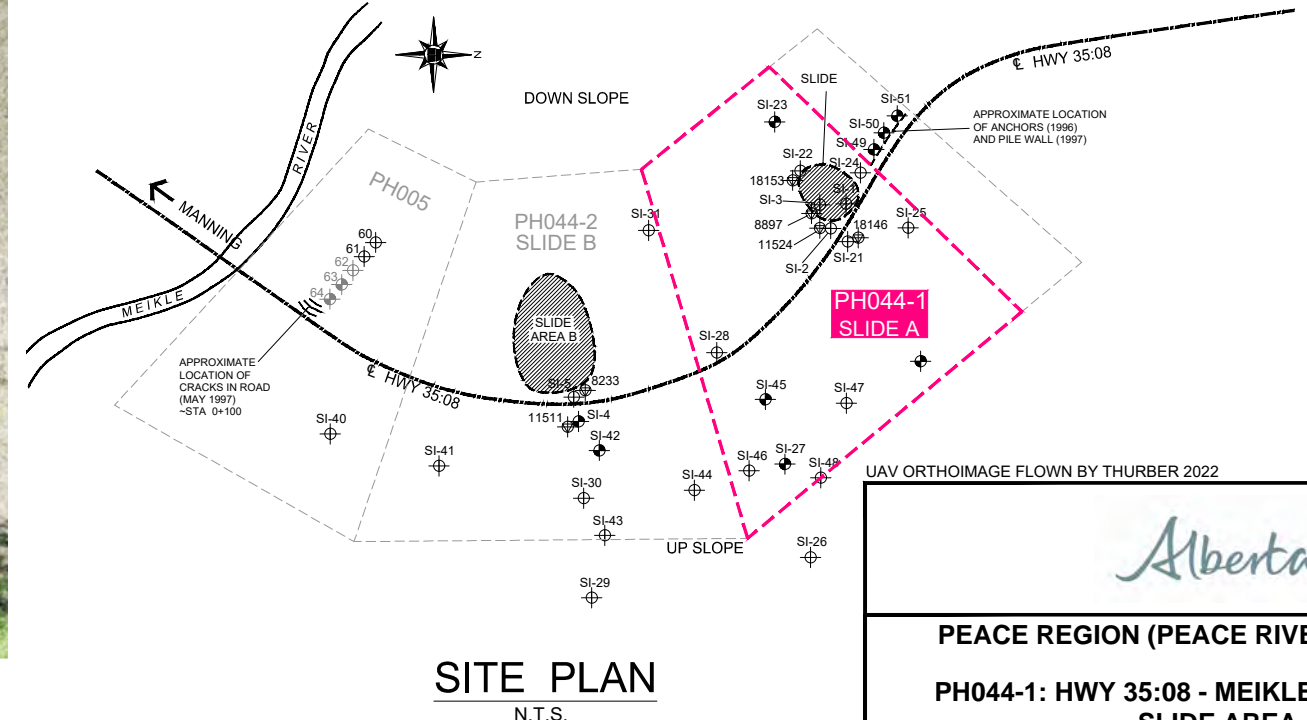
**SITE PLAN**

- NOTES**
1. BASE PLAN COPIED FROM GAEA ENGINEERING DRAWING DATED MAY 1997
  2. SI's 40-48 INSTALLED JULY 1996
  3. SI's 49-51 INSTALLED DEC. 1997
  4. FEATURE LOCATIONS ARE APPROXIMATE.
  5. PREVIOUS OBSERVATIONS SHOWN IN BLACK AND RESET IN 2018
  6. JUNE 2022 OBSERVATIONS SHOWN IN RED
