GEOHAZARD ASSESSMENT PROGRAM

PEACE RIVER / HIGH LEVEL AREA

2011 CALLOUT INSPECTION

Site Number	Location	Name	Hwy	km
PH45	North of Manning, AB	Meikle River (Pile Wall)	35:08	Approx. 27.5
Legal Description		UTM Co-ordinates		
SW1/4 7-94-22-5		11V N 6333081	E 467581

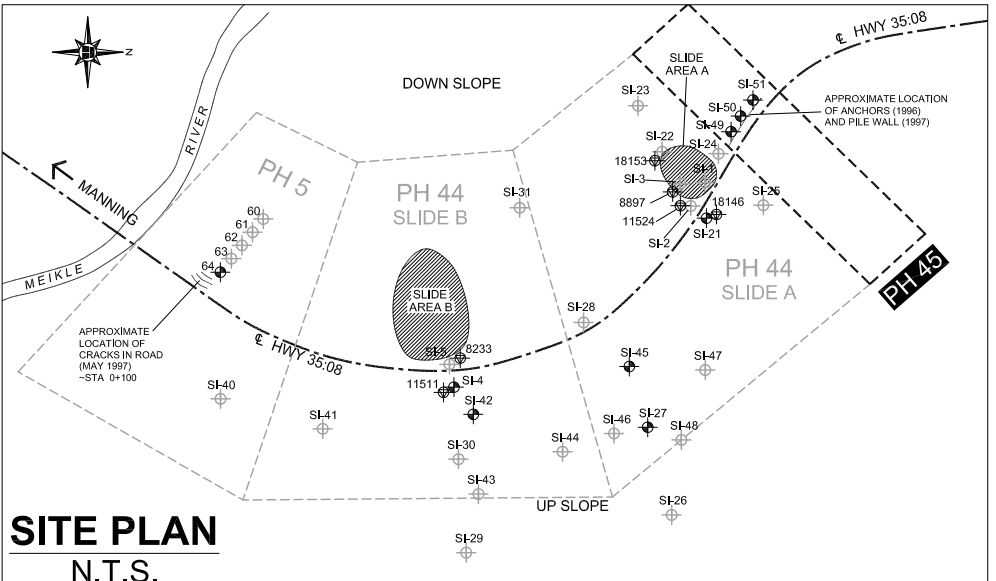
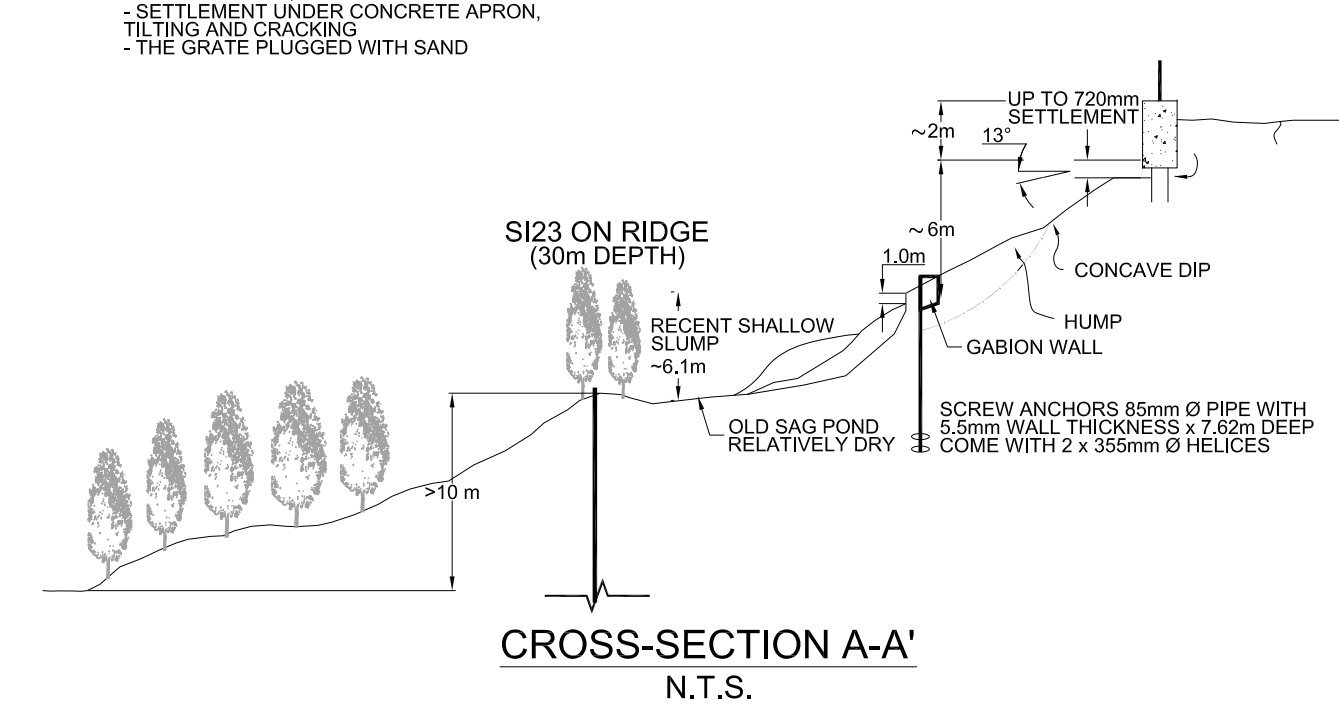
SITE PLAN
N.T.S.

SOIL SETTLEMENT UNDERNEATH PILE CAP		
POINT OF MEASUREMENT	2010 SETTLEMENT (mm)	2011 SETTLEMENT (mm)
SI-49	210	230
SI-50	660	230
12m SOUTHEAST OF SI-50	720 (MAXIMUM RECORDED)	670
SI-51	NONE	NONE
