July 26, 2022

**ALBERTA TRANSPORTATION GRMP (CON0022164)
PEACE REGION (PEACE RIVER DISTRICT)
INSTRUMENTATION MONITORING RESULTS – SPRING 2022**

SITE PH045: HWY 35:08, MEIKLE RIVER (km 26.2 PILE WALL)

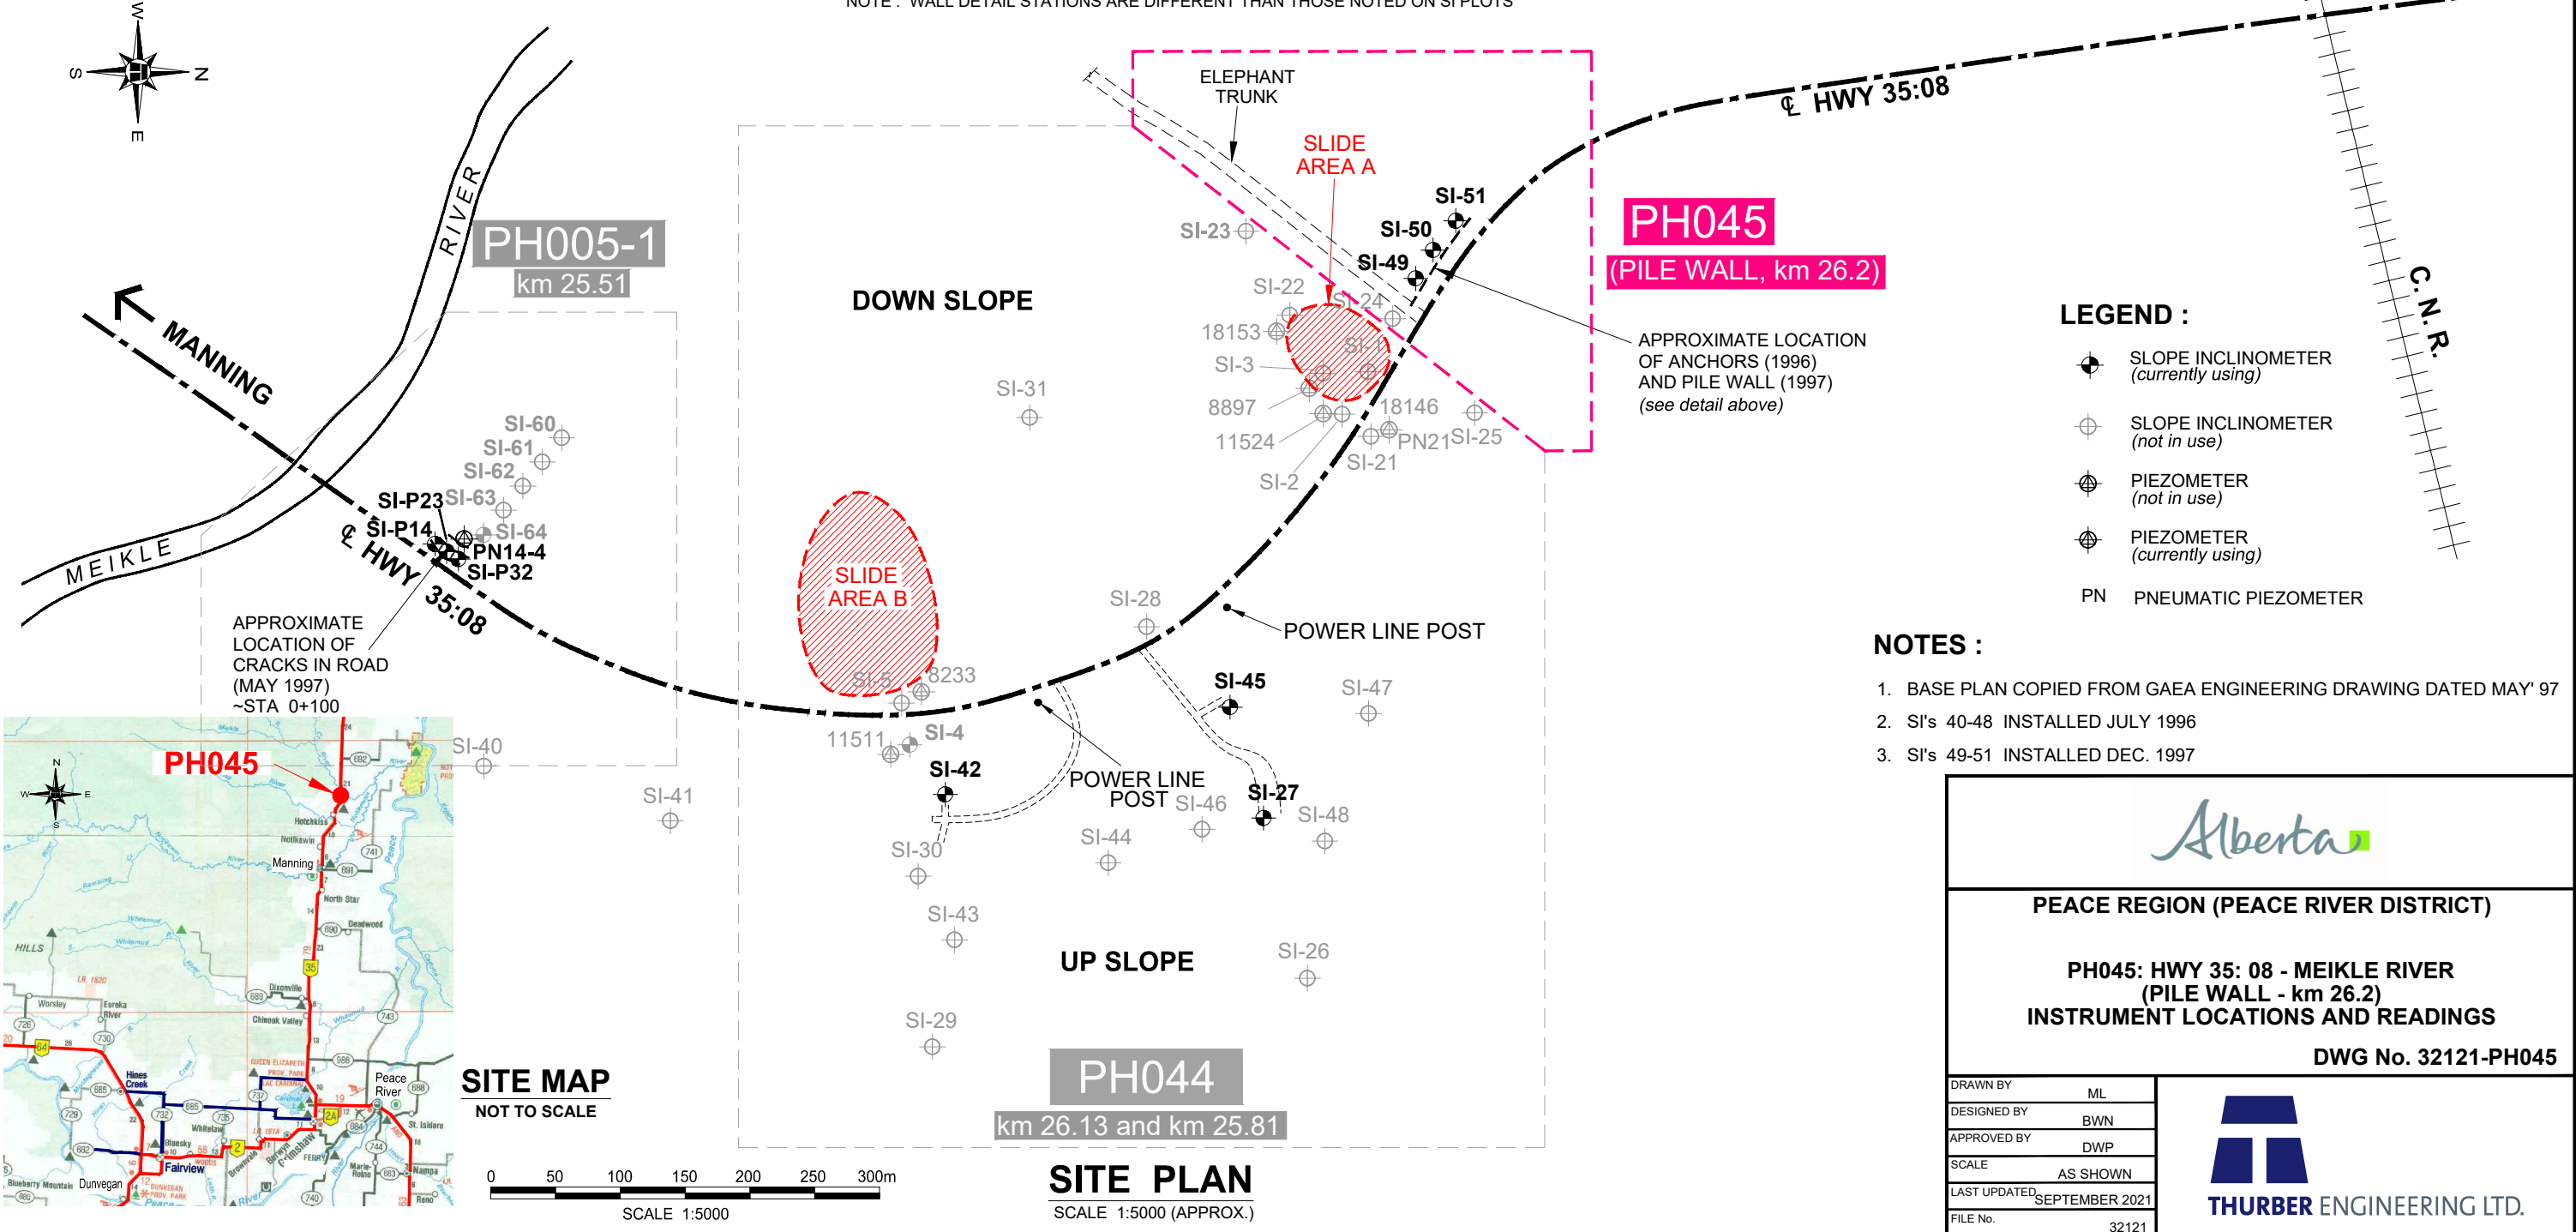
* SI-51 probe comes to surface not in grooves, may be damaged at 2 feet depth. Top of casing damaged
** SI-50 - top of SI slightly damaged
