**GEOHAZARD ASSESSMENT PROGRAM**

**PEACE RIVER / HIGH LEVEL AREA**

**2011 CALL OUT INSPECTION**

Site Number	Location	Name	Hwy	km
PH5	North of Manning, AB	Meikle River (0+100)	35:08	Approx. 28
Legal Description		UTM Co-ordinates		
SW 7-94-22-5		11V N 6333992	E 467077

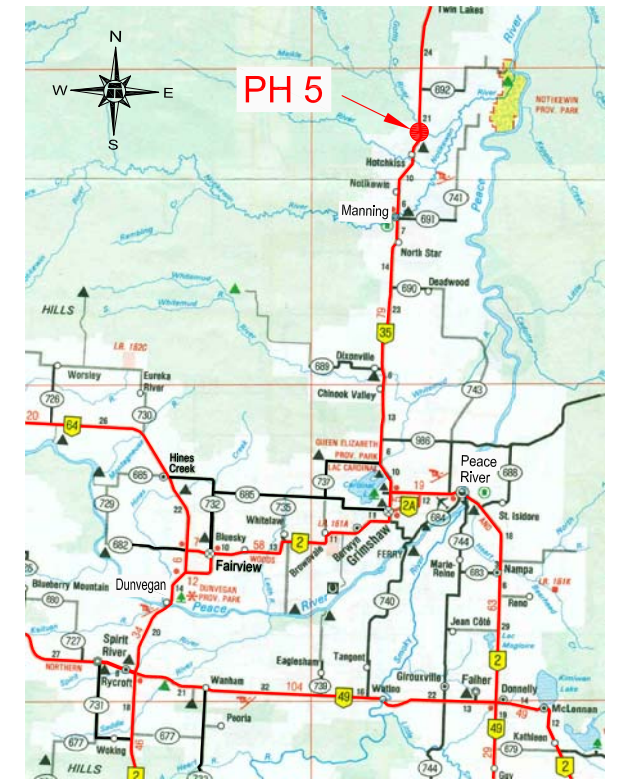
**SITE MAP**  
NOT TO SCALE

**Assessment (Refer to Figure PH5-1):**  
 A slope failure occurred prior to 1998 further downslope, which left a backscarp about 3 m in height. Continued slide movements have occurred in the area behind the backscarp. The movements have extended into the highway pavement.

Fresh cracks of up to 70 mm deep and 50 mm wide appeared at the asphalt patch as a result of heavy precipitation on July 27, 2011. The 200 mm deflection in the guard rail and increased cracking indicates that the rate of movement increased.

- It is recommended to install a driven steel pile wall along the shoulder of the highway for a longitudinal length of about 60 m. The inferred slip surface is expected to be 2.5 to 3 m deep. Based on the similar projects the wall could cost in the order of \$400 - \$500 thousand dollars.
