**ALBERTA TRANSPORTATION  
GEOHAZARD ASSESSMENT PROGRAM  
PEACE REGION – HIGH LEVEL  
2017 INSPECTION**

Site Number	Location	Name	Hwy	km
PH005-1	North of Manning, AB	Meikle River (km 25.21)	35:08	25.51
Legal Description		UTM Co-ordinates		
SW7-94-22-W5M		11U E 467,717	N	6,332,466

**PH005-1: HWY 35:08 (km 25.5) - MEIKLE RIVER SLIDE GEOHAZARD ASSESSMENTS**

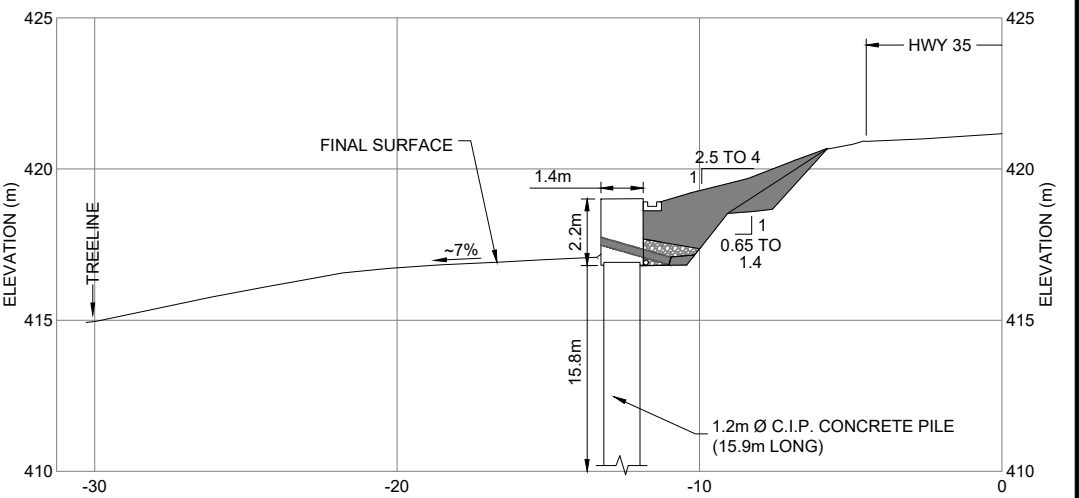
**CROSS-SECTION A-A'**  
SCALE 1:250

CRACK PATTERN NOT VISIBLE THROUGH OVERLAY (2017)

SPLASH PAD  
NO EROSION OBSERVED (2017)

HIGHWAY OVERLAID AND CHIPSEALED IN 2016
