**ALBERTA TRANSPORTATION
GEOHAZARD ASSESSMENT PROGRAM
PEACE REGION – PEACE-HIGH LEVEL
2017 CALL OUT**

Site Number	Location	Name	Hwy	km
	Shafstbury Trail	Shafstbury Trail North Slides	684:02	28.4
Legal Description		UTM Co-ordinates		
NW¼ 19-083-021 W5M		11U E 481381	N 6230300

Date	PF	CF	Total
Previous Inspection:				
Current Inspection:	6-June-2017	11	4	44
Road AADT:	1670		Year:	2016
Inspected By:	Rocky Wang, TRANS Ed Szmata, TRANS		Don Proudfoot, Thurber Shawn Russell, Thurber	
Report Attachments:	<input checked="" type="checkbox"/> Photographs <input checked="" type="checkbox"/> Plans <input checked="" type="checkbox"/> Maintenance Items

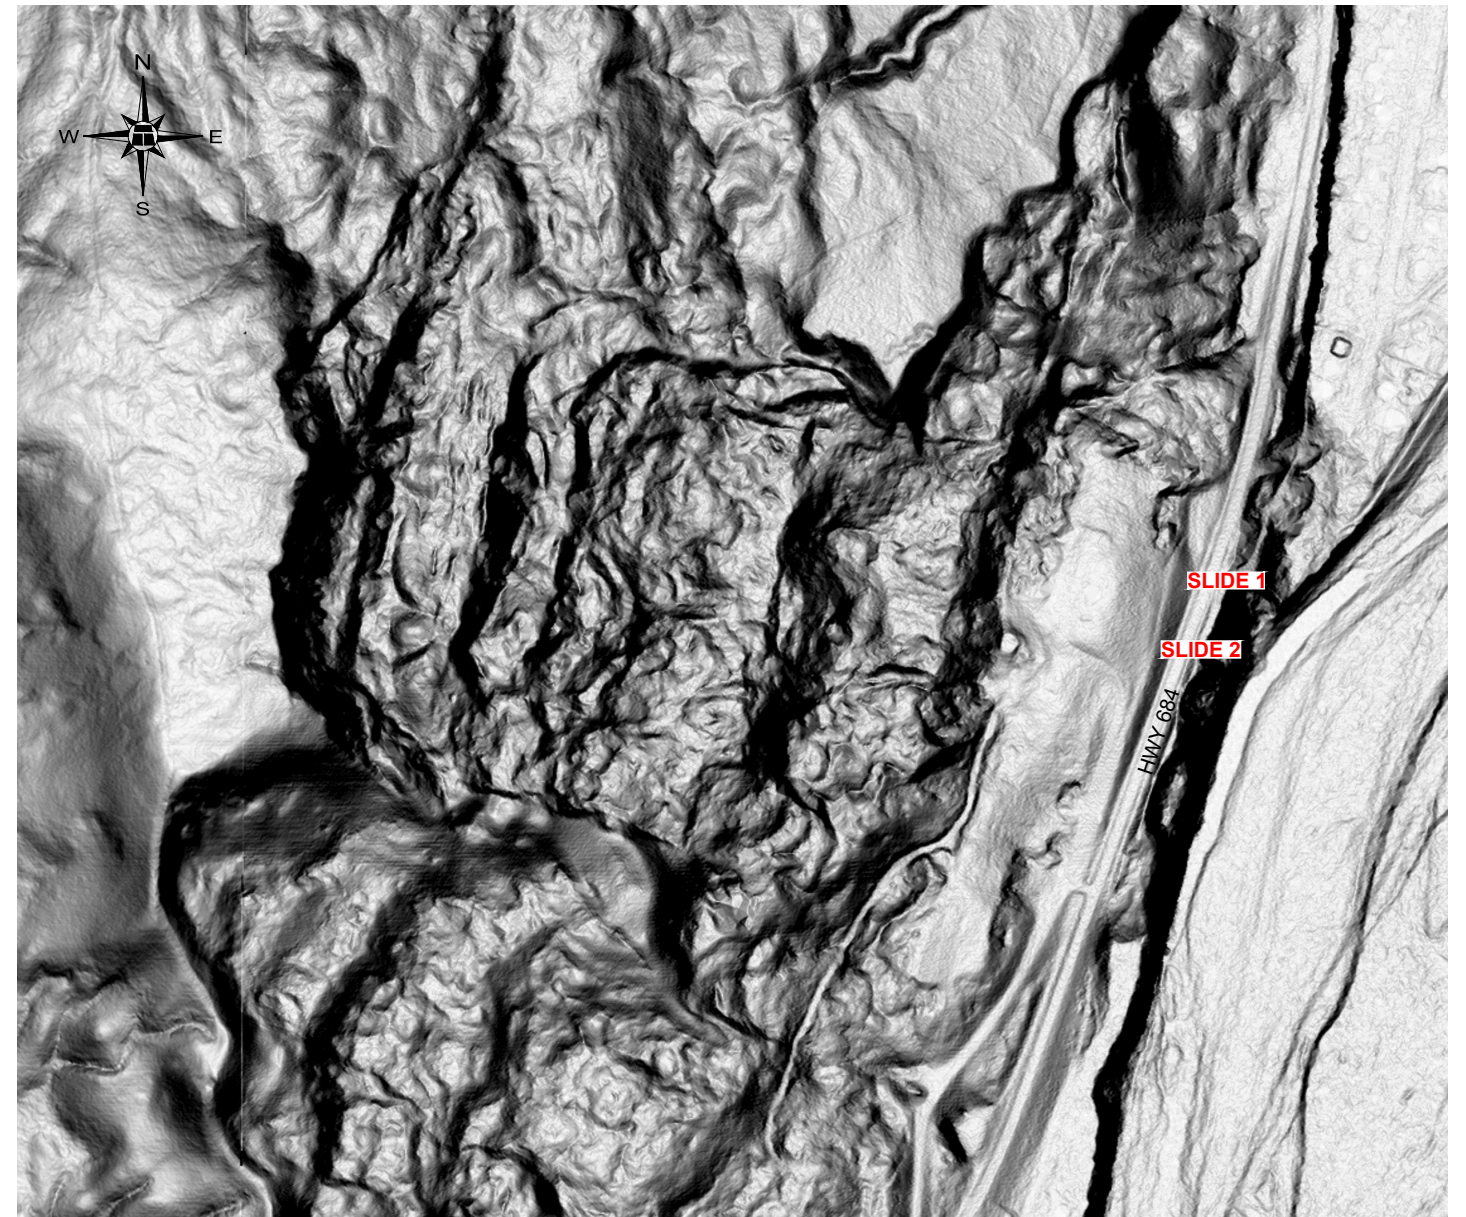
SITE LOCATION PLAN
SCALE 1:6000

Primary Site Issue:	<p>Two landslide features are developing to the east of Hwy 684:02 in the crest of the steep high riverbank slope above an arm in the Peace River. The backscarps have sharp 3 m drop offs and are retrogressing towards the highway to the west and are now encroaching into the highway right-of-way (Photos 1, 2 and 8).</p> <p>Both landslides have failed down to the sandy till ledge which is about 5 m below the existing ground surface.</p> <p>There is a marked gas utility pipeline at the backscarp of Slide 1.</p>	
Dimensions:	<p>Slide 1 is about 12 m wide, with a 3 m drop off along the backscarp which is about 4.8 m east of the NBL guardrail.</p> <p>Slide 2 is about 14 m wide, with a 3 m drop off along the backscarp which is about 7.5 m east of the NBL guardrail.</p>	
History and Date of any Remediation:	It is not known when the landslides began to occur	
Maintenance:	No maintenance has been recently performed at the sites to date.

<u>Long Term</u>	\$1 Million
Given the proximity of the highway to the steep riverbank slope, and the presence of private residences on the west side of the highway, the most feasible long term remedial solution is likely a pile wall at each location to protect the road from the landslides.
