**ALBERTA TRANSPORTATION AND
ECONOMIC CORRIDORS
GEOHAZARD ASSESSMENT PROGRAM
PEACE REGION (PEACE RIVER DISTRICT)
2025 INSPECTION**

Site Number	Location	Name	Hwy	km
PH081	Shaftesbury Trail	Shaftesbury Trail North Slides	684:02	28.4
Legal Description		UTM Co-ordinates (NAD 83)		
NW¼ 19-083-021 W5M		11U E 481381	N 6230300

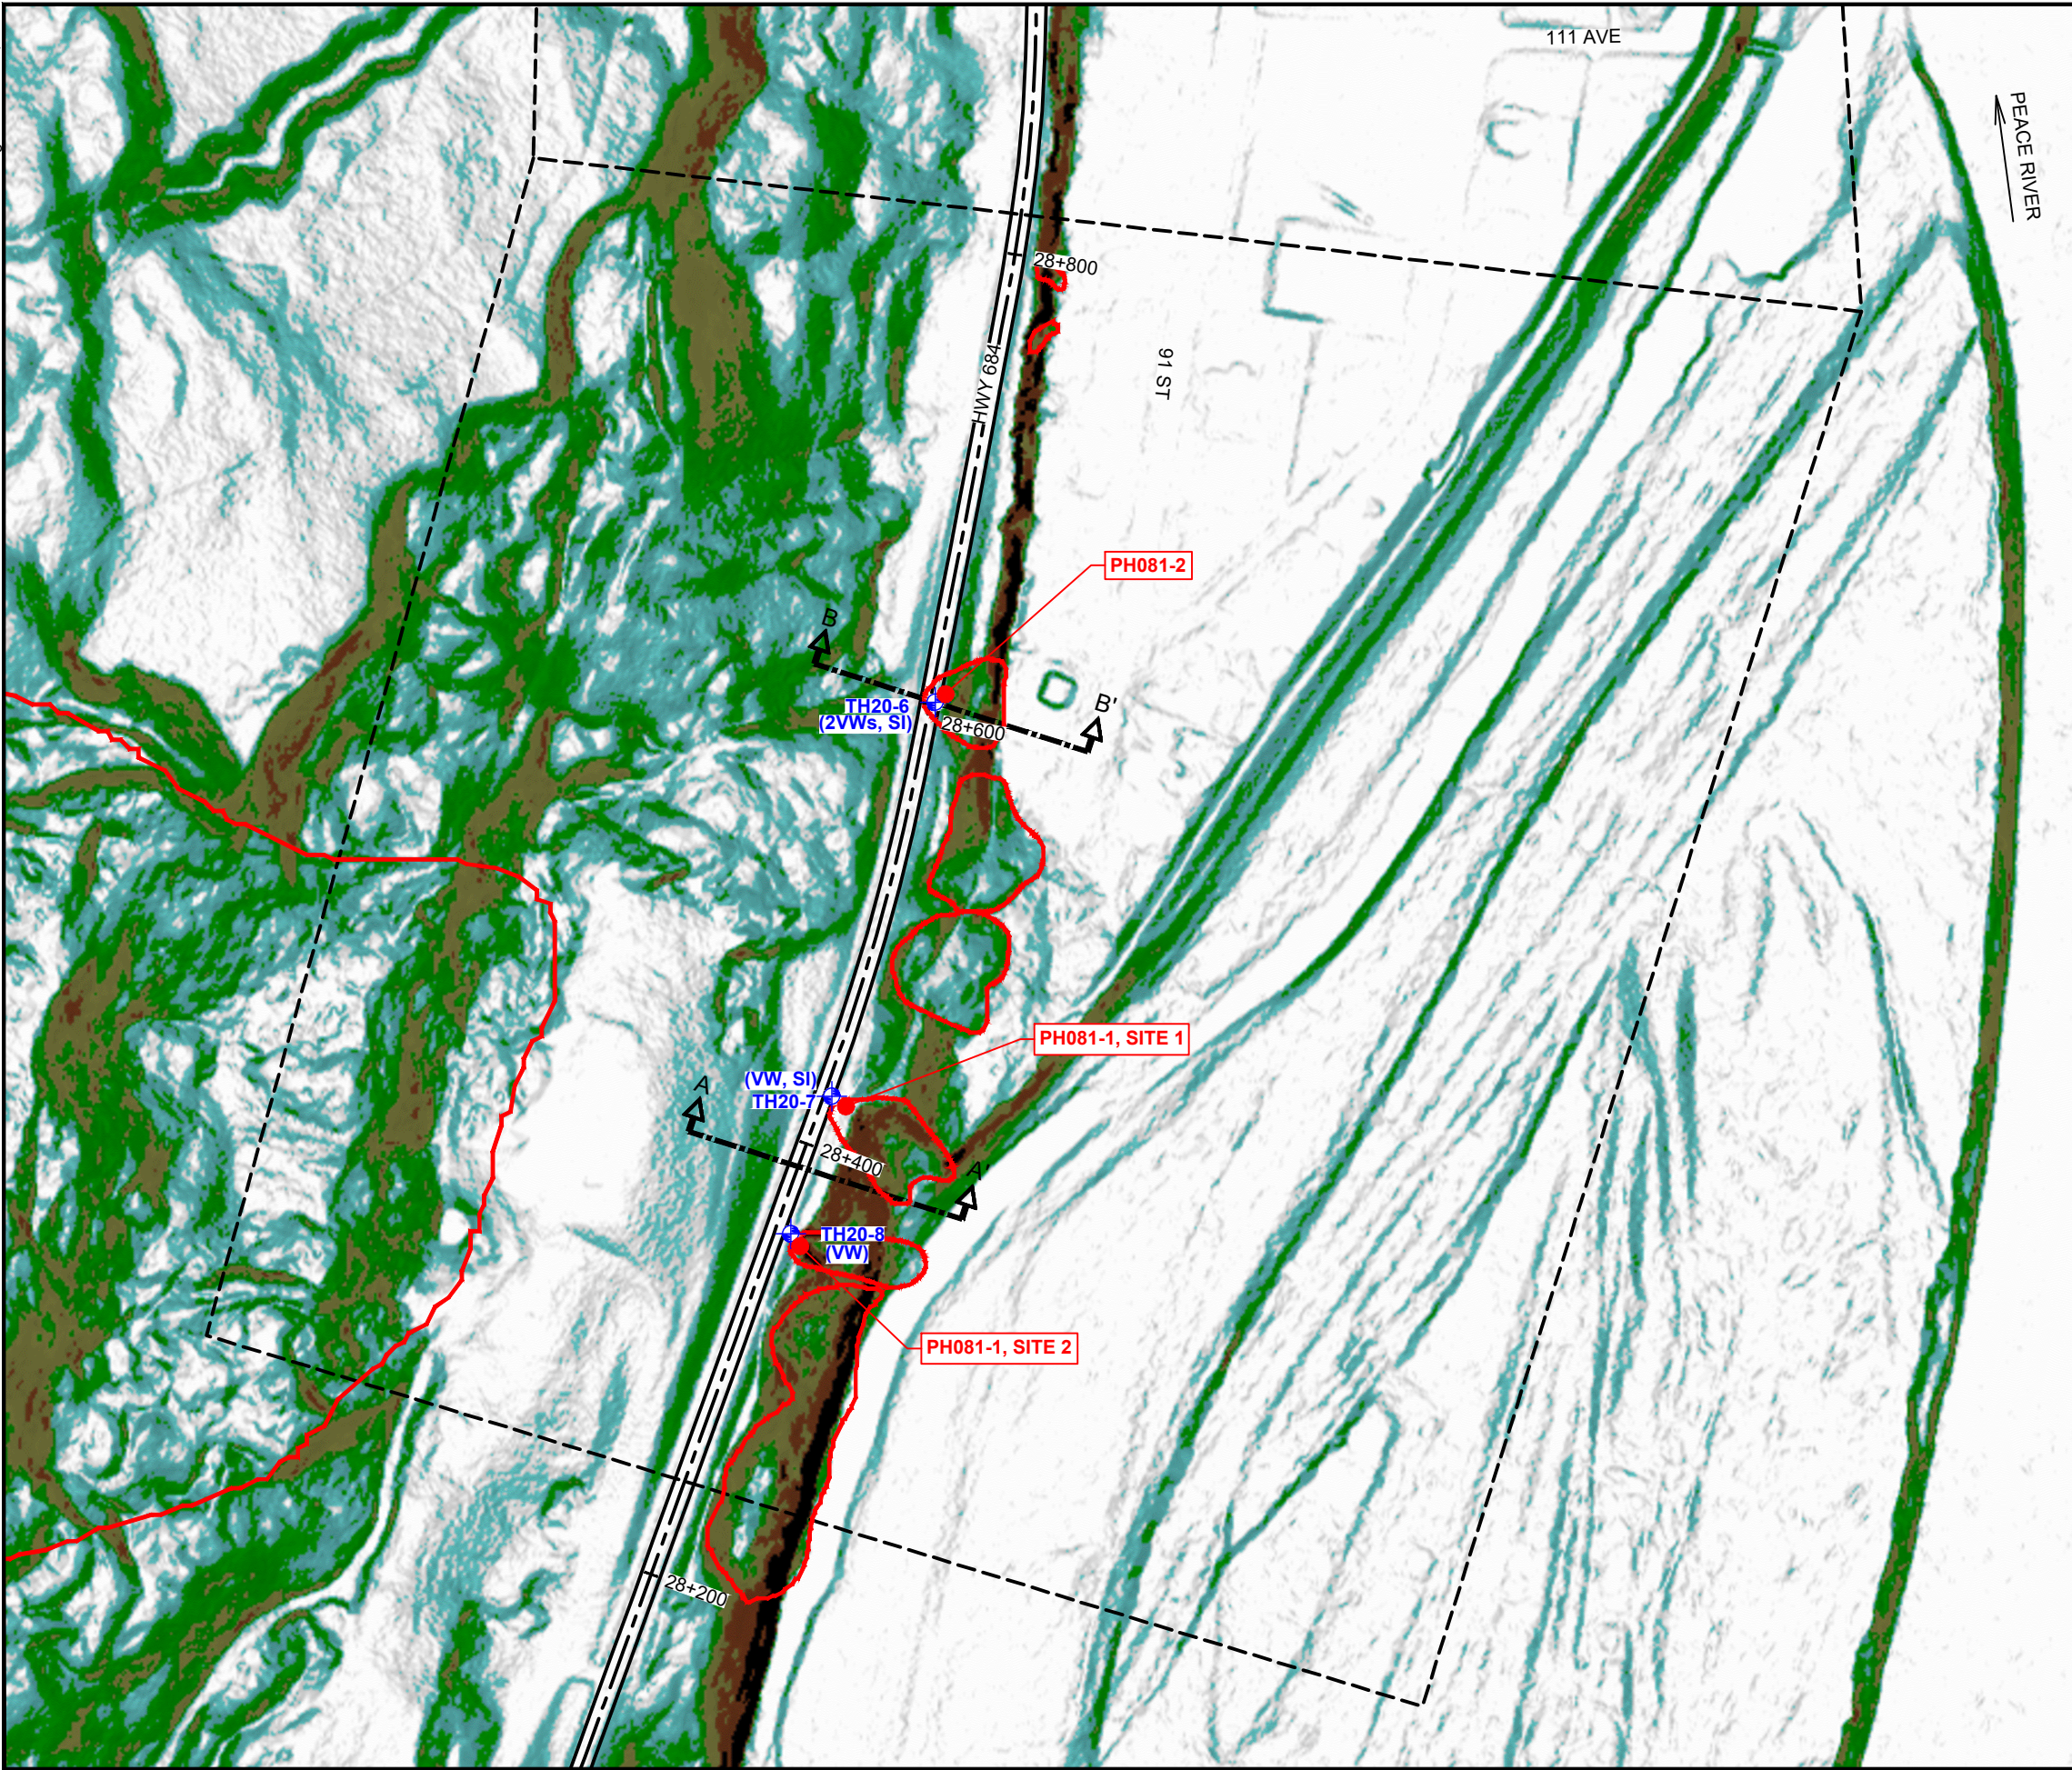
PH081-1: HWY 684:02, KM 28.4
SHAFTESBURY TRAIL NORTH SLIDES -
SLOPE SHADE OVERALL PLAN MAP

It is possible that the landslides are caused by fluctuations in a perched groundwater table that is within the alluvial terrace soils that sit above of the harder/denser soil and bedrock layers, combined with softening and weathering of the very steep riverbank slope. The overburden soils overlie hard bedrock at the north landslide. If a landslide failure occurred at km 28.6, the slide mass could move overtop the steep bedrock face and runout into the backyards of the residences.
