**ALBERTA TRANSPORTATION
GEOHAZARD ASSESSMENT PROGRAM
PEACE REGION – PEACE-HIGH LEVEL
2020 INSPECTION**

THURBER ENGINEERING LTD.

| Site Number | Location | Name | Hwy | km |
|---|---|---|---|---|
| PH009-3 | Peace River | Shaftesbury Trail - Shop Slide | Old 2:02 | 0.025 |

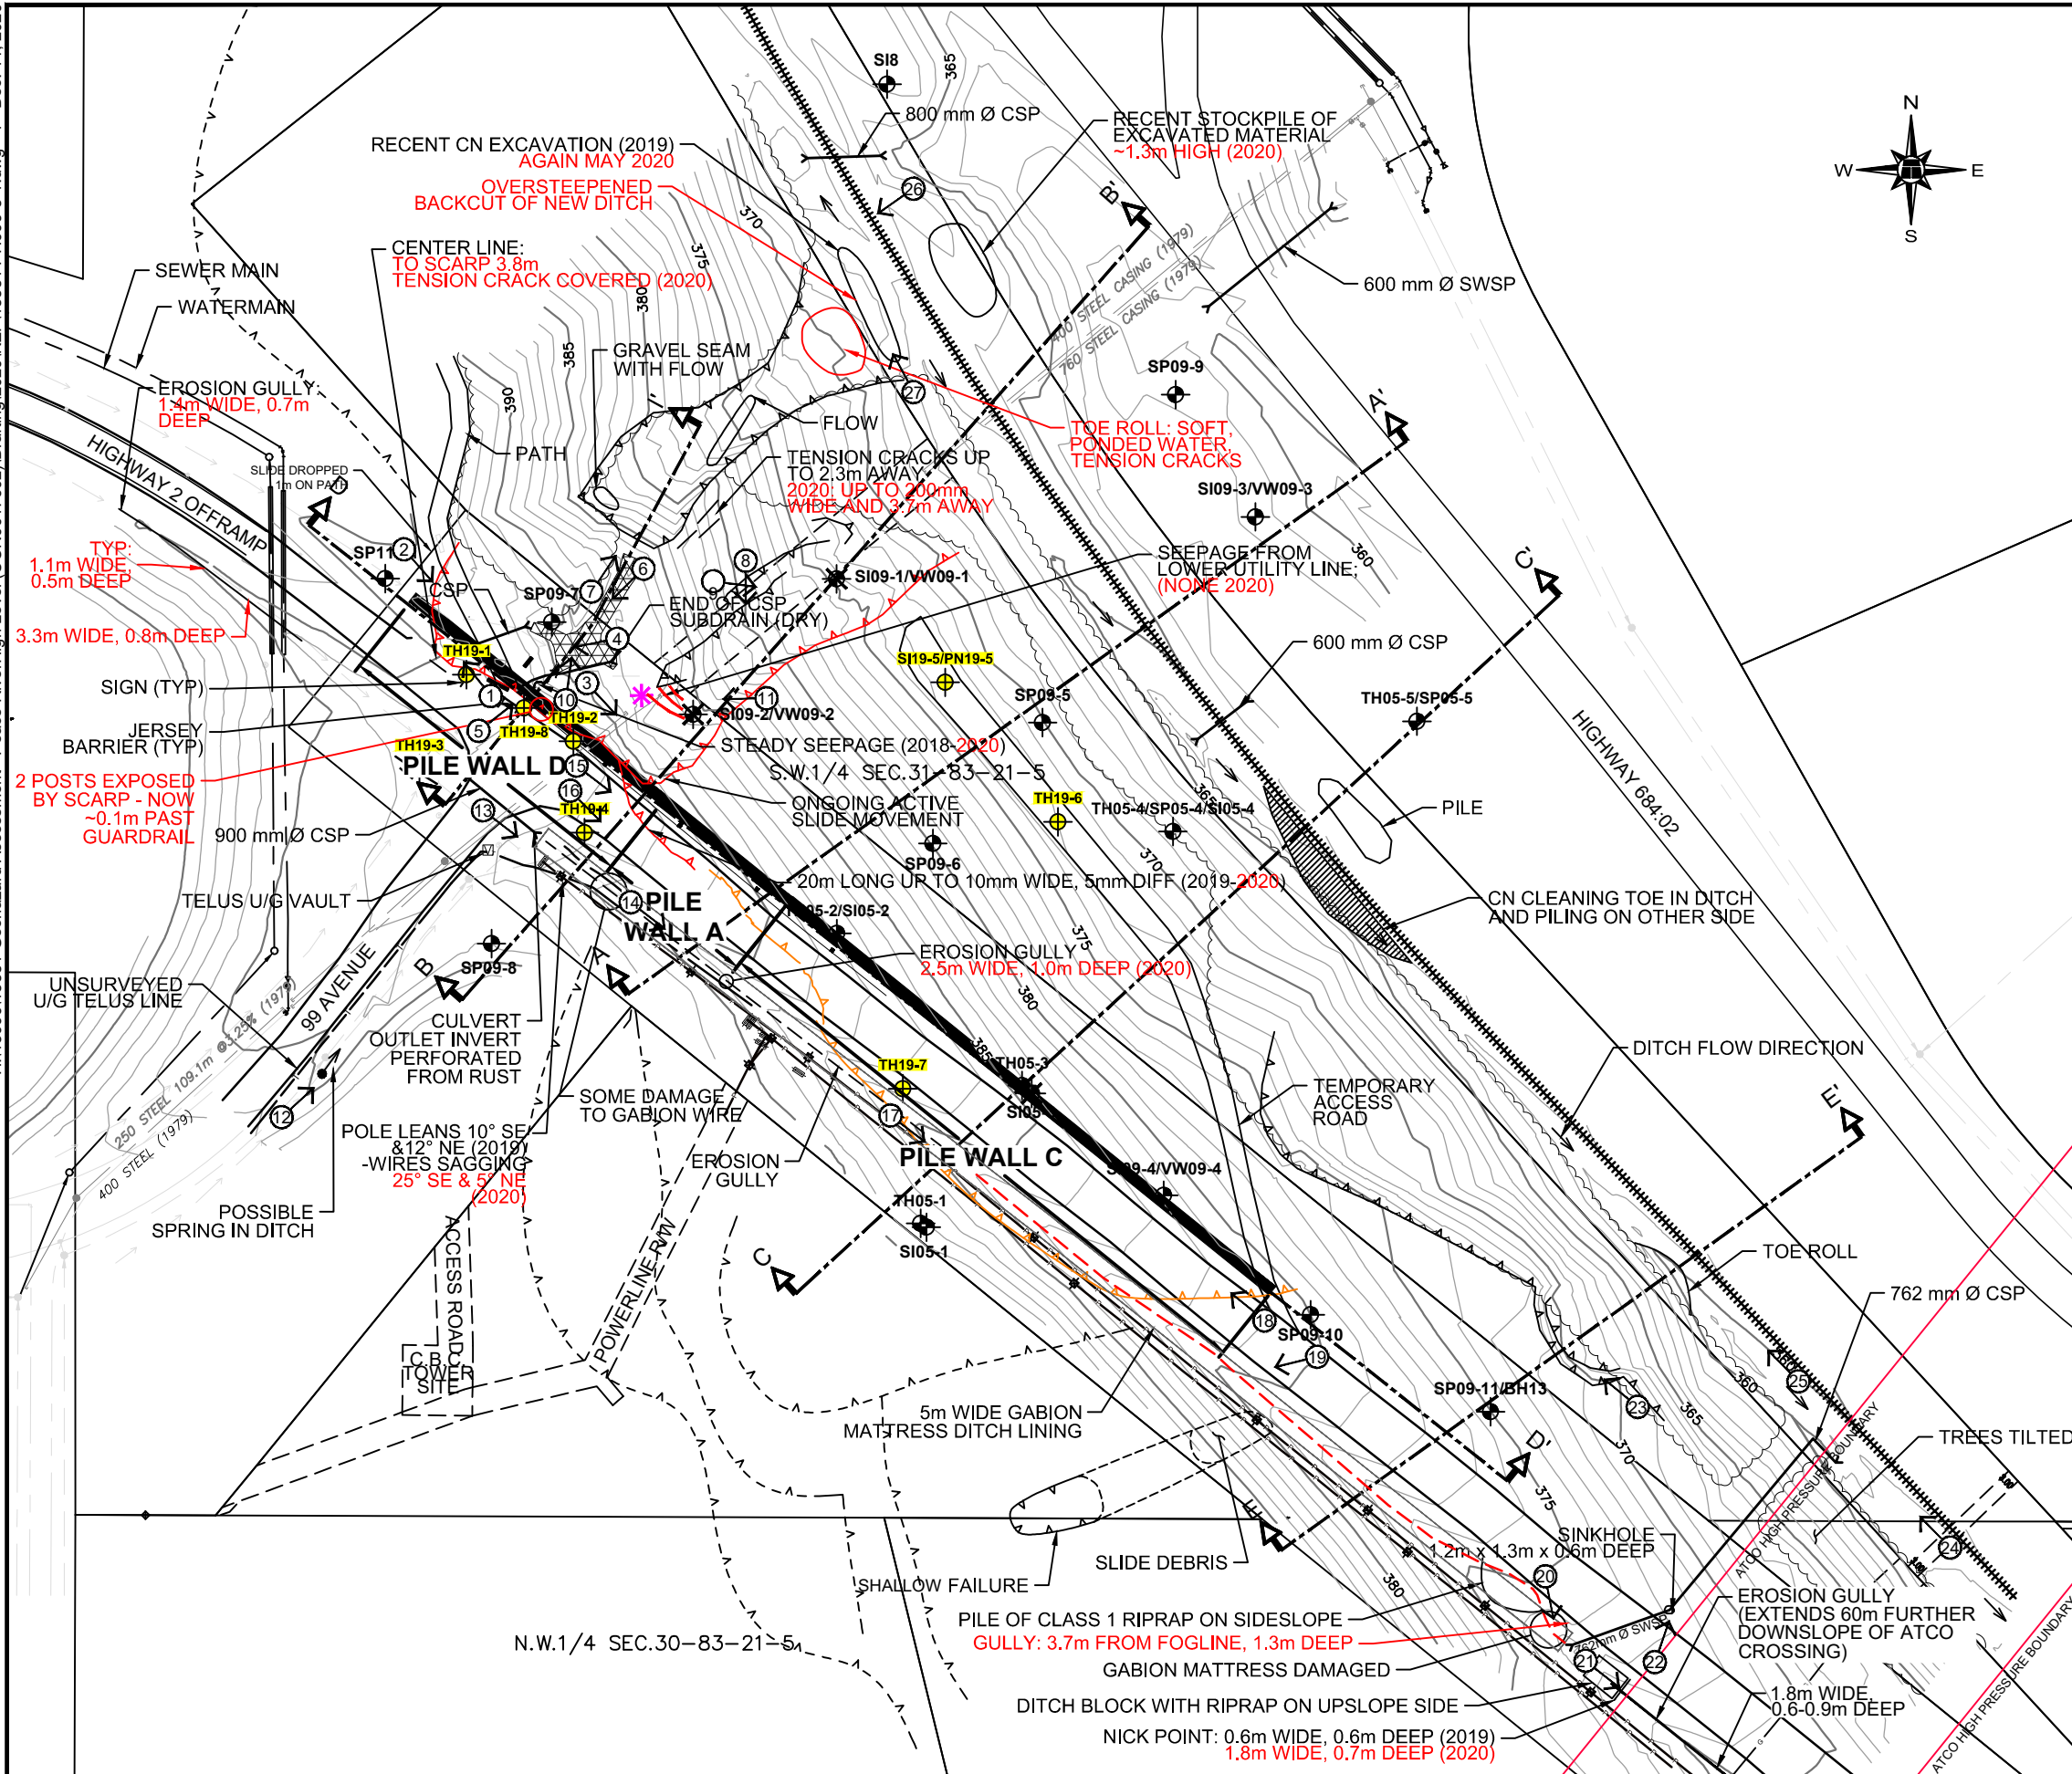
H:\13000\13351 Geohazard Assessment - Peace River/High Level (CON0017602)\Drafting\2020\KEF\13351 PH009-3-1.dwg - 1 - Dec. 14, 2020

As indicated in previous Geohazard inspection reports, this site is characterized by a complex, deep-seated slide movement affecting the hillside above and below the road. The slide bowl above the road appears to be currently inactive, while the lower slide is active. The highest rates of movement appear to be at the NW corner of the lower slide bowl, where the Town of Peace River had to re-grade the slope to protect a sewer and water supply line in 2008 and again in 2013, replaced the pipe rack supports for the water and sewer lines in 2010, and relocated both utility lines further to the north outside the limits of the landslide in 2015/16. The lower slide scarp remains active. The previous semi-active slide scarp has reflected through the recent overlay with a 20 m long crack appearing on the northeast portion of the highway just southeast of the 99 Avenue intersection.

Movement has continued in the area unloaded by the Town at the north end of the slide, as the slope inclinometers have sheared in the area. Cracking and retrogression of slide movement continues upslope of the unloaded area – i.e. the area of the road affected by slide movement is expected to expand to the north in the near future. Water continues to seep onto the slope from gravel seams within the roadway embankment. Although the Town has placed geomembrane sheets to line a channel to contain the water, this only extends about partway down the slope and the scour below the end of the membrane continues to grow, with the flow slide encroaching into CNR's right of way and the resulting debris fan regularly obstructing the west railway line ditch. CNR has been removing the slumped soil from the west ditch and placing it on the east side of the railway trunk which appears to have been done shortly before the 2020 inspection. The active erosion scarp downslope of the end of the membrane is still increasing in size with tension cracks noted along the east flank in 2019.
