**ALBERTA TRANSPORTATION AND
ECONOMIC CORRIDORS GRMP
PEACE REGION – (PEACE RIVER DISTRICT)
INSTRUMENTATION MONITORING - SPRING 2024**

Site Number	Location	Name	Hwy	km
PH009	Hwy 684:02 km 30.99, Town of Peace River	Shaftesbury Trail - Shop Slide	684:02	0.0-0.4
Legal Description:		UTM Co-ordinates		
4-31-83-21 W5		11U E 480321	N	6232126

Current Monitoring:	22-May-2024	Previous Monitoring	10-Oct-2023
Instruments Read By:	Mr. Niraj Regmi, G.I.T., and Mr. Nixson Mationg, of Thurber

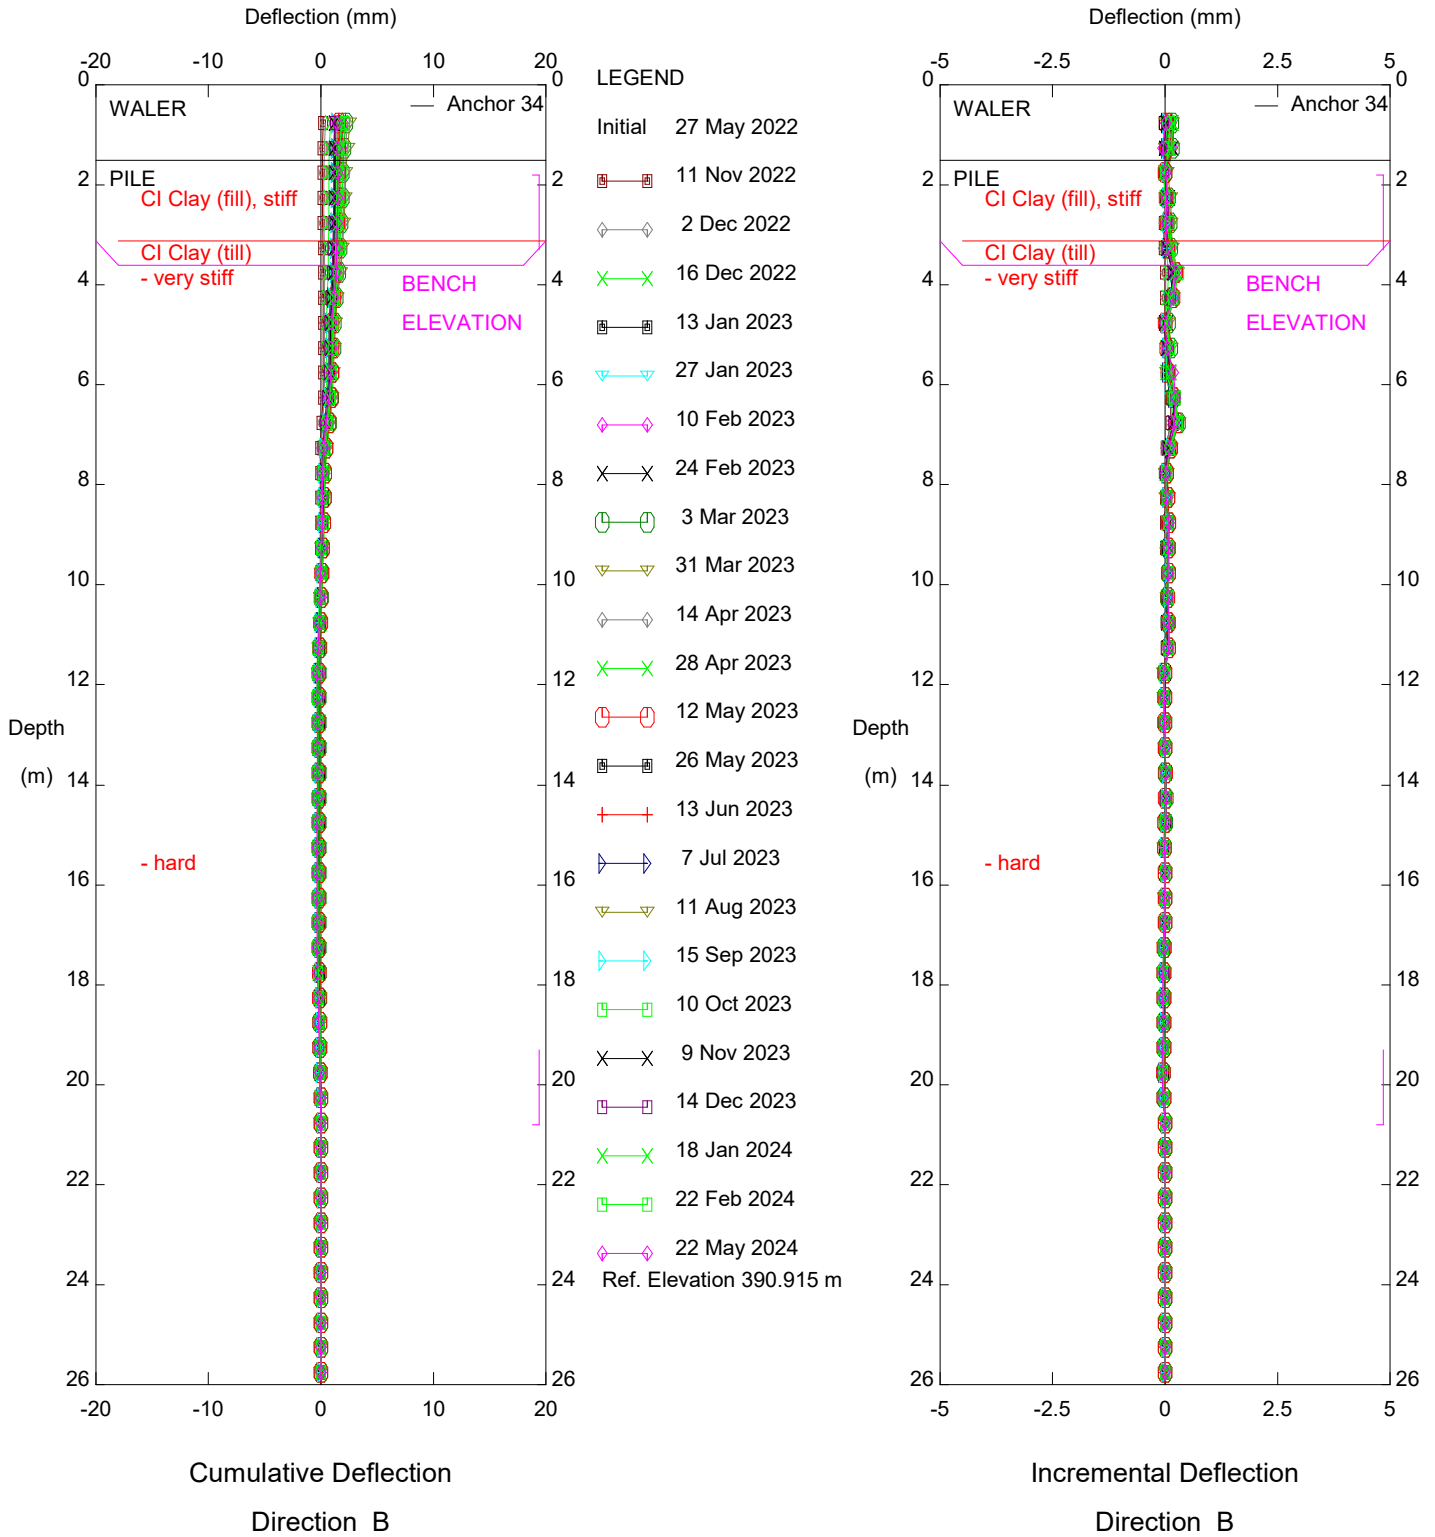
Shop Slide Type 1 Wall Section, Inclinator SAA-P34

Dates of Note:
 July 31, 2021 - P34 poured, SAA installed
 February 8-April 20, 2022 - wall backfilled to top of water
 April 20, 2022 - Anchor A34 locked off
 April 20-May 31, 2022 - wall backfilled to top of lagging and road level
 May 3-June 27, 2022 - Grading downslope of pile wall
