ALBERTA TRANSPORTATION AND
ECONOMIC CORRIDORS
GEOHAZARD ASSESSMENT PROGRAM
PEACE REGION (PEACE RIVER DISTRICT)
2025 INSPECTION

Site Number	Location	Name	Hwy	km
PH093-1	Brick's Hill/Shaftesbury Trail	The Big Eddie	684:02	8.86-8.98
Legal Description		UTM Co-ordinates		
NW24/SW25-91-23-W5M		11 E 467,076	N	6,219,660

PH093: BIG EDDIE: HWY 684:02 KM 8.86 TO KM 8.98
2025 SITE INSPECTION PLAN

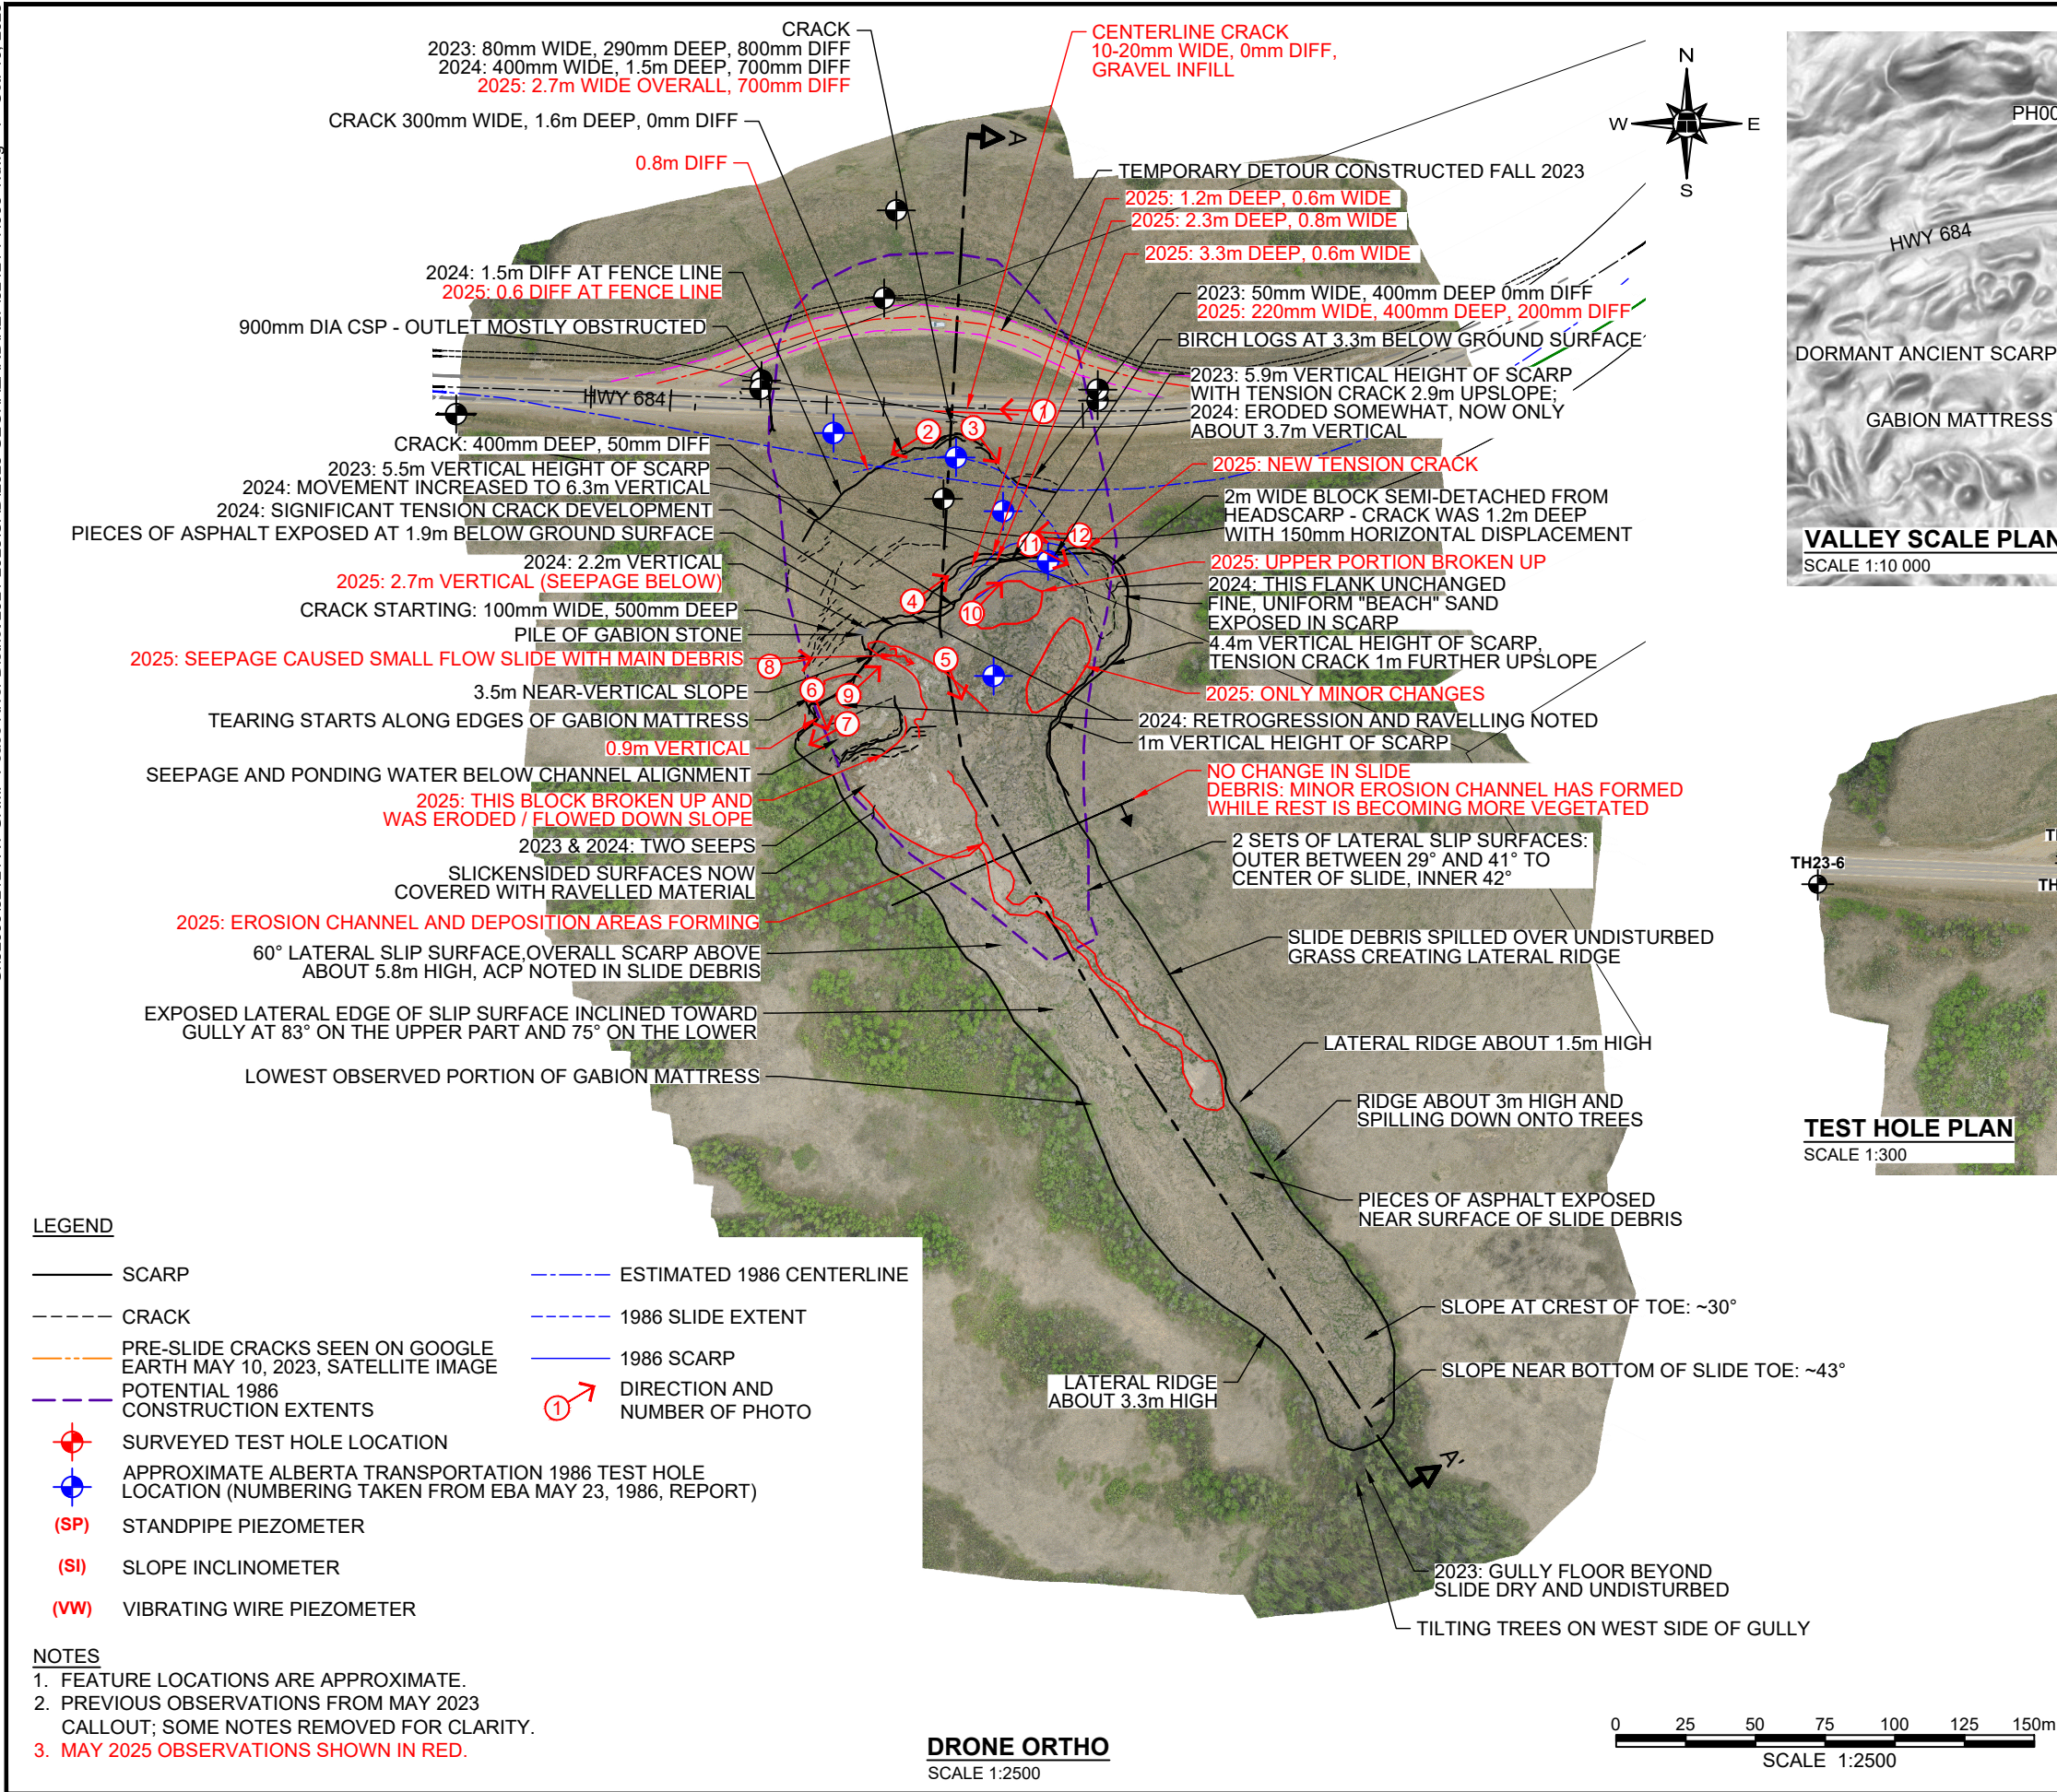
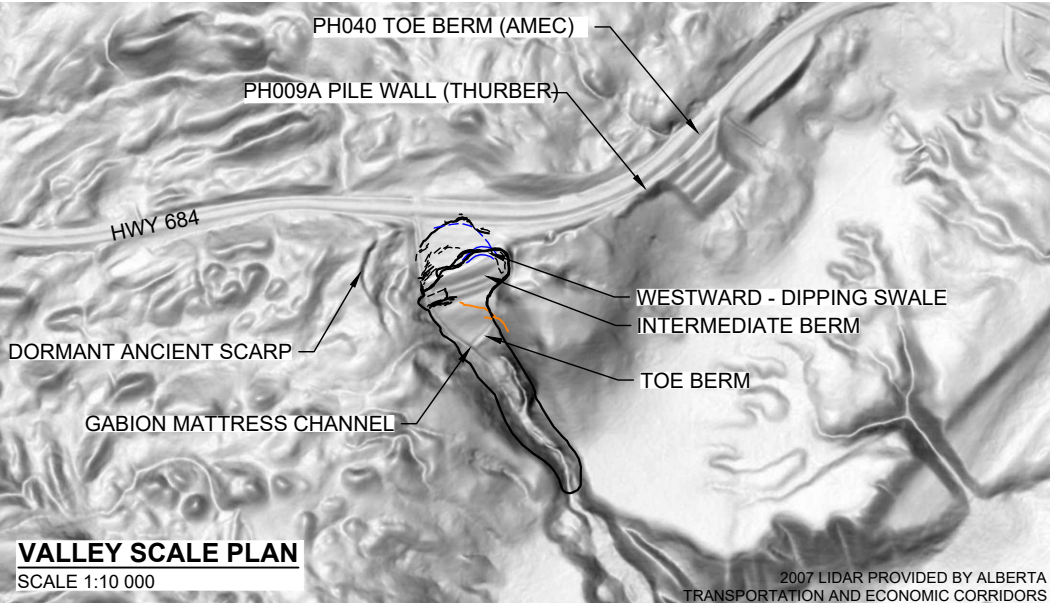
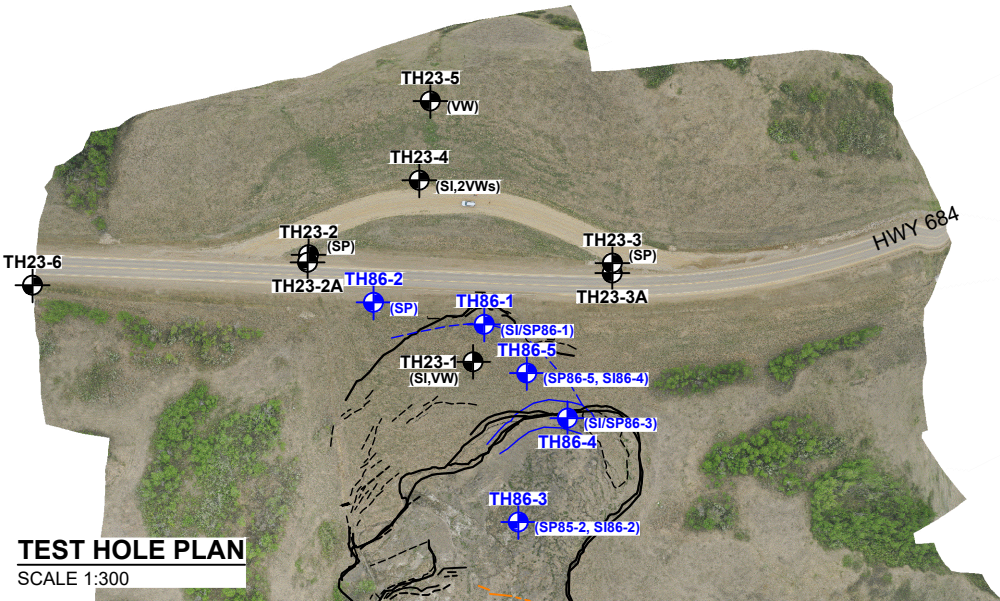
DWG No. 32121-PH093-1

Primary Site Issue:	Massive flow slide through existing fill located downslope of the highway with retrogressive cracks in the sideslope within 3.5 m of highway shoulder. The slide is located where a similar slide occurred in 1986. The current slide has overwhelmed the mitigation work done to repair the 1986 slide.	
Dimensions:	Main landslide is 340 m long, and 43 m from the highway. The main head scarp is about 120 m wide and 6.3 m high while the main earth flow slide body is about 50 m wide.	
Date of Remediation:	1986: Translational landslide repaired using subdrains and toe berm to pinch off the movement flow at the narrow part of the flow path. 2023: Temporary detour constructed to north of site, accepting that the slide retrogression could affect the highway with little warning.	
Maintenance:	2023: Jersey barriers and warning signs installed.	
Observations:	Description	Worsened?
<input checked="" type="checkbox"/> Pavement Distress	Centerline crack about 30 m long (may be from paving).	<input type="checkbox"/>

<input checked="" type="checkbox"/> Slope Movement	Tension crack arcs along south highway sideslope and continues to drop and widen. The headscarp is slowly retrogressing and may rapidly retrogress as water infiltrates the cracks.	<input checked="" type="checkbox"/>
<input checked="" type="checkbox"/> Erosion	Ongoing seepage and weathering causing upper slide blocks to erode.	<input checked="" type="checkbox"/>
<input checked="" type="checkbox"/> Seepage	There are damp areas on the west flank. The location of previously installed subdrains is not known. Seepage from the headscarp observed in 2025.	<input checked="" type="checkbox"/>
<input checked="" type="checkbox"/> Bridge/Culvert	Outlet of 900 mm CSP on west side is mostly obstructed. Temporary detour has diverted ditch flow to the east along the north side of the highway.	<input type="checkbox"/>
<input type="checkbox"/> Other		<input type="checkbox"/>

- Routine monitoring to determine if tension cracking has started within the pavement. If this occurs, then traffic should be shifted onto the temporary detour.

- The geotechnical drilling investigation has been completed. The preliminary engineering assessment is underway to consider the potential long-term remediation options.
- Ongoing monitoring of the instrumentation should be continued under the GRMP program.
- It is recommended that this site be inspected annually under the GRMP program.
