**ALBERTA TRANSPORTATION
GEOHAZARD ASSESSMENT PROGRAM
PEACE REGION – HIGH LEVEL
2020 CALLOUT**

Site Number	Location	Name	Hwy	km
PH075-2	North of Town of Peace River	Whitemud River (km 44.8)	743:02	44.8
Legal Description		UTM Co-ordinates		
NE02-88-21-W5		11V N 6273979	E 486113

PH075-2 AUGUST 4, 2020 CALL OUT PLAN

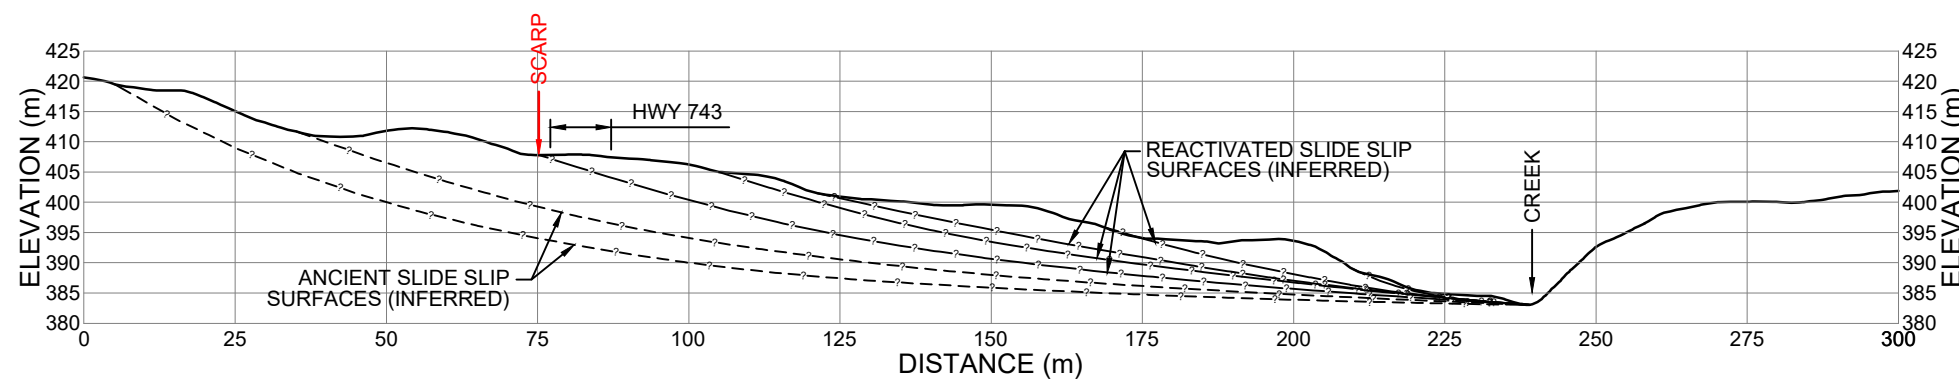
SECTION
SCALE 1:1250

Primary Site Issue:	A landslide scarp has developed in the surface of a two laned gravelled road.		
Dimensions:	55 m wide along the shoulder, approx. 275 m wide at the creek and 160 m long from the highway to the creek.		
Date of any remediation:			
Maintenance:	Highway officially closed on July 13, 2020 due to landslide movements at other sites.	Worsened?	
Observations:	Description	Yes	No
<input checked="" type="checkbox"/> Pavement Distress	Cracks and dip in gravel road surface.	<input checked="" type="checkbox"/>	<input type="checkbox"/>
<input checked="" type="checkbox"/> Slope Movement	Cracks and dip across roadway indicate slope movement. LiDAR indicates historical scarps on slope above and below roadway.	<input checked="" type="checkbox"/>	<input type="checkbox"/>
<input checked="" type="checkbox"/> Erosion	Erosion occurring in east ditch sporadically over 200 m length between Km 44.3 to 44.1 south of PH075-1 (photo 4 and 5)	<input checked="" type="checkbox"/>	<input type="checkbox"/>

The most practical solutions available at the PH075-2 landslide site involve monitoring and re-aligning the highway away from the current slide cracks.

- A localized realignment of the roadway around the slide could be carried out if the road condition worsens.
- A local driven steel pile wall might also be considered to provide temporary support to the road but might become distorted and fall out of service over time if the larger slide blocks move again.
