**ALBERTA TRANSPORTATION
GEOHAZARD ASSESSMENT
PEACE REGION (PEACE RIVER DISTRICT)
2021 INSPECTION**

Site Number	Location	Name	Hwy	km
PH075-1	North of Peace River	Whitemud River (km 44.4)	743:02	44.4
PH075-2		Whitemud River (km 44.8)		44.8
Legal Description		UTM Co-ordinates		
NE2-88-21-W5M		11U E 486,395 486,112	N	6,273,737 6273,982

**PH075-1: HWY 743:02 AT km 44.4
2021 GEOHAZARD ASSESSMENT**

**PH075-2: HWY 743:02
2021 SITE INSPECTION PLAN**

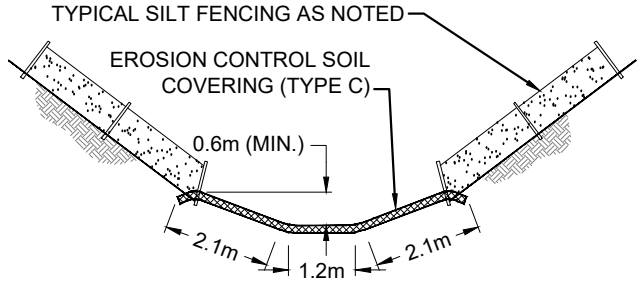
DETAIL
N.T.S.

SHALLOW GULLY (0.6m WIDE, 0.4m DEEP) - 2014
 (1.2m WIDE, 0.4m DEEP) - 2015
 (1.2m WIDE, 0.6m DEEP) - 2016
 (1.3m WIDE, 0.6m DEEP) - 2017
 (1.4m WIDE, 0.7m DEEP) - 2018-2020
