**ALBERTA TRANSPORTATION  
GEOHAZARD ASSESSMENT PROGRAM  
PEACE REGION (PEACE RIVER DISTRICT)  
2021 INSPECTION**

Site Number	Location	Name	Hwy	km
SH010-1	Little Smoky River	Little Smoky River Valley, South Hill – Site #1	744:02	14.4-14.7
Legal Description		UTM Co-ordinates		
NE-13-76-23-W5		11U E 473,759	N	6,160,016

**SH010: HWY 744:02 LITTLE SMOKY RIVER VALLEY (SITE #1)  
2021 SITE INSPECTION PLAN**

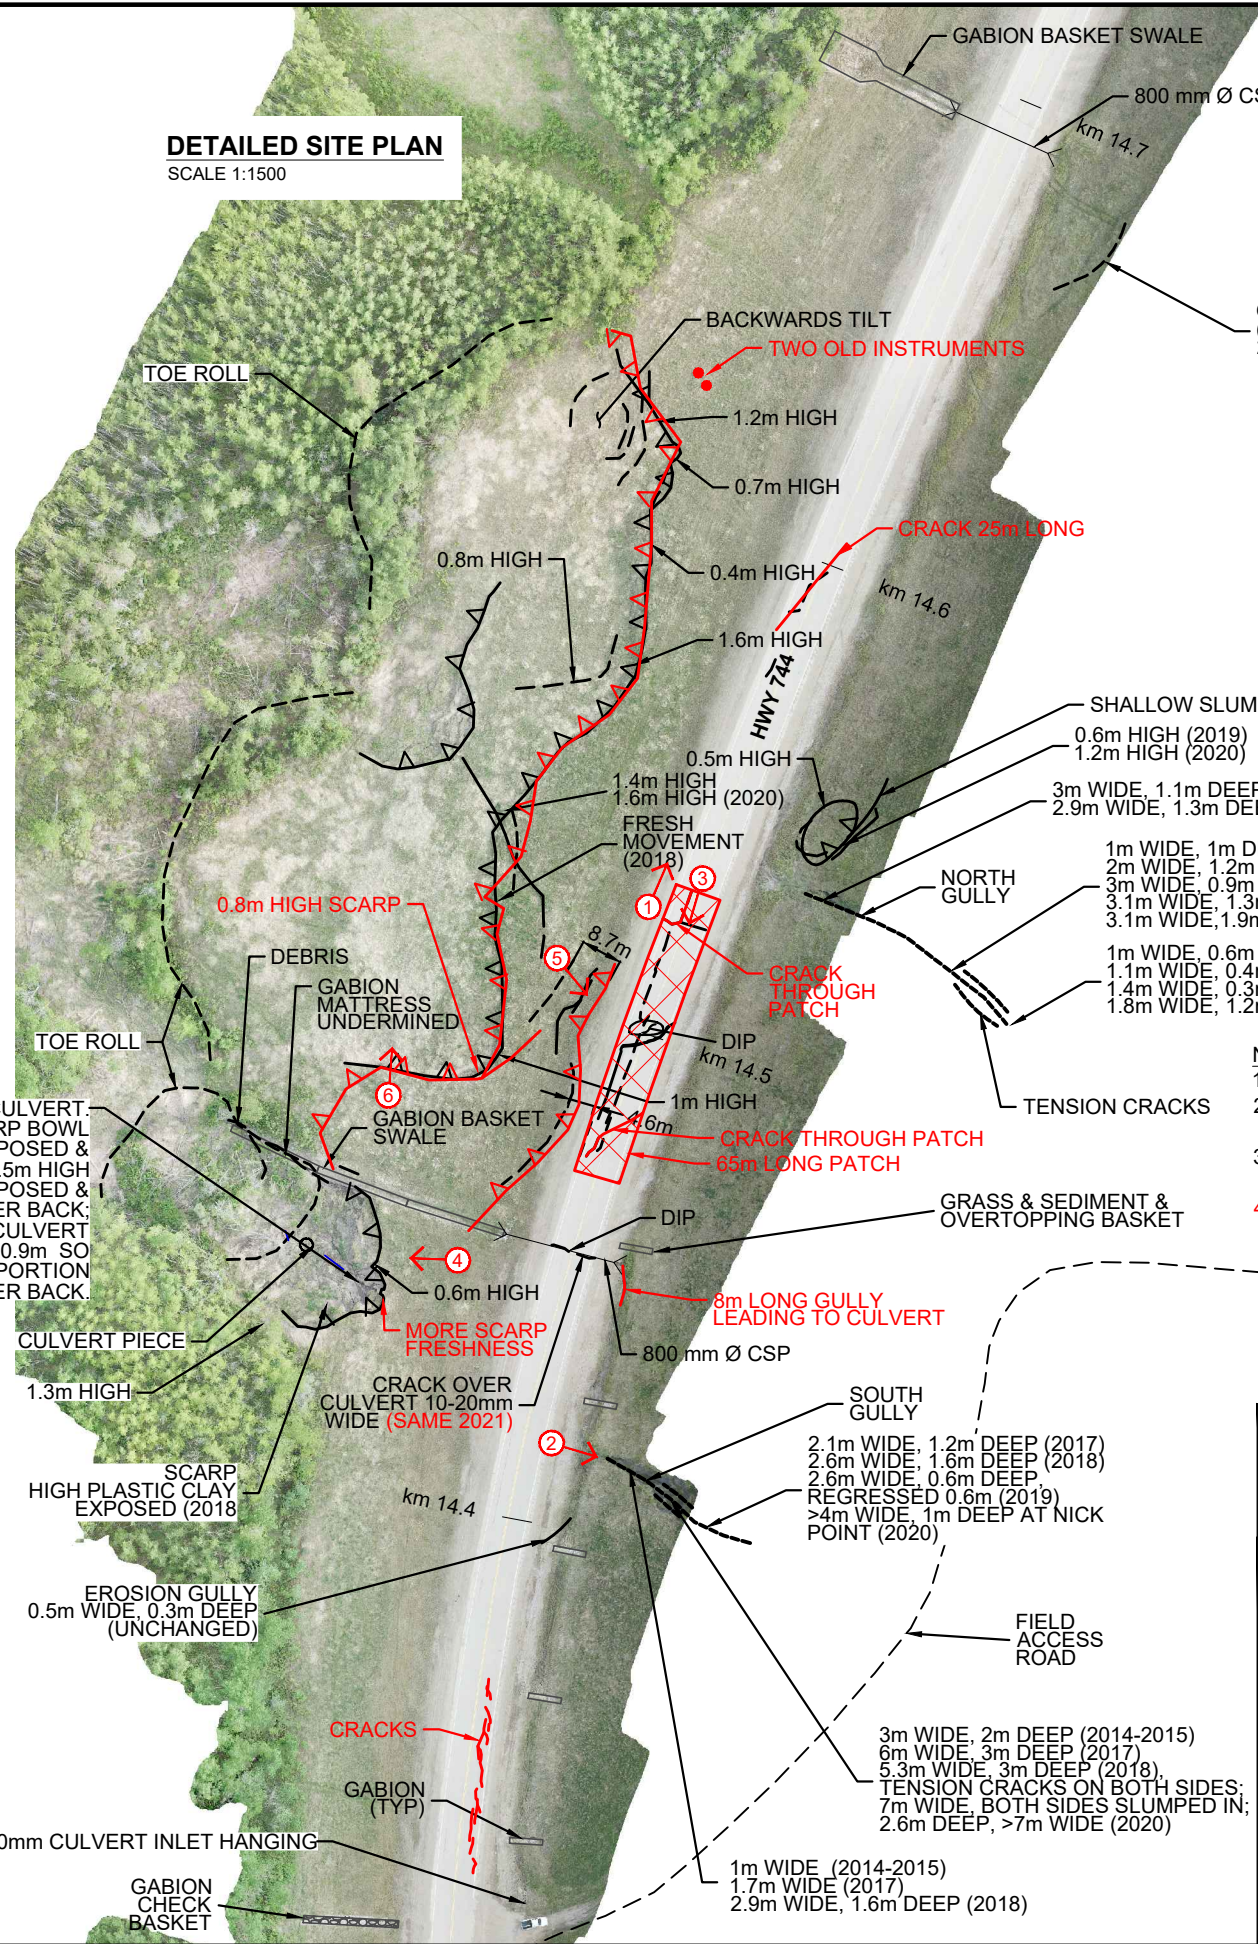
EXPOSED END OF OLD CULVERT:  
2019: OUTLET 0.74m ABOVE SCARP BOWL  
NORTH SIDE: 2.8m LENGTH EXPOSED &  
SCARP 1.5m HIGH  
SOUTH SIDE: 3.65m LENGTH EXPOSED &  
SCARP 1.7m FURTHER BACK;  
2020: 4.9m LONG PIECE OF CULVERT  
DETACHED. SCARP EXPOSING 0.9m SO  
REGRESSED 0.5m SINCE 2019. A PORTION  
OF THE SCARP IS 1.6m FARTHER BACK.
