**ALBERTA TRANSPORTATION
GEOHAZARD ASSESSMENT PROGRAM
PEACE REGION – SWAN HILLS
2020 INSPECTION**

Site Number	Location	Name	Hwy	km
SH013-13	Little Smoky River	Little Smoky River Valley, North Hill – Site #13	744:02	21.36-21.49
Legal Description		UTM Co-ordinates		
SE28/SW27-76-22-W5M		11U E 478,608	N	6,162,922

**SH013-13: HWY 744:02 LITTLE SMOKY RIVER VALLEY
2020 SITE INSPECTION PLAN**

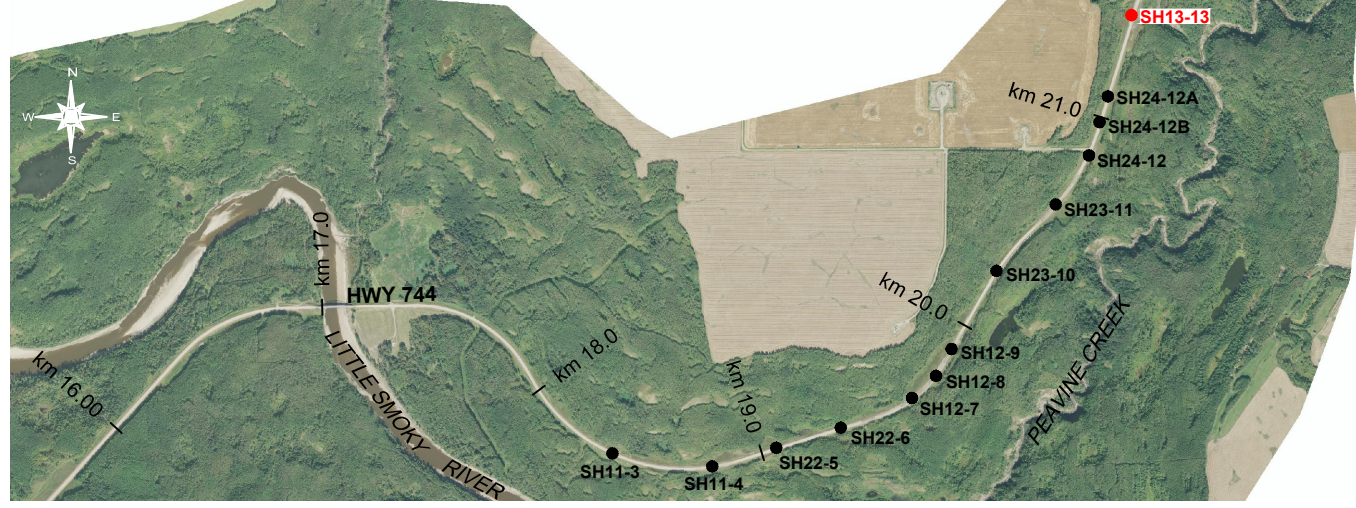
OVERALL SITE PLAN
SCALE 1:30 000

STAKE	SCARP (HEIGHT)	
	2019	2020
A	3.1m (1.5m HIGH)	? (1.8m HIGH)*
B	1.5m DOWNSLOPE 1.7m LATERAL	0.3m / 2.0m** (0.5m HIGH)
C	1.3m 11.6m TO GUARDRAIL	0m / 2.0m**
D	0.6m	FELL / 2.0m**
E	0.6m TO CRACK 1.9m TO SCARP (0.5m HIGH)	0.6m TO CRACK 1.9m TO SCARP (0.5m HIGH)

* STAKE MISSING; SCARP HEIGHT MEASURED AT APPROXIMATE LOCATION
** OFFSET FROM SCARP BEFORE/AFTER STAKE RELOCATED
