**ALBERTA TRANSPORTATION
GEOHAZARD ASSESSMENT PROGRAM
PEACE REGION – SWAN HILLS
2020 INSPECTION**

Site Number	Location	Name	Hwy	km
SH024-12 SH024-12B* SH024-12A* SH024-12D**	Little Smoky River	Little Smoky River Valley, North Hill – Sites #12, #12B, #12A, and #12D	744:02	20.80-20.90 20.94-21.03 21.03-21.12 21.17-21.30
Legal Description		UTM Co-ordinates		
Site 12: NE21-76-22-W5M		11U E 478,432	N	6,162,375
Site 12B: NE21-76-22-W5M		11U E 478,472	N	6,162,492
Site 12A: NE21-76-22-W5M		11U E 478,504	N	6,162,588
Site 12D: NE21- and SE28-76-22-W5M		11U E 478,550	N	6,162,737

**SH024-12: HWY 744:02 LITTLE SMOKY RIVER VALLEY
2020 SITE INSPECTION PLAN**

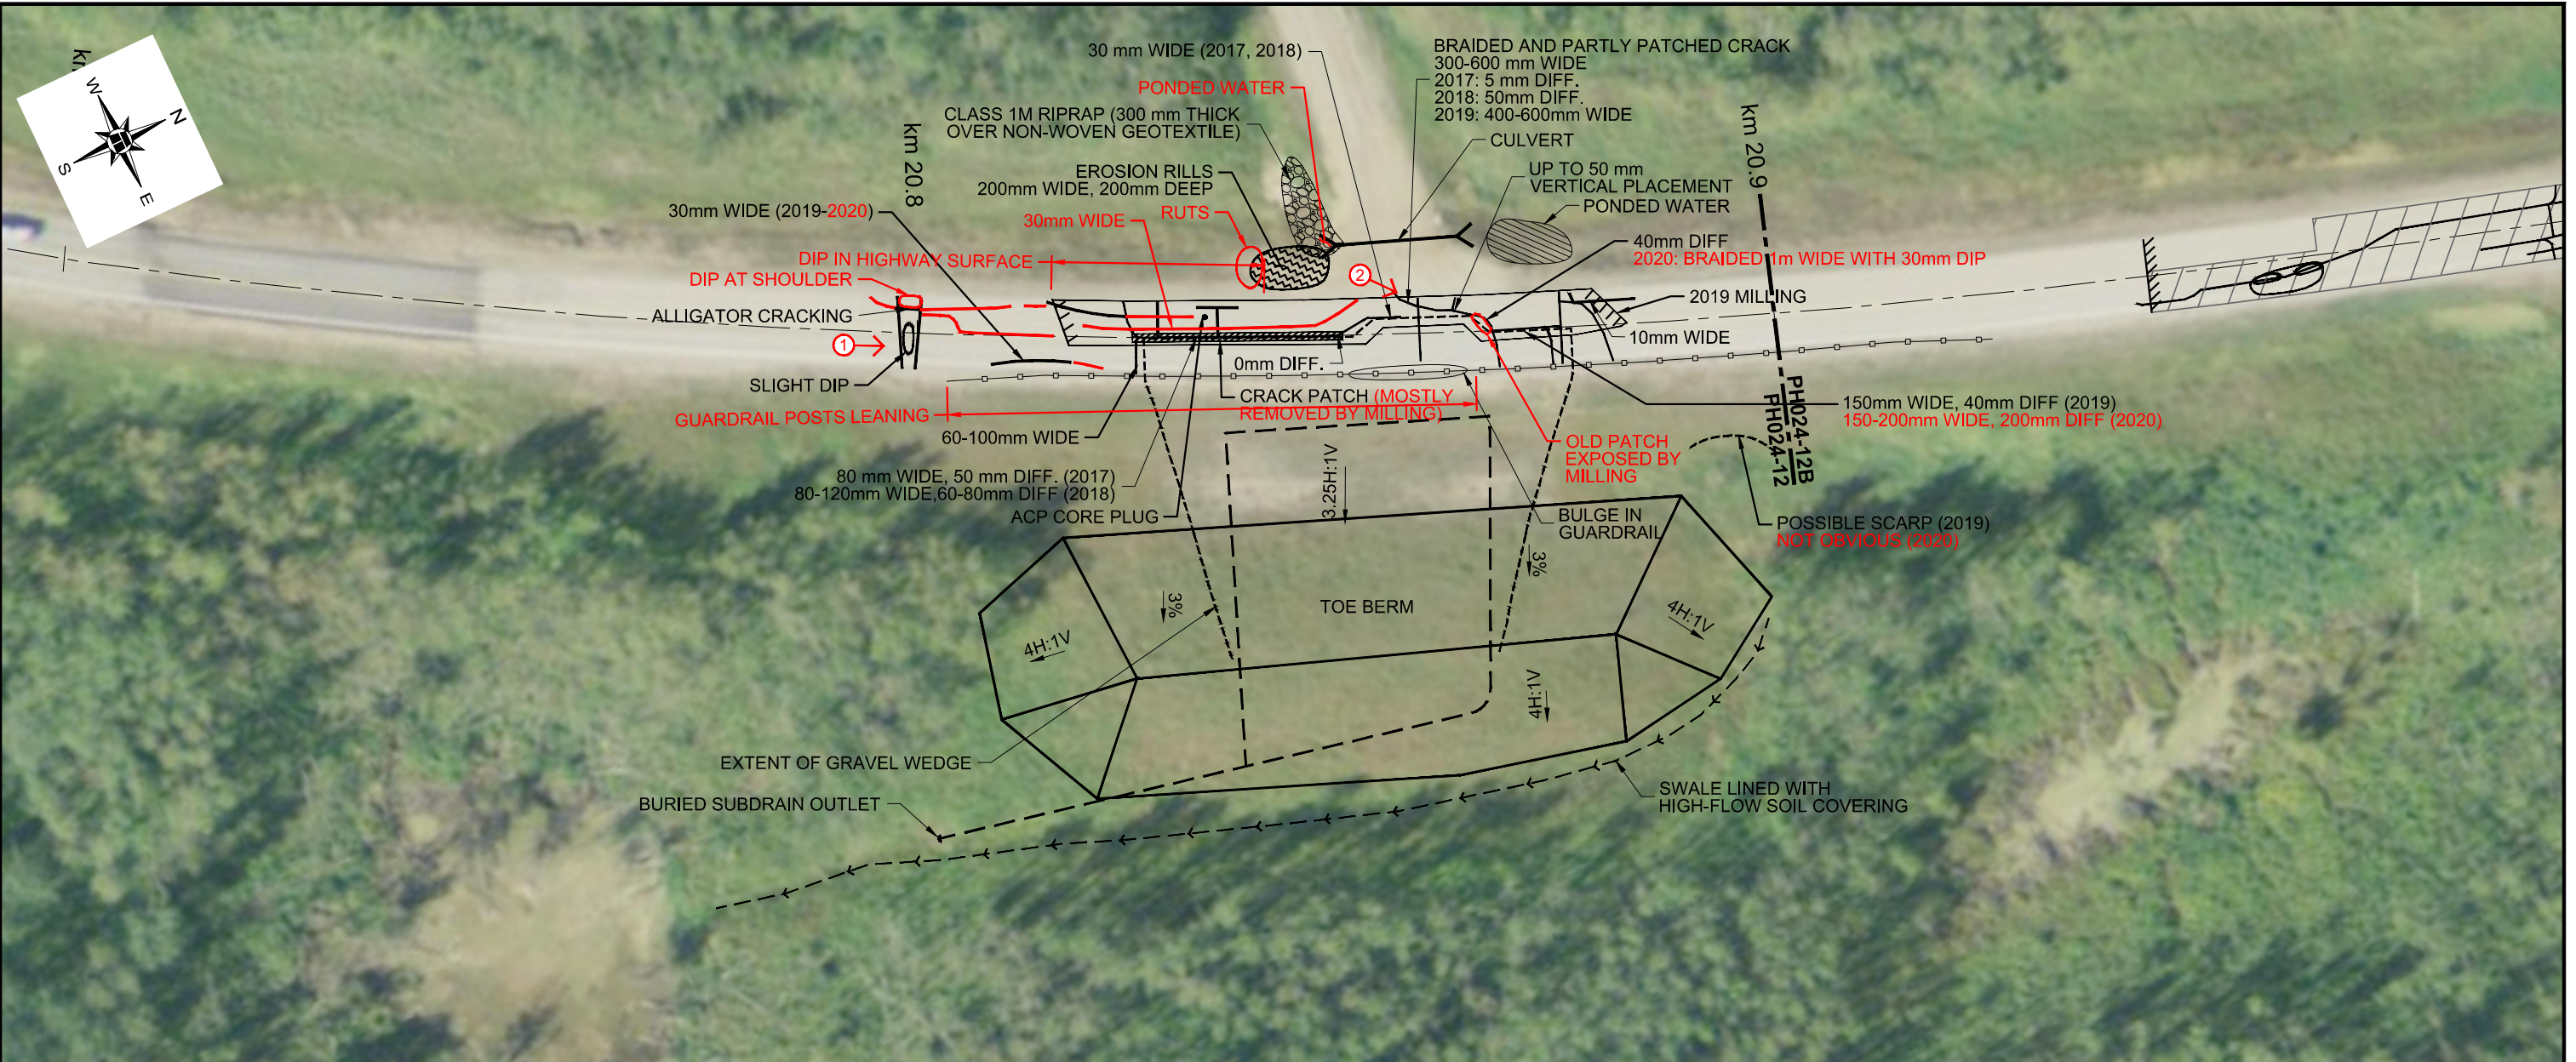
DETAILED SITE PLAN

<input checked="" type="checkbox"/> Slope Movement	Site is located on an active deep-seated landslide moving toward the Peavine Creek. The toe berm appears to be functioning to stabilize the local embankment.	<input type="checkbox"/>
<input checked="" type="checkbox"/> Erosion	Minor erosion along grassed-lined channel at culvert outlet (km 21.081).	<input type="checkbox"/>
<input type="checkbox"/> Seepage		<input type="checkbox"/>
<input checked="" type="checkbox"/> Bridge/Culvert Distress	Culvert at km 21.081: outlet of SWSP liner is rusting.	<input type="checkbox"/>
<input type="checkbox"/> Other		<input type="checkbox"/>
Instrumentation:		
None.		
Assessment:		
<p>The overall valley slope is moving as several separate slide blocks in response to the toe erosion and downcutting of two different rivers resulting in numerous scarps, sag ponds, and differential movement zones going in slightly different directions. The highway intersects the scarps of these blocks at several locations resulting in an uneven highway surface and cracking.</p> <p>Site 12: The main slide scarp crack was visible at the Township Road 764 (TR764) intersection and the site required milling in 2019 to remove the growing vertical differential. The main crack was also patched afterward. The vertical differential and crack development continued to deteriorate despite the recent maintenance. In 2020, there appeared to be a slight sag in the highway surface just south of the TR764 intersection. The south 2/3's of the guardrail appears to be leaning downslope and vertical deflection of the rail was noted across from the TR764 intersection. Overall, the toe berm appears to be functioning to stabilize the highway fill embankment; however, it is not conclusive if the pavement cracking and guardrail deformation is related to the local or global slope movements. A potential scarp</p>

feature was identified on the sideslope of the highway embankment just north of the toe berm but was not apparent in 2020.

There is some longitudinal and transverse cracking along the highway above the toe berm; however, it was not apparent if this was related to subgrade issues or slope movement. The site was milled in 2019 which has exposed additional cracks. There was continued deterioration observed in 2020. Two zones of seepage were noted in the downslope ditch which may be subdrain outlets. It appears that the toe berm has been successful in stabilizing the local highway embankment at this location.

- Road maintenance should continue as necessary to maintain a safe roadway surface and may consist of milling, patching, and crack sealing of the ACP.

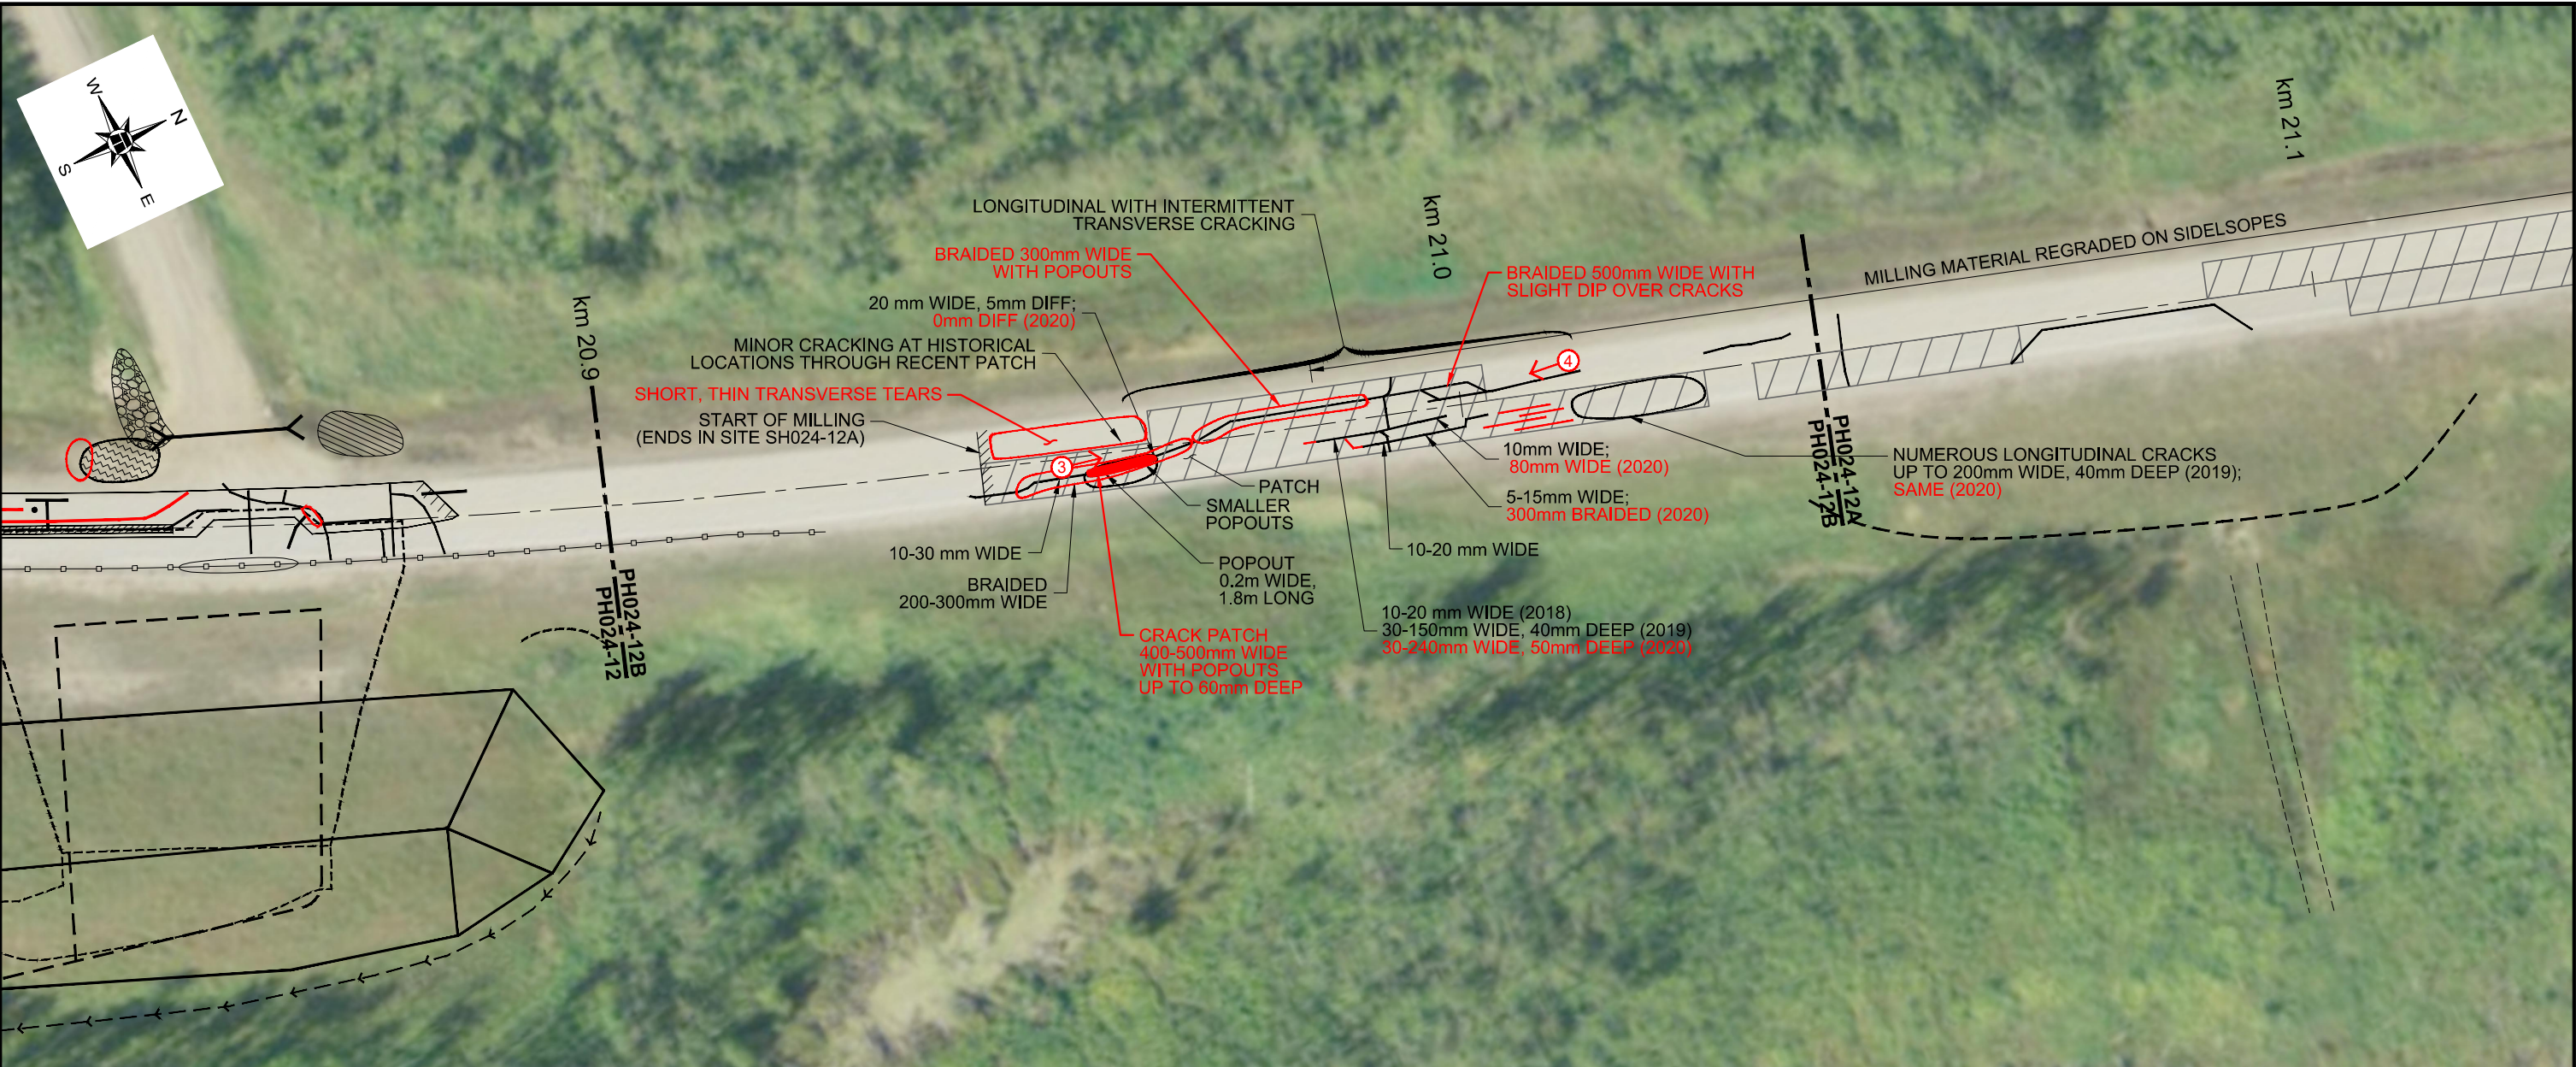
DETAILED SITE PLAN
SCALE 1:750

This site, an area of additional cracking between the two toe berms at Site #12 and Site #12A, was discontinued from the GeoHazard Assessment program in 2007. At the time of the 2016 inspection, there appeared to be a long crack roughly parallel to the highway that may be associated with slope movement and the width and extents of cracking have increased slightly each year following. The recent milling appears to have exposed previously-covered cracks and there does appear to be an arc-shape to the pattern. The crack widths are on the order of 10 mm to 20 mm with some areas up to 30 mm. Some of the cracks are braided with overall widths up to 500 mm and at least had a slight dip over the width of the braided cracks.
