<b>SITE NUMBER</b> SH 28	<b>SITE NAME</b> Little Smoky Valley	<b>HIGHWAY &amp; KM</b> HWY 744:02	<b>PREVIOUS INSPECTION DATE</b> 03 July 2014	<b>INSPECTION DATE</b> 25 June 2015
<b>LEGAL DESCRIPTION</b> LSD 13-18-76-22 W5M	<b>NAD 83 UTM COORDINATES</b> N6160721 E474084	<b>PREVIOUS RISK ASSESSMENT</b>		
		PF: 8*	CF: 3	<b>TOTAL: 24</b>
		<b>CURRENT RISK ASSESSMENT</b>		
		PF: 8*	CF: 3	<b>TOTAL: 24</b>
*There are currently no slope movement instruments installed at this site and it is difficult to estimate rates of movement.

PROJECT:	GEO HAZARD ASSESSMENT PEACE REGION (SWAN HILLS)
TITLE:	SH28: HWY744:02 - LITTLE SMOKY VALLEY SITE PLAN

DATE:	JULY, 2015
PROJECT No.:	EG10030
REV. No.:	A
FIGURE No.:	FIGURE 1

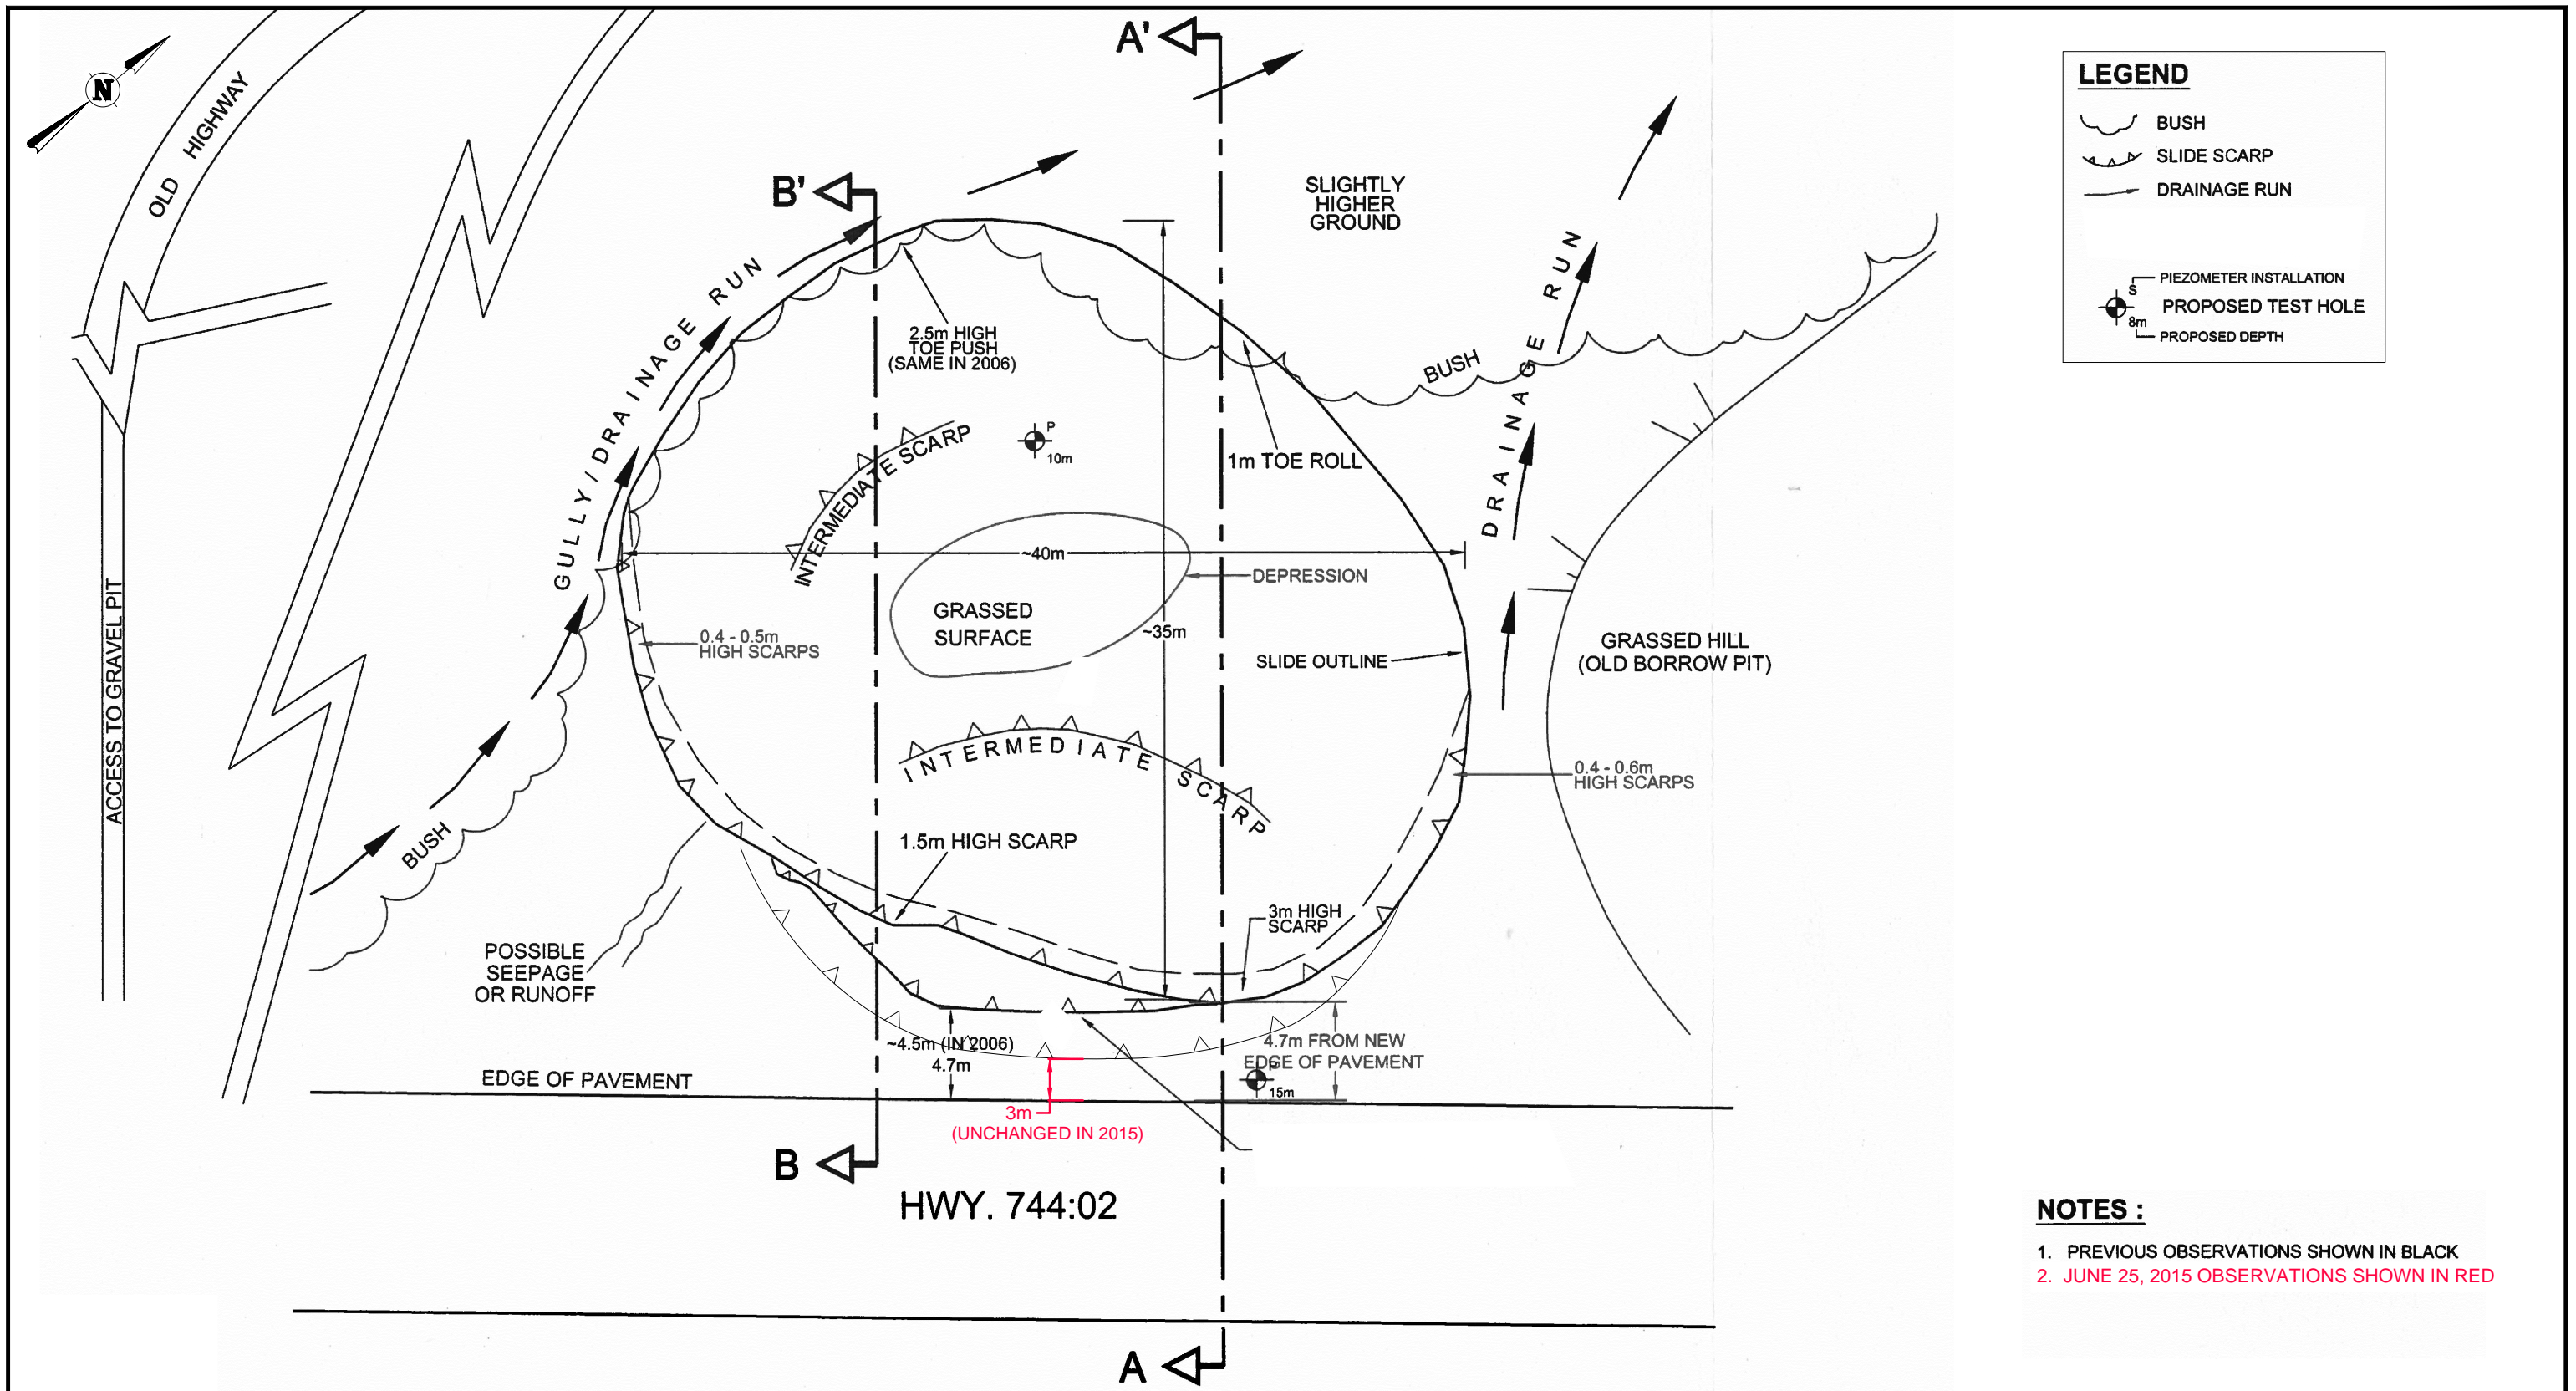
<p><b>PRIMARY SITE ISSUES:</b></p> <p>The primary issue at this site is a failure on the embankment (4 to 5 m high) and natural slope that has historically been encroaching on the highway. The oval-shaped failure occurred in Fall 2004. Currently, the failure headscarp is 3.0 m from the highway (asphalt) and there appears to have been no change between the 2014 and 2015 inspections.</p> <p>Based on a discussion with AT staff and local Amec Foster Wheeler experience, it is possible that the feature is failed uncontrolled fill material that has been saturated and subsequently failed on the natural grade. The backslope ditch is wet and it is possible there is seepage from the backslope side, under the highway and into the failure area.</p> <p><u>Note:</u> Refer to previous inspection reports for further details</p>
<p><b>APPROXIMATE DIMENSIONS:</b></p> <p>Oval shaped failure approximately 45 m wide (along highway) and about 35m in length (perpendicular to highway). The headscarp is up to 3 m in height, and currently 3 m from the road (5.1 m from the white line). The failure mass is estimated to be approximately 3 m deep at its deepest. The overall embankment slope is at ~19 degrees from horizontal in the area.</p>

ITEM	CONDITION EXISTS		DESCRIPTION AND LOCATION	NOTICABLE CHANGE FROM LAST INSPECTION		
	YES	NO		YES	NO	See Comment
PAVEMENT DISTRESS		X			X	
SLOPE MOVEMENT	X		Oval shaped failure of possible saturated, uncontrolled fill. Headscarp of failure is ~3 m from the edge of the roadway.		X	
EROSION		X			X	
SEEPAGE	X		Possible seepage from backslope ditch, under highway and into failure area.		X

A guard rail would be required along the roadway if the headscarp of the failure is within or retrogresses into the Clear Zone of the roadway. If retrogression is observed in the future, stabilization of the failure would be required to preserve the R/W and to mitigate further retrogression and encroachment towards the highway. Stabilization/remediation may include drainage improvements and slope flattening/buttressing. An investigation and possibly instrumentation would be required if remedial works were planned.
