ALBERTA TRANSPORTATION AND
ECONOMIC CORRIDORS GRMP
PEACE REGION – (PEACE RIVER DISTRICT)
INSTRUMENTATION MONITORING - SPRING 2025

Site Number	Location	Name	Hwy	km
PH031	HWY 744:04 C1 57.7	Michelin Slide- Judah Hill	744:04	Km 57.7
Legal Description:		UTM Co-ordinates		
9-20-83-21 W5		11U E 483125.92	N	6229725.01

Current Monitoring:	9-Jun-2025	Previous Monitoring	21-Sep-2024
Instruments Read By:	Mr. Niraj Regmi, G.I.T and Mr. Godfred Etiendem, of Thurber

SITE PH031: HWY 744:04, JUDAH HILL (MICHELIN SLIDE)

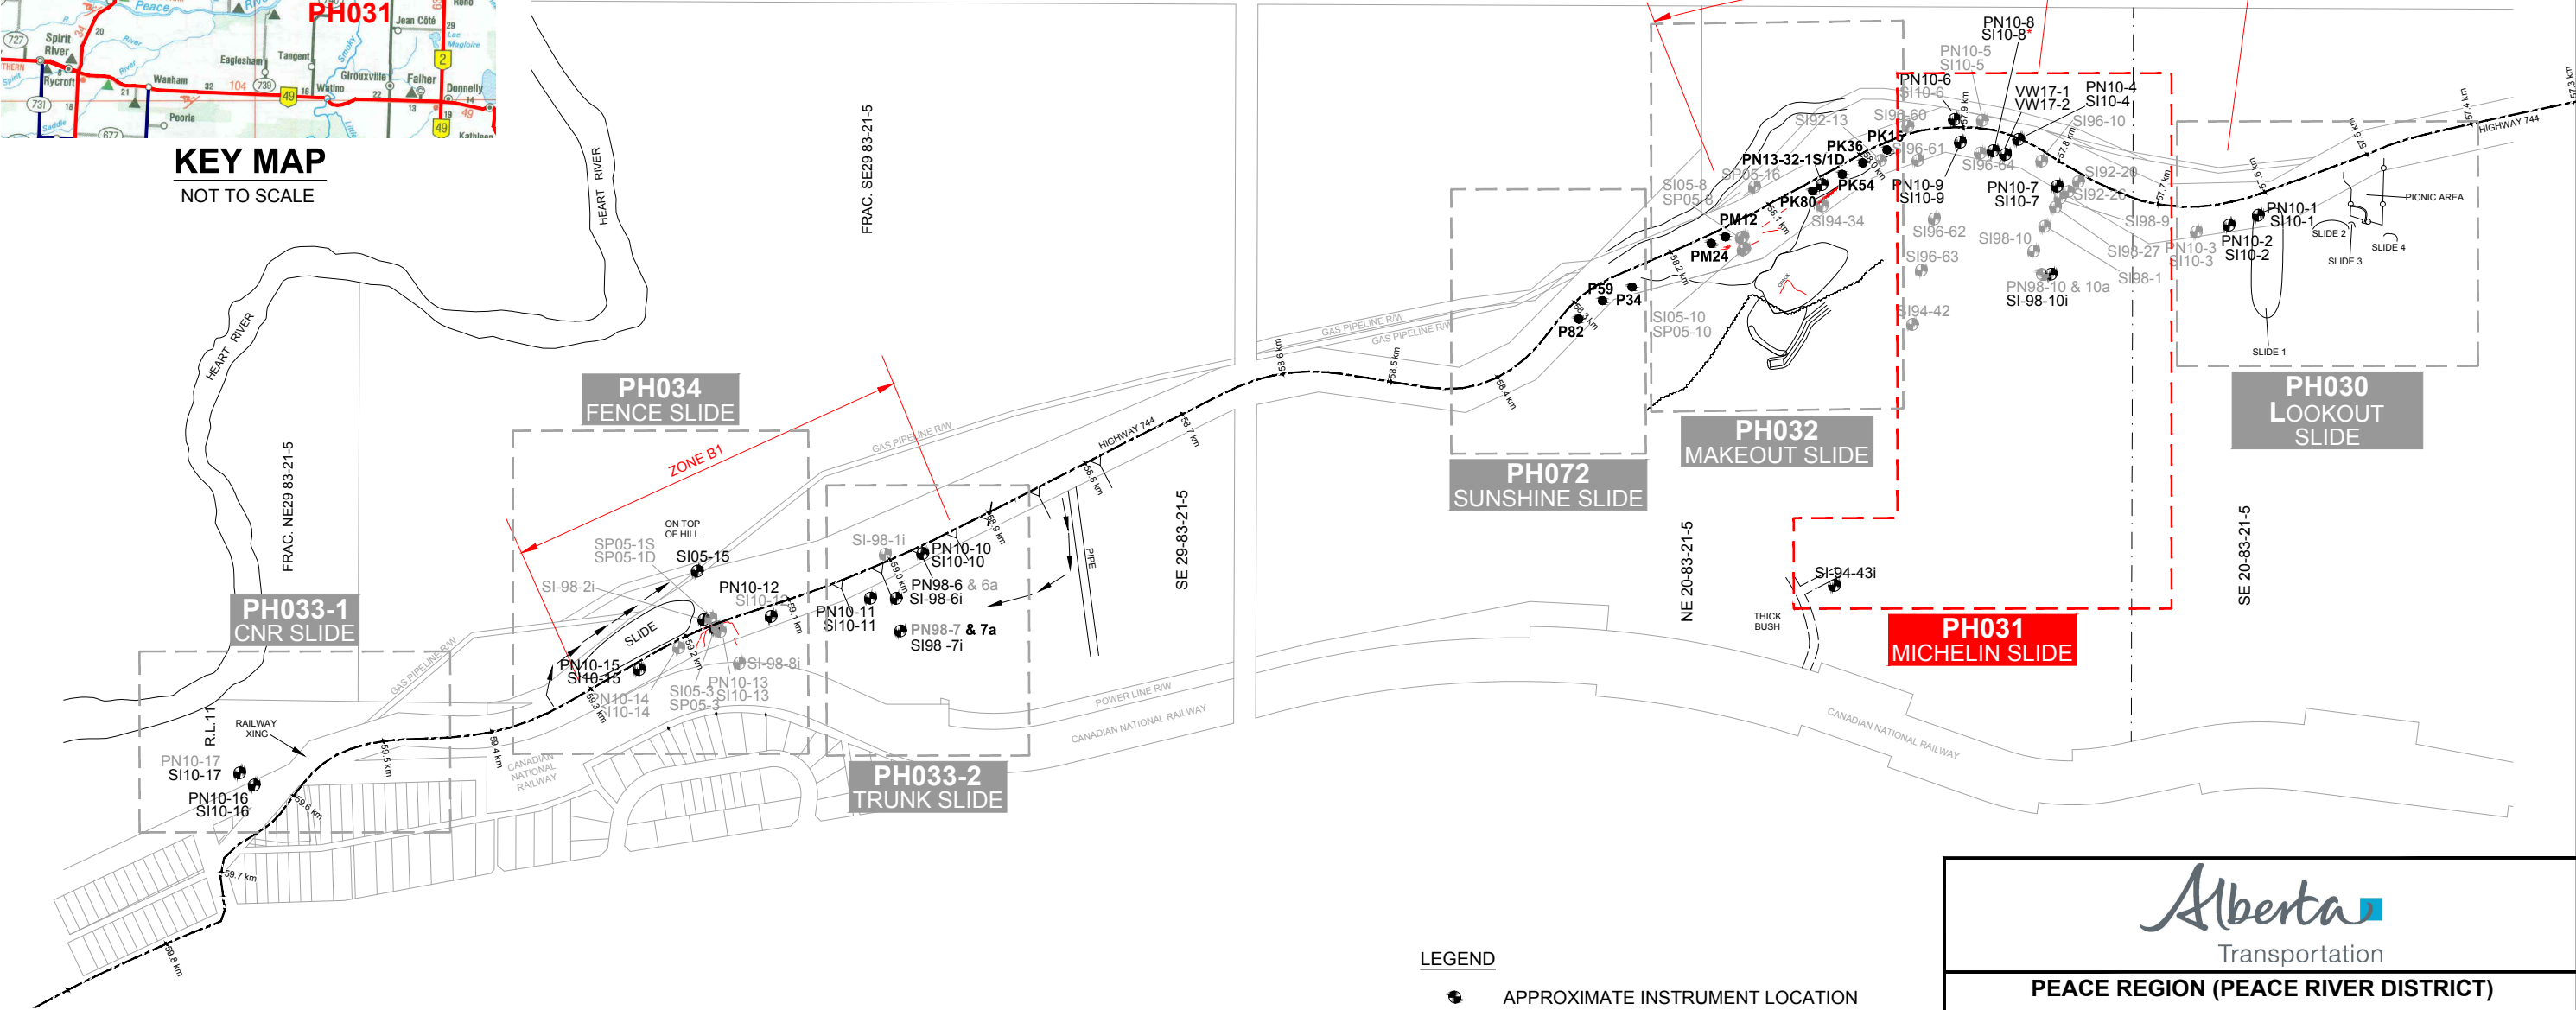
DWG No. 32121-PH031

NOTE:
* A SHAPE ACCELEROMETER ARRAY (SAA) WAS INSTALLED
INSIDE THE **SI10-08** CASING IN DECEMBER 2014.
