ALBERTA TRANSPORTATION GEOHAZARD ASSESSMENT PROGRAM PART A: FILE REVIEW

PEACE REGION – PEACE-HIGH LEVEL

PH34 JUDAH HILL – FENCE SLIDE

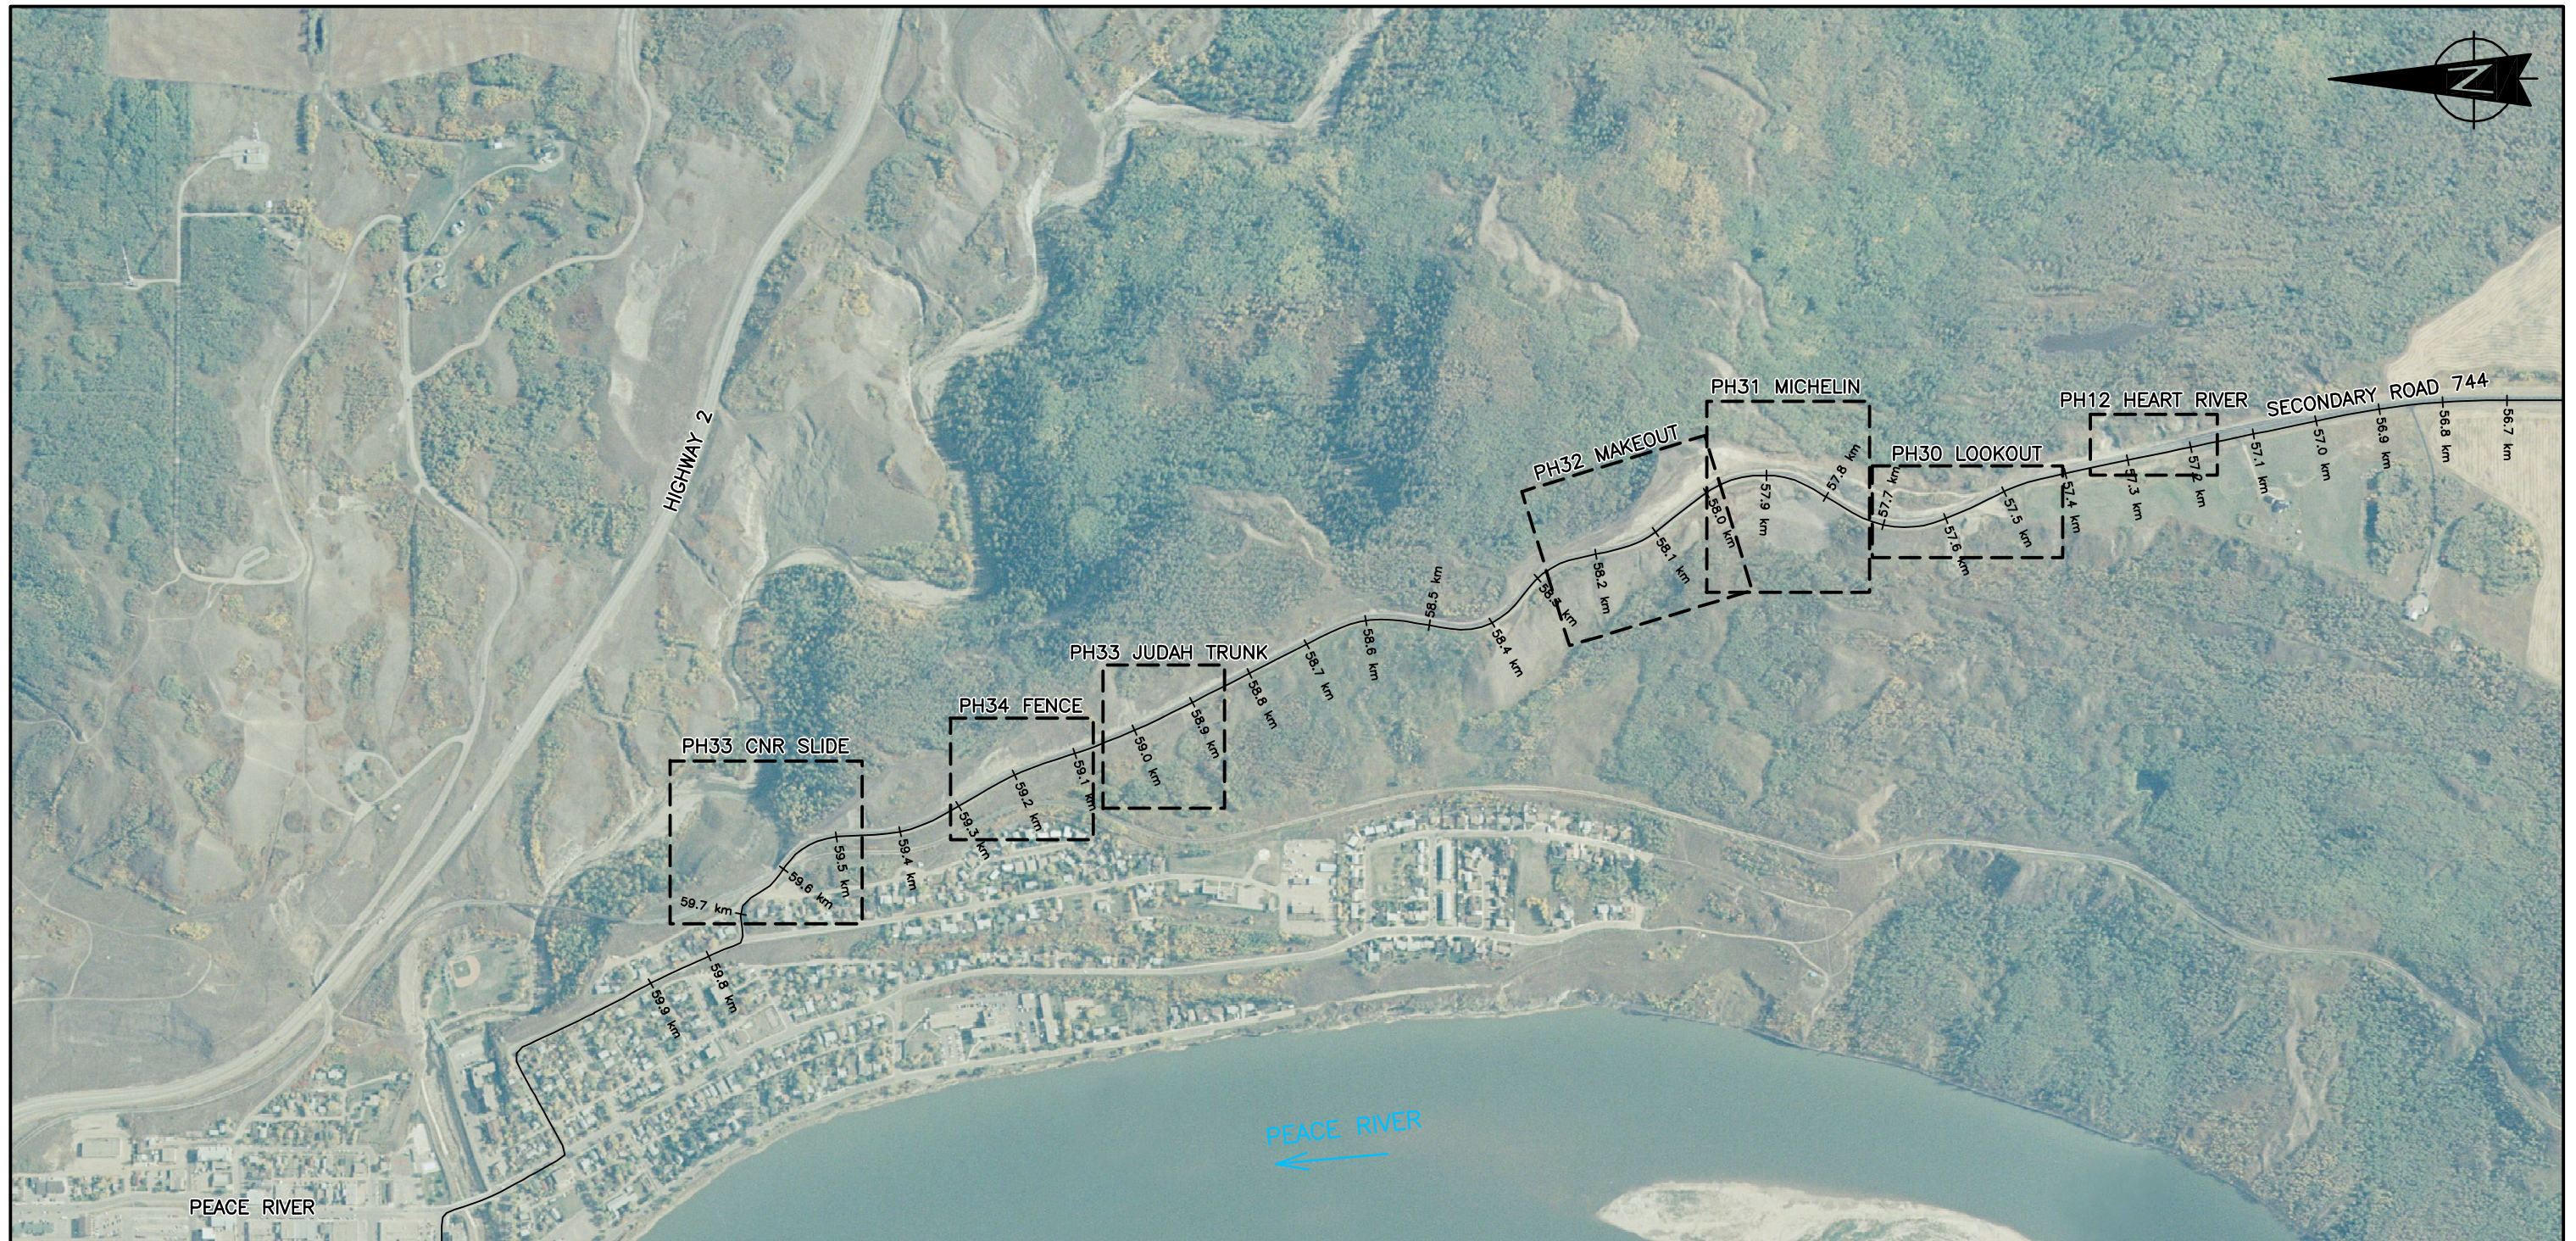
CRACKING HAS WORSENERD SINCE 2007 AND DEPRESSION NOW > 300 mm CAUSING N-BOUND VEHICLES TO TIP INTO ON-COMING TRAFFIC

CRACKS EXTEND 2.5m BEYOND ASPHALT REPAIR

CRACKING HAS EXTENDED AND WORSENERD

CRACK IN NEW PAVEMENT POSSIBLY AT EXTENT OF REPAIR

CRACKING AND DEPRESSIONS IN ASPHALT REPAIR
